HMS VICTORY CONSERVATION MANAGEMENT PLAN

Volume 1

**THE
NATIONAL
MUSEUM**

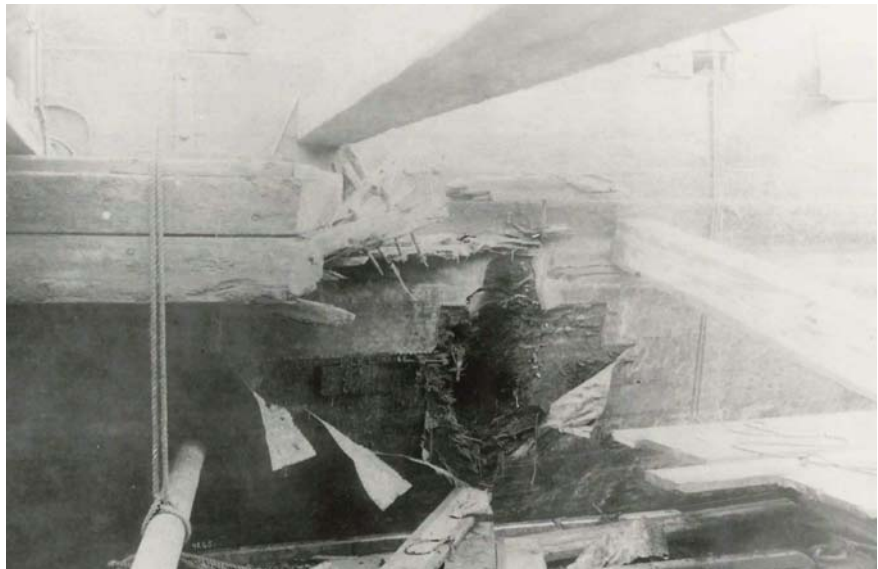
Plate 6. An image of *Victory* in dock showing the damage sustained to the hull following the ramming by HMS *Neptune* in 1903

The unfortunate accidental ramming of *Victory* in 1903 by HMS *Neptune* necessitated urgent repairs, and it was during this episode that attempts were made to reconfigure the area of the cockpit on the orlop deck (where the principal damage was sustained during the ramming) where Nelson spent his last moments (**Plate 6**). This marks the beginning of a conscious effort to symbolise this event in restoring elements of the ship fabric to the perceived configuration of that at Trafalgar.

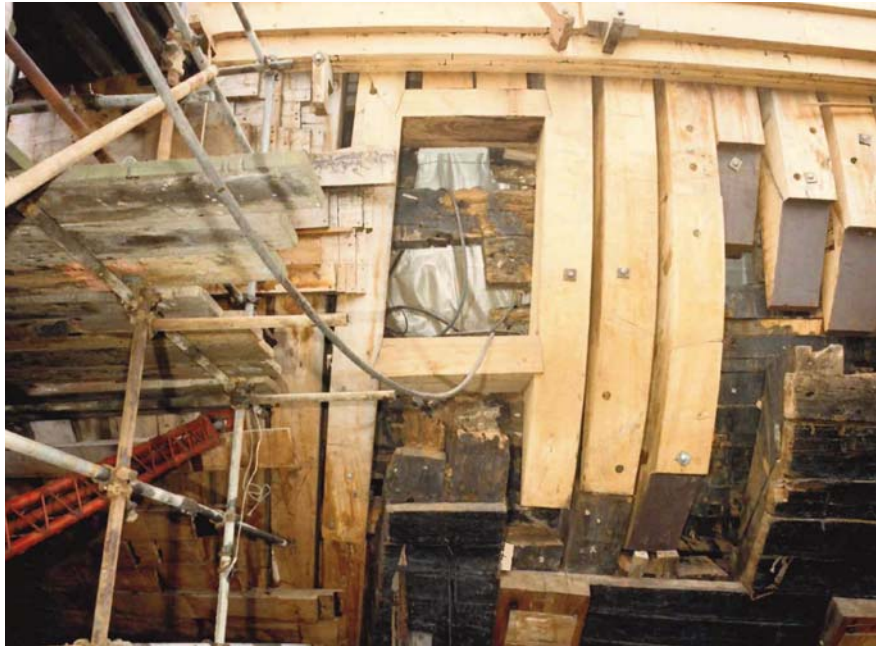
Plate 8. Repairs from 1965 onwards resulted in the replacing of oak frames with teak and the use of laminated iroko planking

It is also during this phase that we witness the introduction of adapted techniques with the fabrication of components using laminates, and the use of adhesives; including the use of iroko hardwood for the first time in the 1980s (McGowan 1999). The timeline (see **Appendix 1**) outlines the detail of the repairs during this period and illustrates quite clearly the extent of new fabric introduced into the ship (see **Figures 4–9**) during this phase (**Plate 8**).

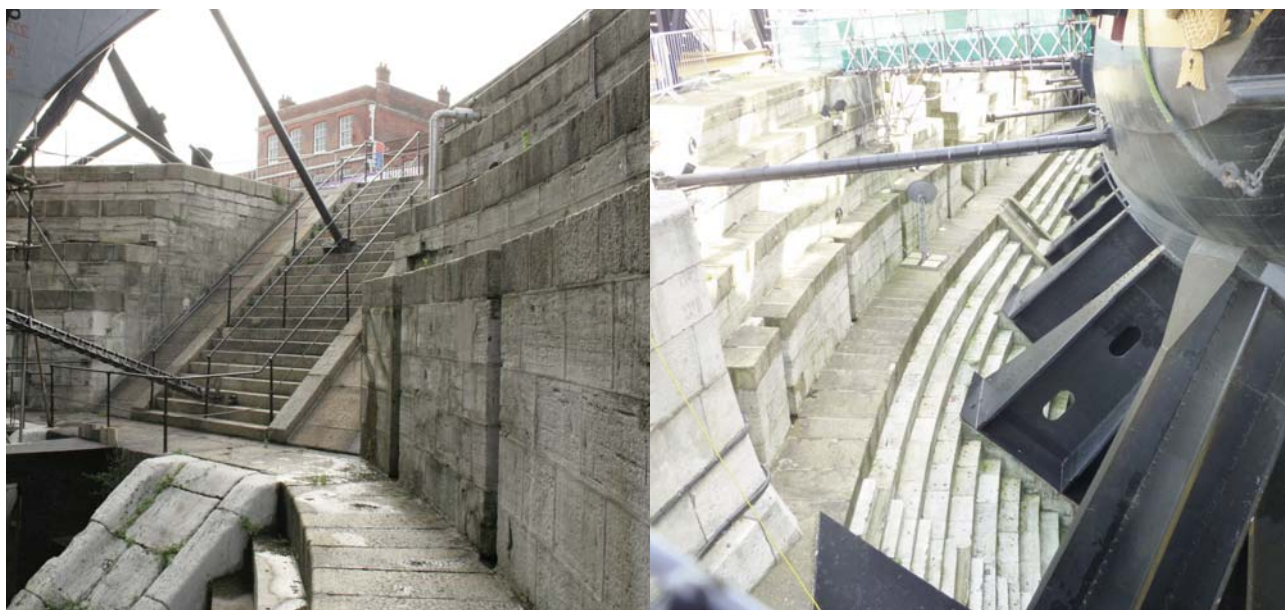
Plate 14. Views of No. 2 Dock structure illustrating the scale of the monument and impressive construction detail

No. 2 Dock (**Plate 14**) was completed in 1805 and with the exception of the modern concrete caisson replacing the timber dock gates, and some later concrete steps and repairs, appears to comprise a great deal of the original fabric. However, where the original fabric has failed, the quality of the repairs varies considerably, from replacement granite blocks, to extensive areas of cement repair, particularly in the area of the 1941 bomb damage.

The *Technical Structural Appraisal of 2 Dock* (BAE Systems Maritime Services Estates 2013) suggested that the Dock was generally in a fair condition, though it is apparent that there are problems with water ingress which will inevitably take its toll on the granite block structure of the dock if left un-resolved. Careful consideration will need to take account of how the monument is used and maintained in the future (discussed further in **Part 3 Issues and Policies**).

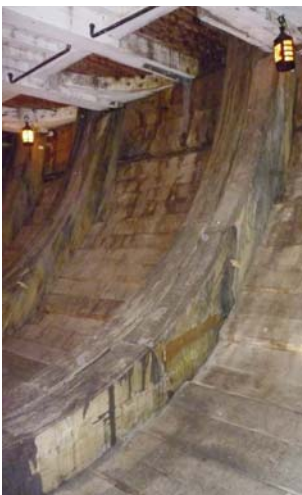
Plate 17. Riders located in the hold

Allied with the internal planking is the internal stiffening (1.11) of the hull with a number of key structural components. Key examples include the large riders crossing the keelson in the hold (**Plate 17**) and the breasthooks and crutches noted in the bow and stern respectively. All of these large elements relate to the modern repairs in Phase 4a and 4b, with the potential for a small percentage of historic fabric surviving, such as the heads of the riders (**Figures 7 and 8**). It is of note that many of these timbers bear the signs of significant splitting or 'shakes', the result of the use of unseasoned timber and the continued movement of the ship over time, also noted in Nielsen & Co.'s survey report (2012).

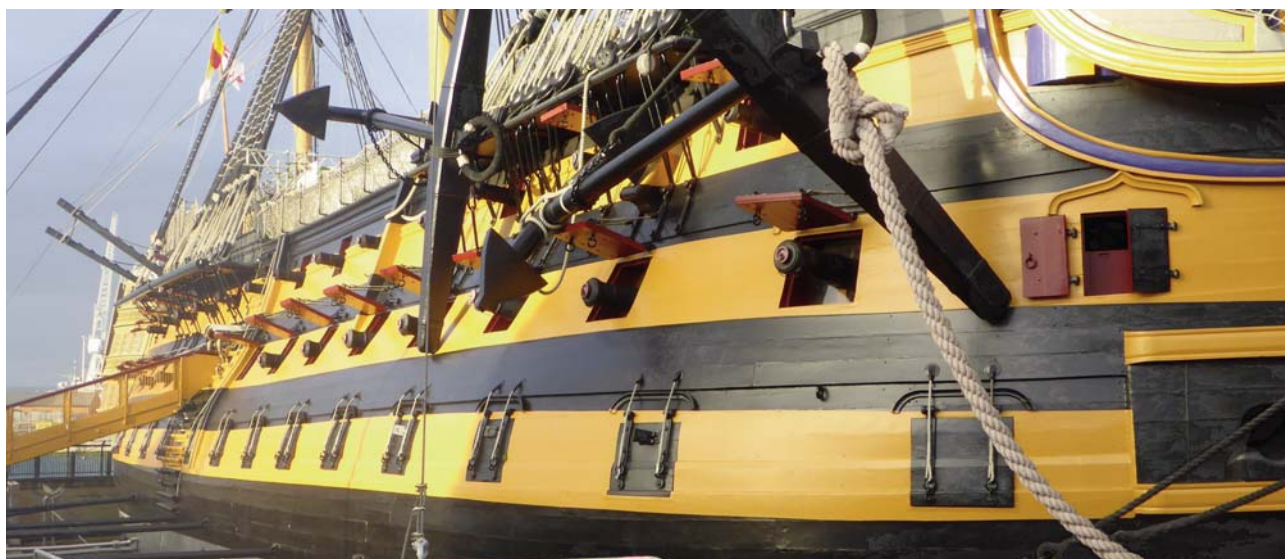
Plate 18. External planking along the starboard side

The external planking (1.13) on *Victory* is almost entirely representative of the ongoing repairs since the 1960s; with the exception of a few segments of earlier historic planking noted along the lower hull on the port side (possibly belonging to Phase 3) (**Plate 18**). Similarly to the internal planking, the external hull skin, while maintaining the ship's form and presenting a relatively uniform outward appearance, actually comprises a mixture of fabrication techniques, including the use of laminates, the use of tropical hardwoods and the employment of modern adhesives and fastenings. Observations made during the site visit identified potential planking (noted as replicating the anchor stock technique) dating to Phase 4a located approximately mid-ships on the starboard side below the main wale.

It is perhaps significant that observations made of the condition of the external planking, particular in the upper parts of the ship, that have employed the laminate technique are now seen to be in an advanced stage of decay. The effects of this on the deflection of the lower hull between the cradles has been exacerbated by the reduced structural integrity of these elements and their ability to provide longitudinal stiffening to the ship – as highlighted in the structural analysis report undertaken by Fenton Holloway Ltd.

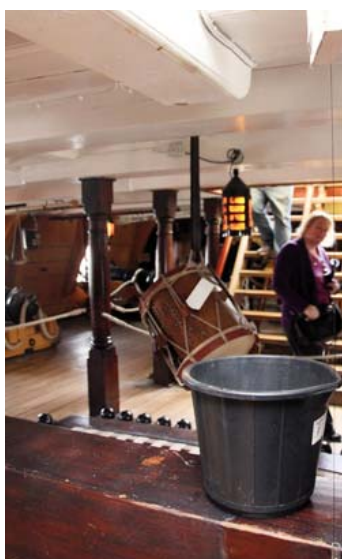
Plate 51. Remedial measures during episodes of water leakage through the deck above

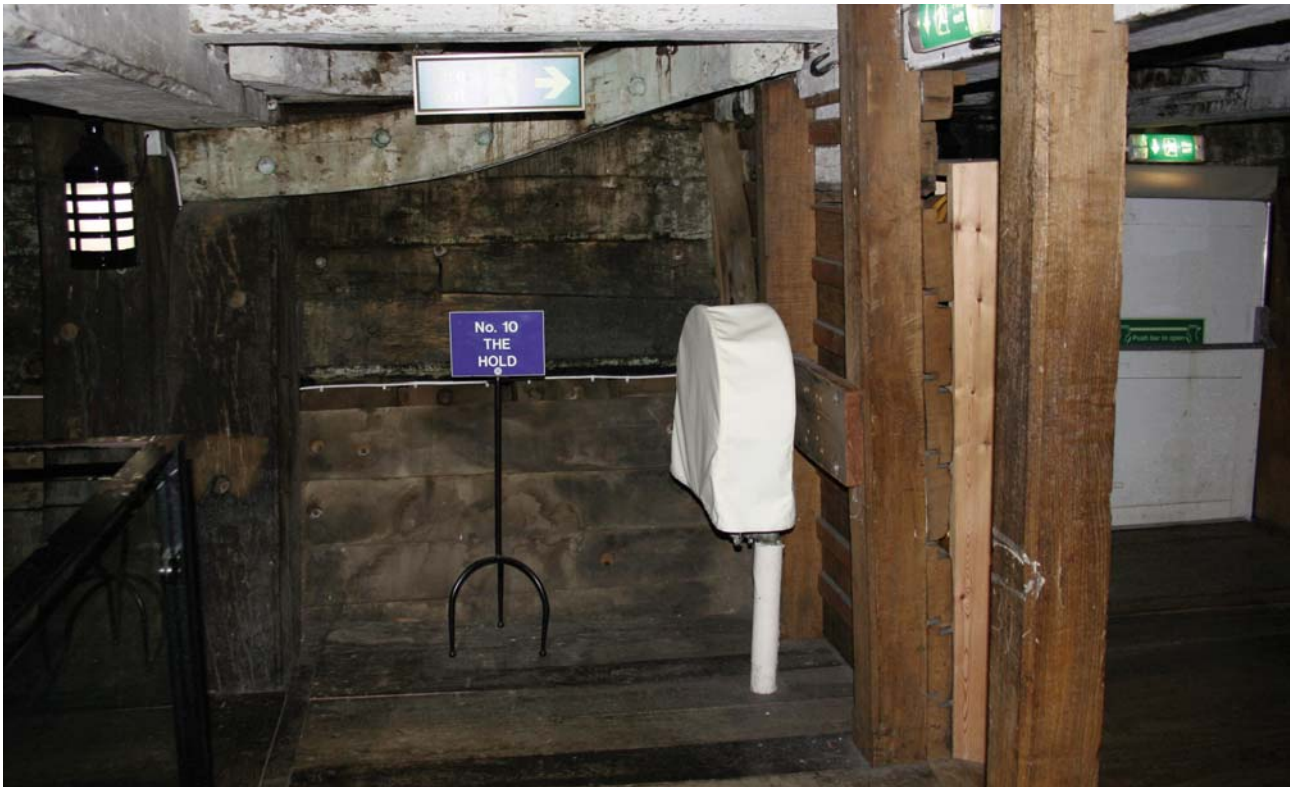
Plate 55. Intrusive firefighting apparatus and signage clearly evident in the hold

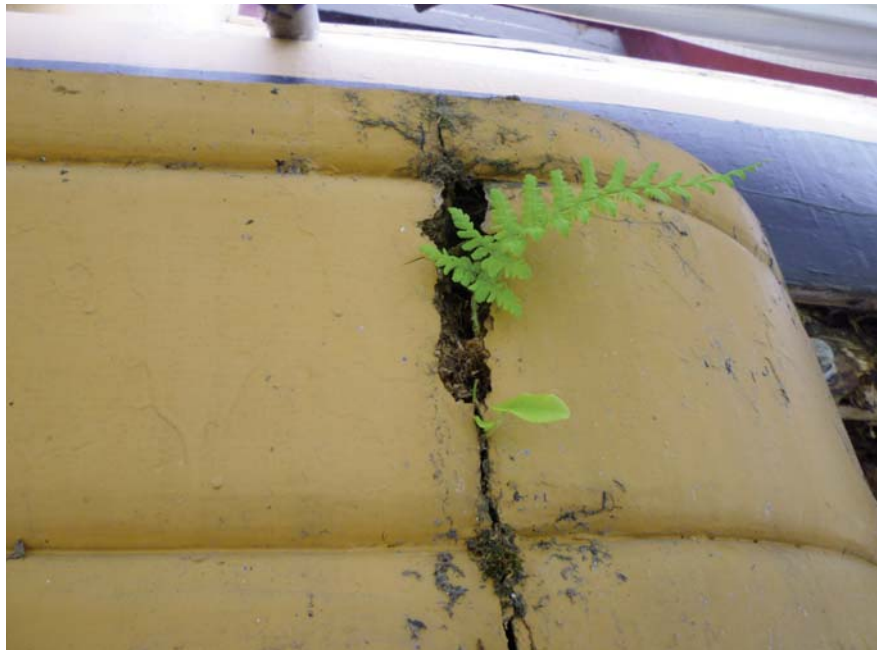
Plate 56. Vegetation growth on the outer hull
