The Gresham Ship Project

A 16th-Century Merchantman Wrecked in the
Princes Channel, Thames Estuary

Volume I: Excavation and Hull Studies

Jens Auer and Thijs J. Maarleveld

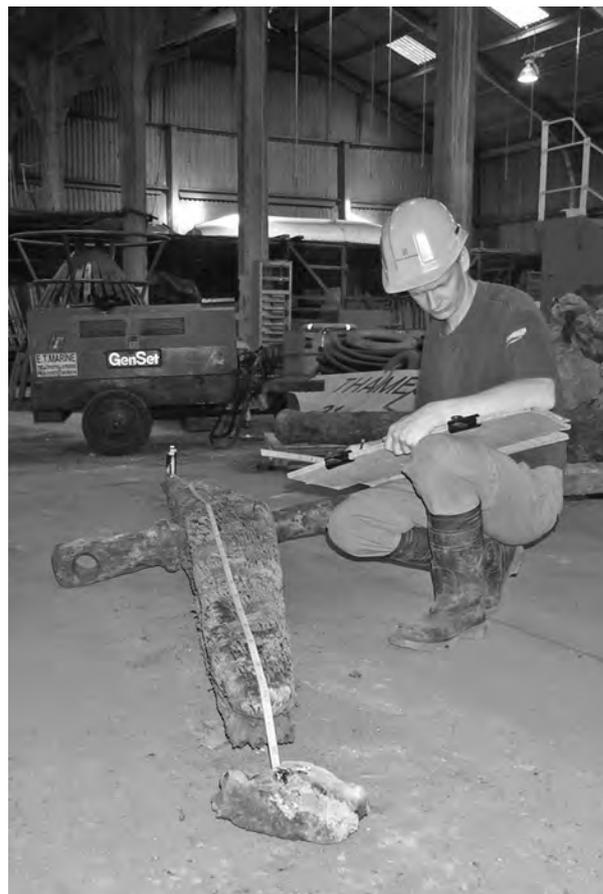
Figure 1-2: Wessex Archaeology staff recording the anchor and wooden stock in August 2003 (Wessex Archaeology)

Over two days, Wessex Archaeology personnel provisionally recorded a total of 47 timber fragments, a large number of iron bars, an anchor with a wooden stock (Figure 1-2) and a cast-iron gun, as well as a wrought-iron breech-loader. All the material was photographed and important timbers, as well as the iron guns and the anchor, were drawn at a scale of 1:10. The timbers were suggested to derive from a vessel of approximately 200 tons burthen. Curatorial staff at the

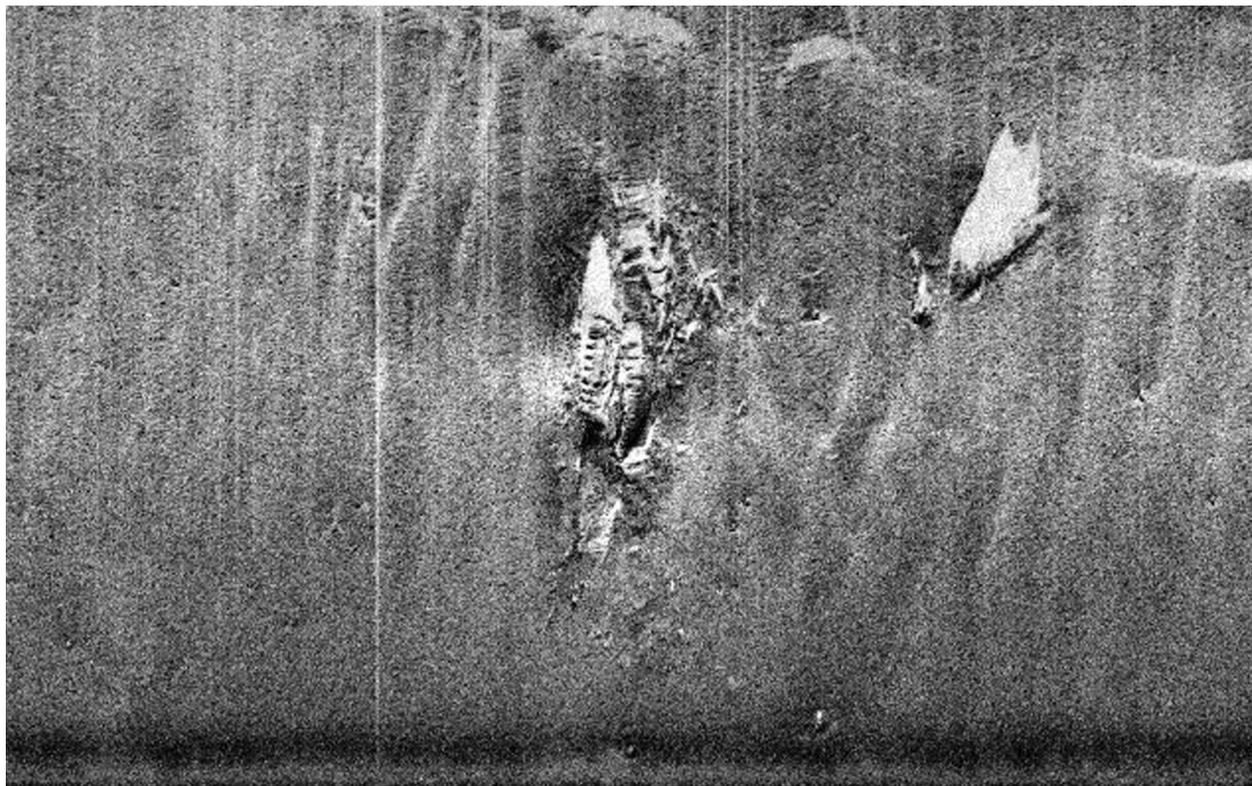
Figure 1-3: Screen capture taken during the sidescan survey between inspection dives in October 2003. The capture shows the principal wreck site (left) and the dived anomalies (right) (Wessex Archaeology)

Consequently, Wessex Archaeology was commissioned to carry out an inspection dive in the same month. When the wooden structures could not be found at the given position during the first dive, a short sidescan sonar survey was conducted with the aim to relocate them. The survey was successful, producing evidence of a larger, seemingly coherent wreck site in situ (Figure 1-3). During a second dive, the Wessex Archaeology diver described two sections of a curved hull structure, a smaller and a larger one (Auer and Steyne, 2004).

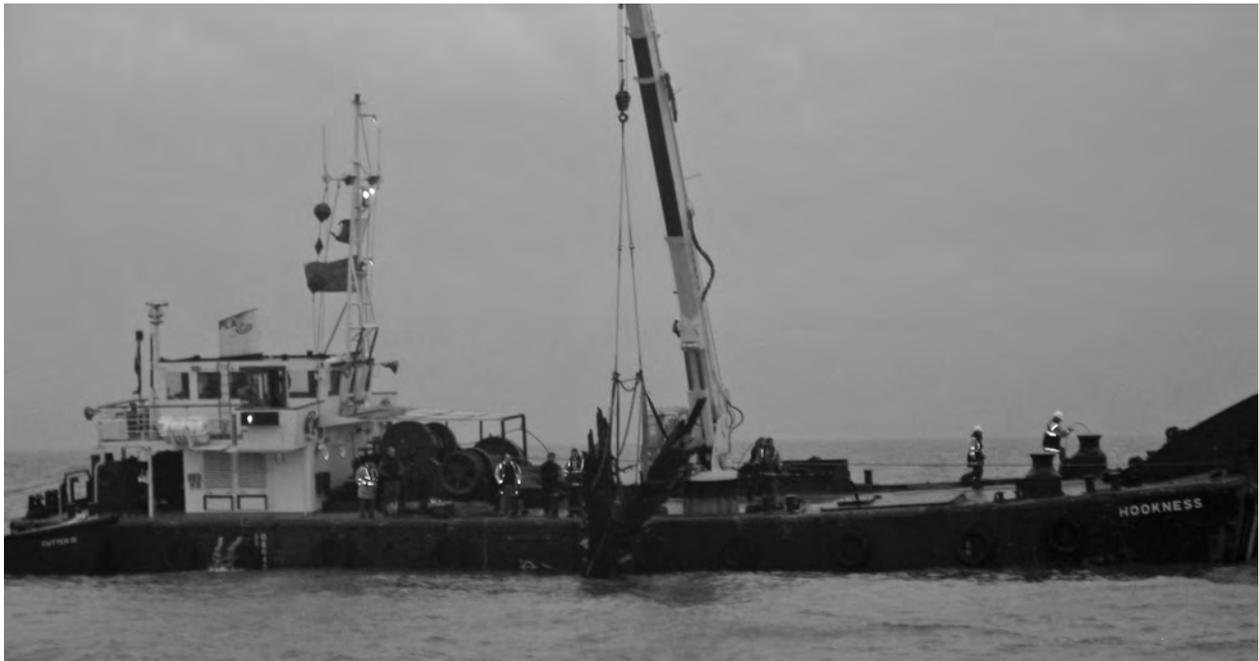
Figure 1-4: The recovered hull structure breaking into two sections during the lift in November 2003 (Wessex Archaeology)

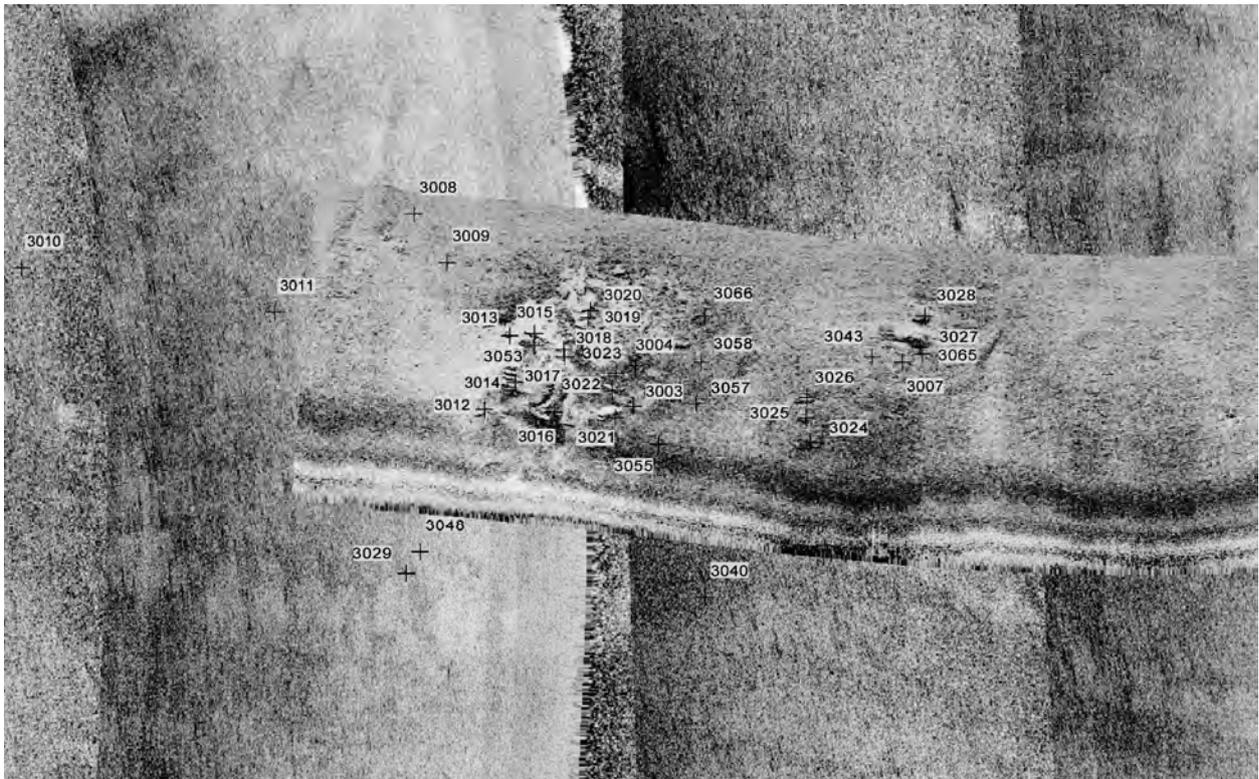
Figure 1-5: Results of the sidescan survey in May 2004. All targets have been marked and labelled. There is a concentration of targets on the main site and towards the east of the site (right in the image) (Wessex Archaeology)

concentrated on and around the main site. A trail of targets was observed to the east of the site (Figure 1-5).

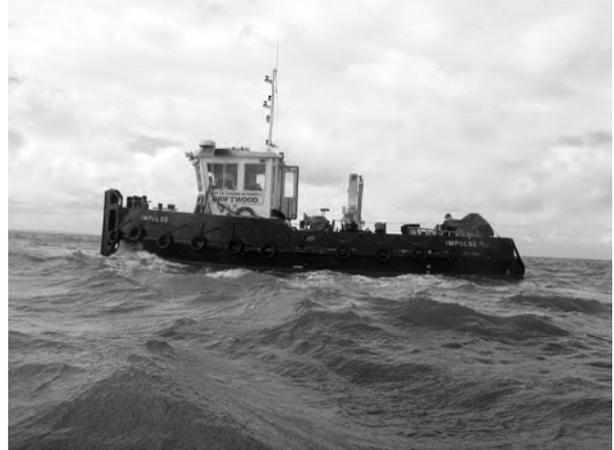
Figure 2-1: The Port of London Authority river tug *Impulse* was the main diving support vessel for the excavation (J. Auer, Wessex Archaeology)

tug was equipped with a one-ton crane and provided ample deck space for an airlift compressor and the low-pressure diving air supply compressor (Figure 2-1). After 11 October diving was conducted from the PLA Marine Services dive boat *PLA Diver*. As this boat was not equipped with a crane and had insufficient deck space for the airlift compressor, diving after this date was limited to seabed searches and recording.

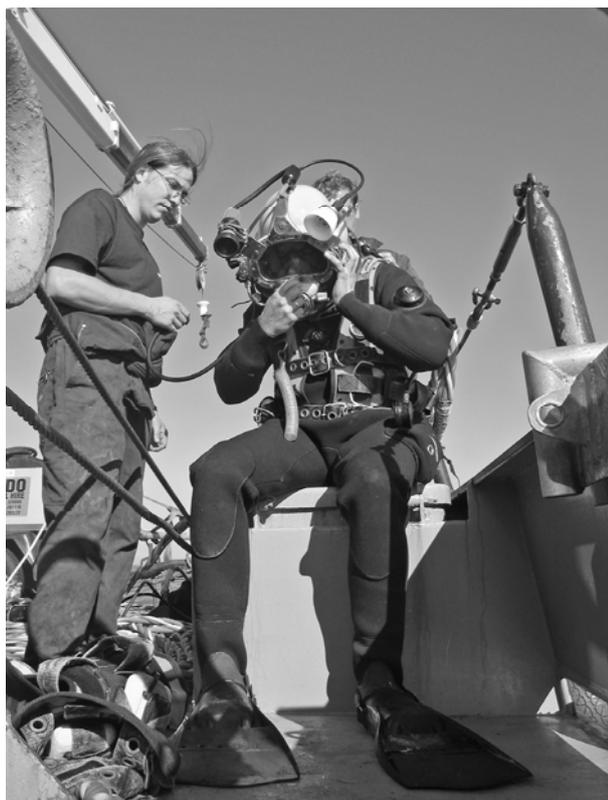
Figure 2-2: A diver from Wessex Archaeology being prepared for a dive (F. Mallon, Wessex Archaeology)

To maximize work efficiency, two divers were deployed simultaneously. The first diver was equipped with a Kirby Morgan Superlite 27B helmet with attached surface-powered light and digital video camera (Figure 2-2), while the second diver wore a Kirby Morgan 18 band mask with a battery-powered light. The divers either descended along the mooring wires or used a separate shot line to locate the site. A diving ladder provided a safe exit.

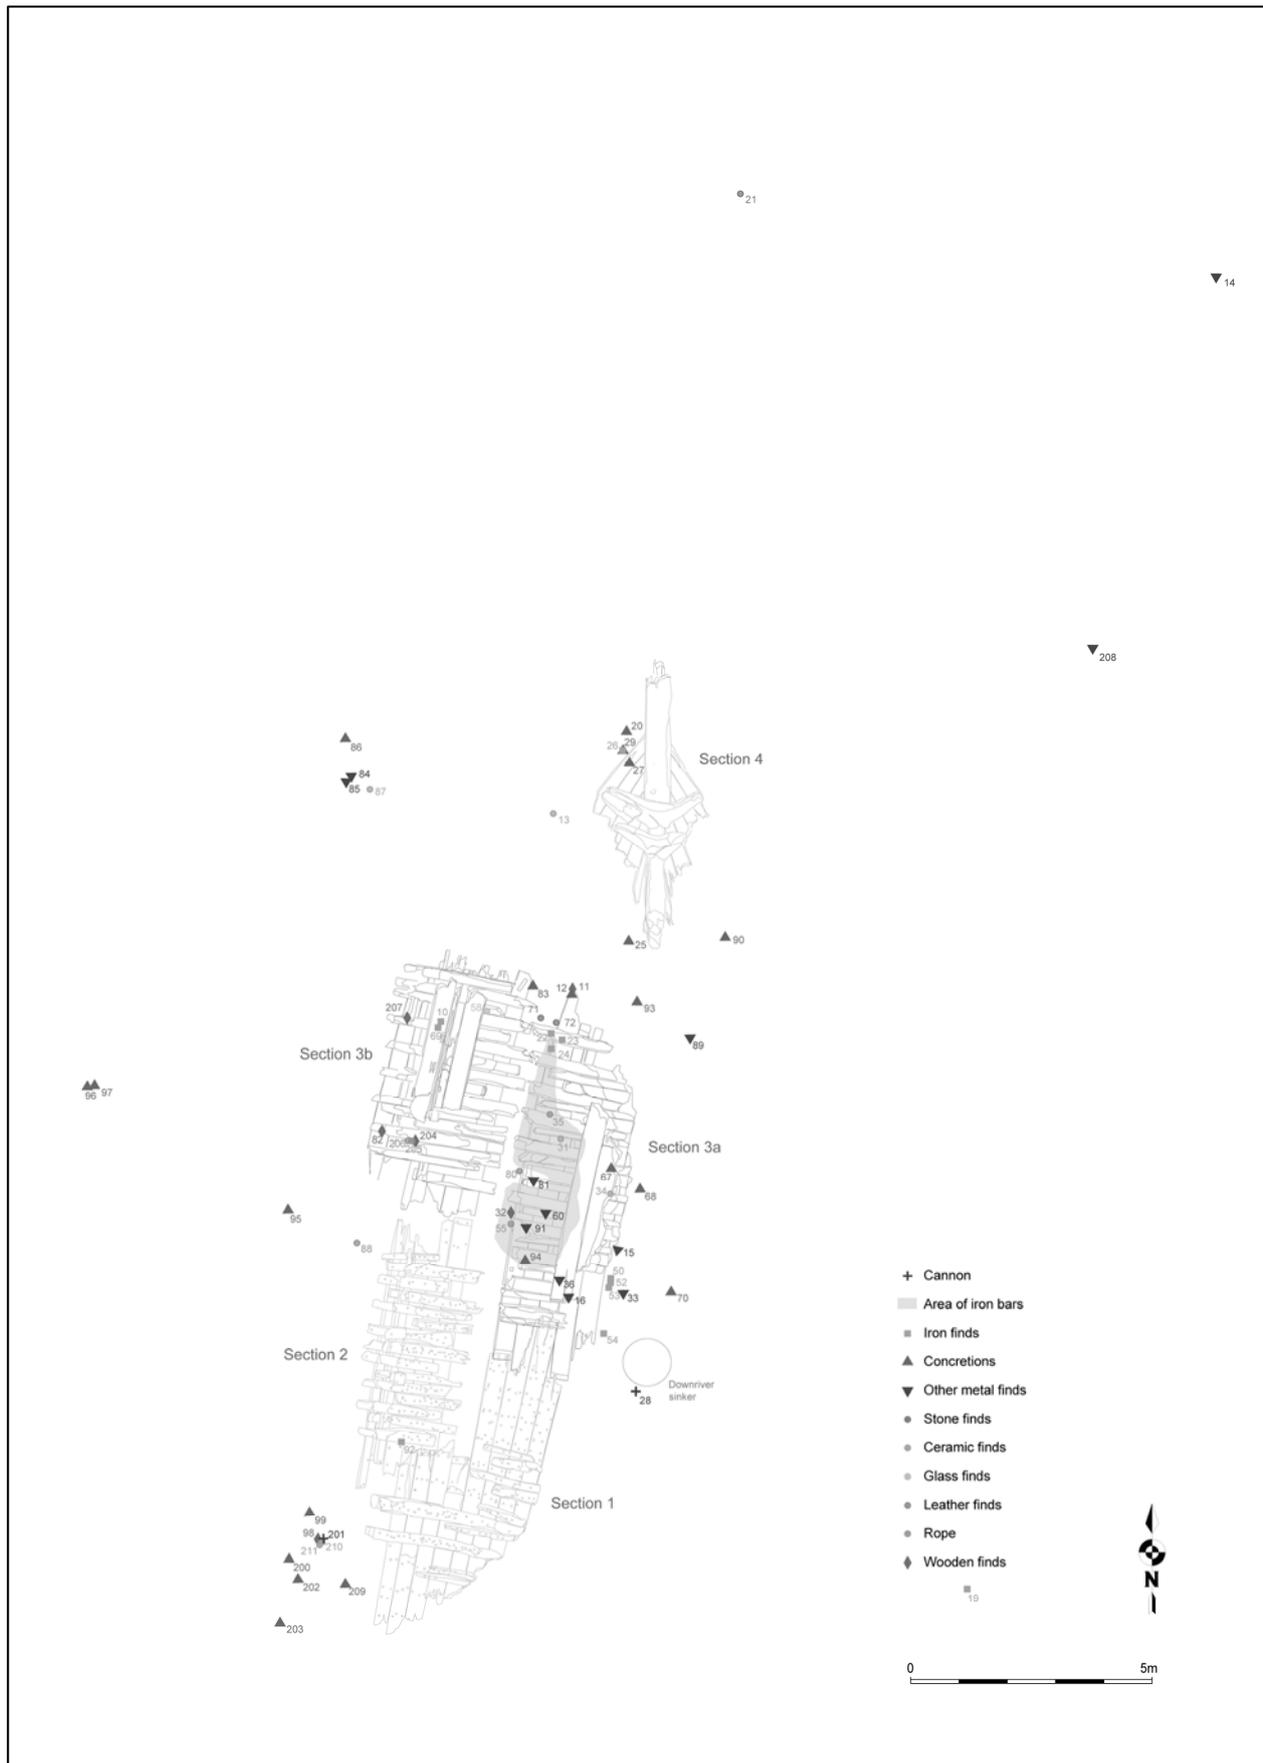
Figure 2-4: Reconstructed site plan of the Princes Channel Wreck, based on the results of shore-side recording. Timber sections, which were lifted prior to the excavation, are greyed out (K.J. Brandon, Wessex Archaeology)

The underwater recording served two main objectives. Recording the timber structures in situ would help to devise a strategy for the planned recovery. Additionally it was important to document the location of the individual structures in relation to each other, as well as the location of cargo, disarticulated timbers and artefacts in relation to the surviving wreck remains. This information could then be used to compile a basic plan of the wreck structures (Figure 2-3). Considering the adverse environmental conditions on site, it was decided to carry out all detailed recording of the timber structures after the recovery. Based on the results of shore-side recording, a more detailed underwater site plan was produced during post-processing (Figure 2-4).

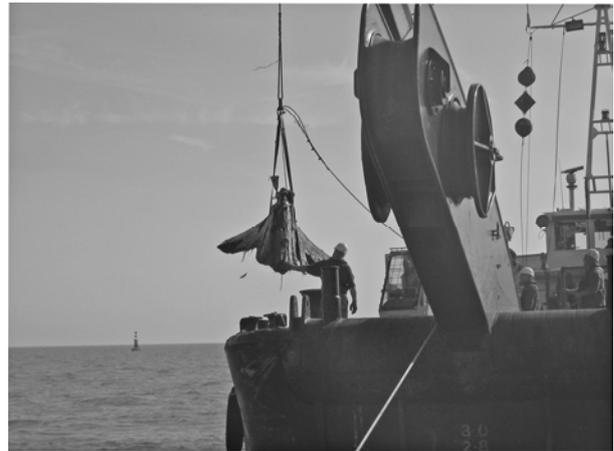
Figure 2-5: Recovery of the bow section (section 4) by the PLA salvage vessel Hookness on 2 September 2004 (J. Auer, Wessex Archaeology)

However, during the first days of the excavation, section 4, the presumed bow section, could not be found in the surveyed position. After extensive circular searches, the bow section was discovered 25 m north-east of its original location. Attempts to establish guide lines between it and section 3 failed, as section 4 kept moving on the seabed. Finally, the decision was made to lift section 4, although the underwater recording was not complete. The PLA survey vessel *Verifier* located the hull section with the help of multibeam sonar. Section 4 was then stropped and lifted to the surface by the PLA salvage vessel *Hookness* on 2 September 2004 (Figure 2-5). The section was supported with wooden chocks and transported to Gravesend, where it was unloaded into a flooded barge to prevent it from drying out.

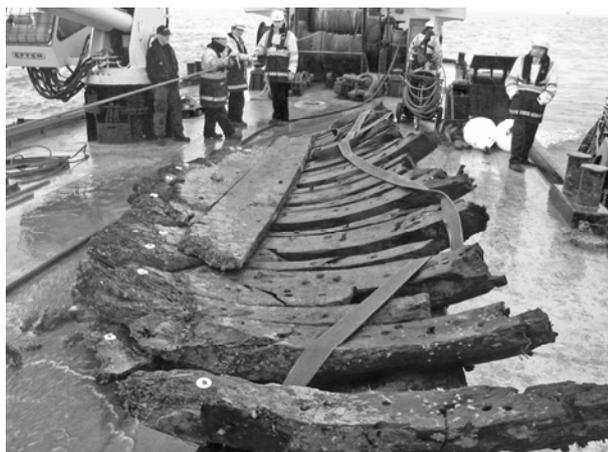
Figure 2-6: Section 3a on board of the salvage vessel *Hookness* after recovery (J. Auer, *Wessex Archaeology*)

However, on the first dive after a long spell of bad weather on 15 September 2004, the divers found section 3 broken in half. The eastern side of the wreck section (section 3a) had been turned upside down and was located approximately 3 m to the west of the other half (section 3b), which remained in its original location. As section 3a was now entangled in the mooring arrangement for the diving support vessel, it had to be lifted to allow *Impulse* to moor above the wreck site. It was lifted using a conventional strop arrangement on 30 September 2004. It was transported to Gravesend on board the salvage vessel *Hookness* and deposited on the quayside, where it was covered and kept wet with a leaky hose system (Figure 2-6).

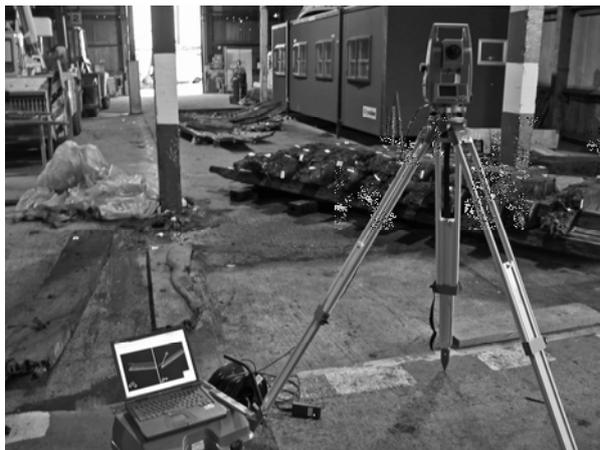
Figure 2-8: Total station setup for the recording of section 1 and section 2 (J. Auer, Wessex Archaeology)

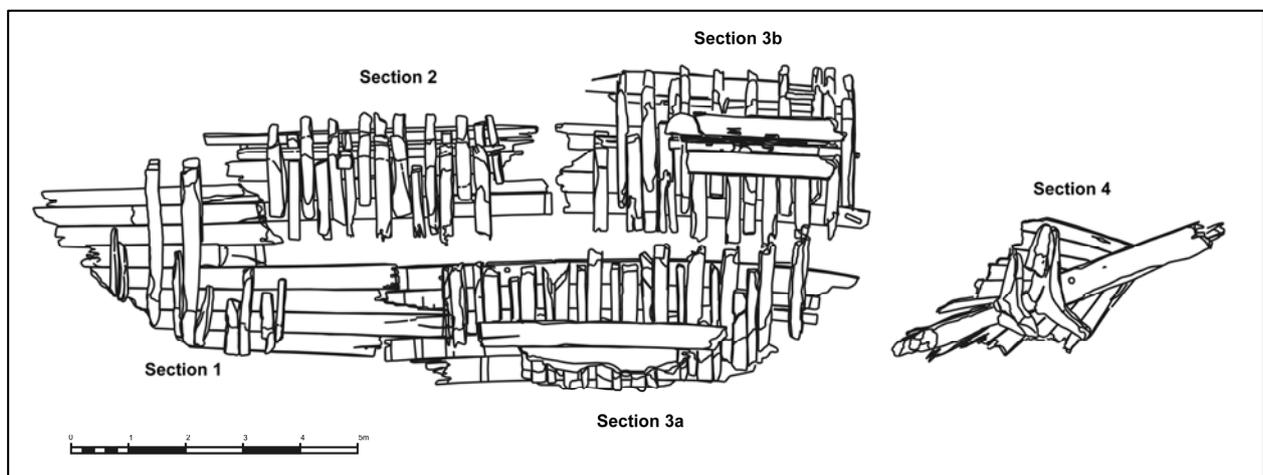
Figure 3-1: Overview plan of all wreck sections showing their approximate location and relation to each other (drawing J. Auer, based on data acquired by Wessex Archaeology)

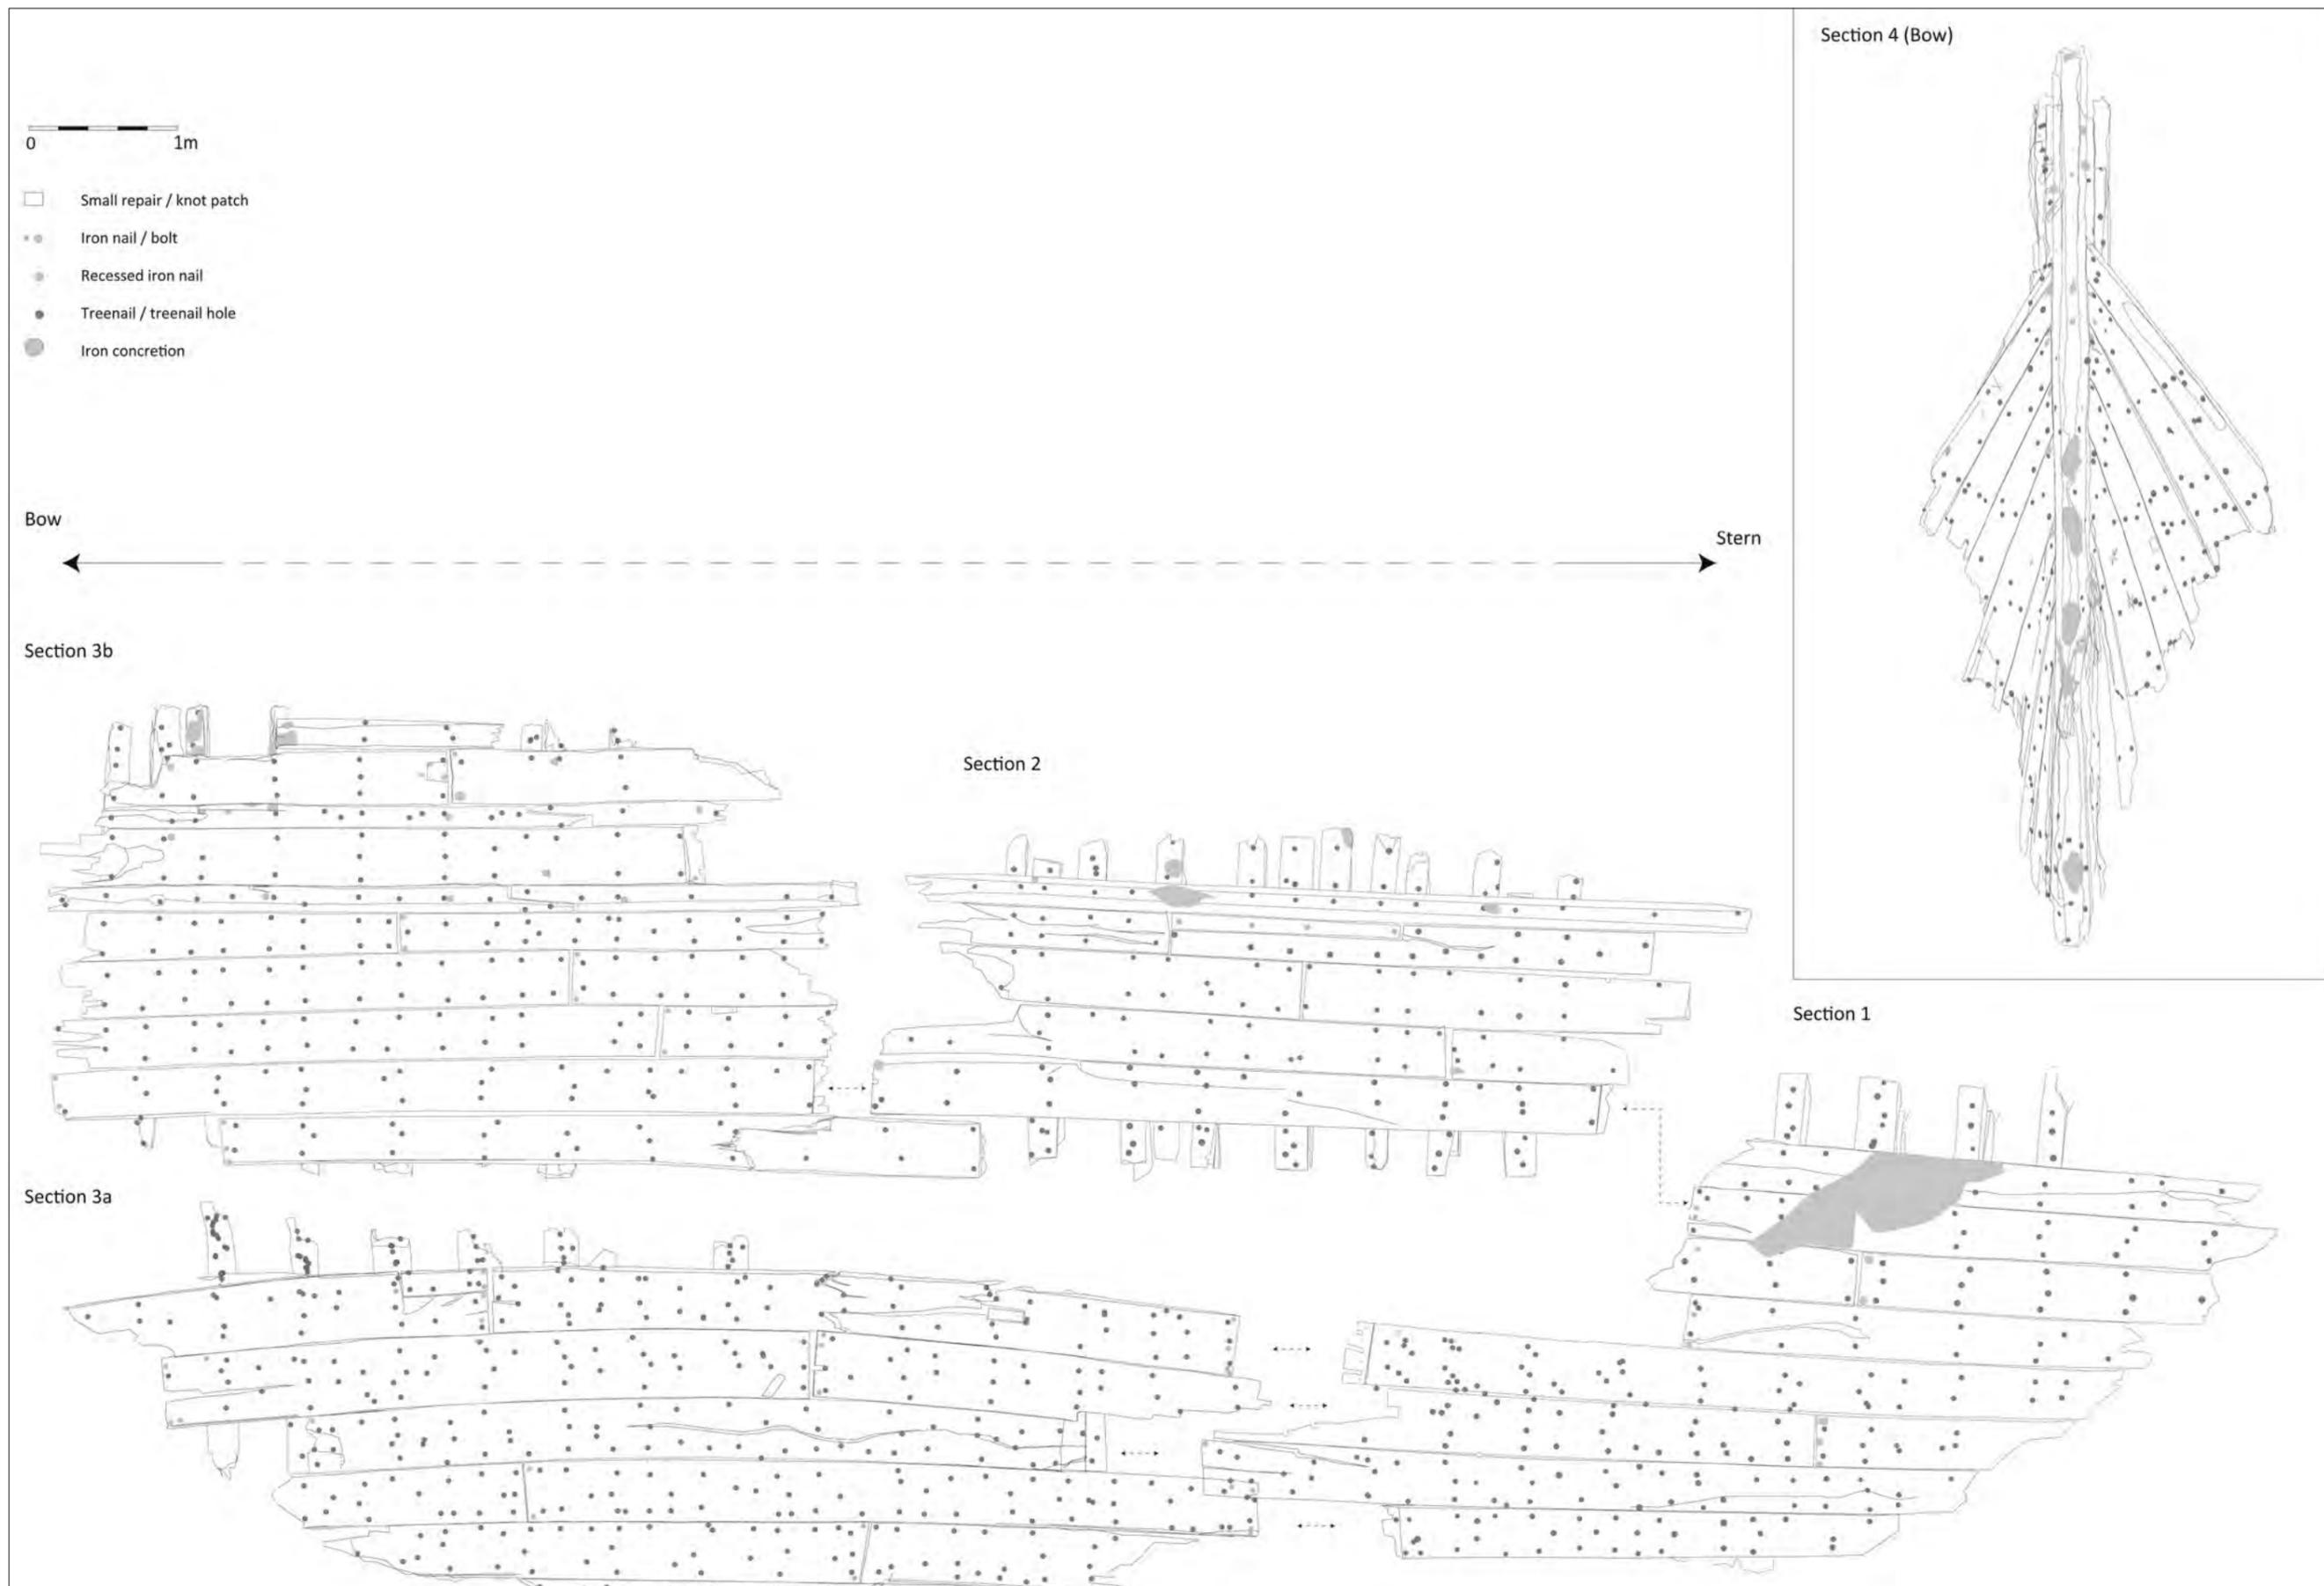
Figure 3-2: Plan of the wreck sections, outside view (J. Auer, based on the original recording results and illustrations by Wessex Archaeology); section 4 (inset) was originally located forward of sections 3a and 3b

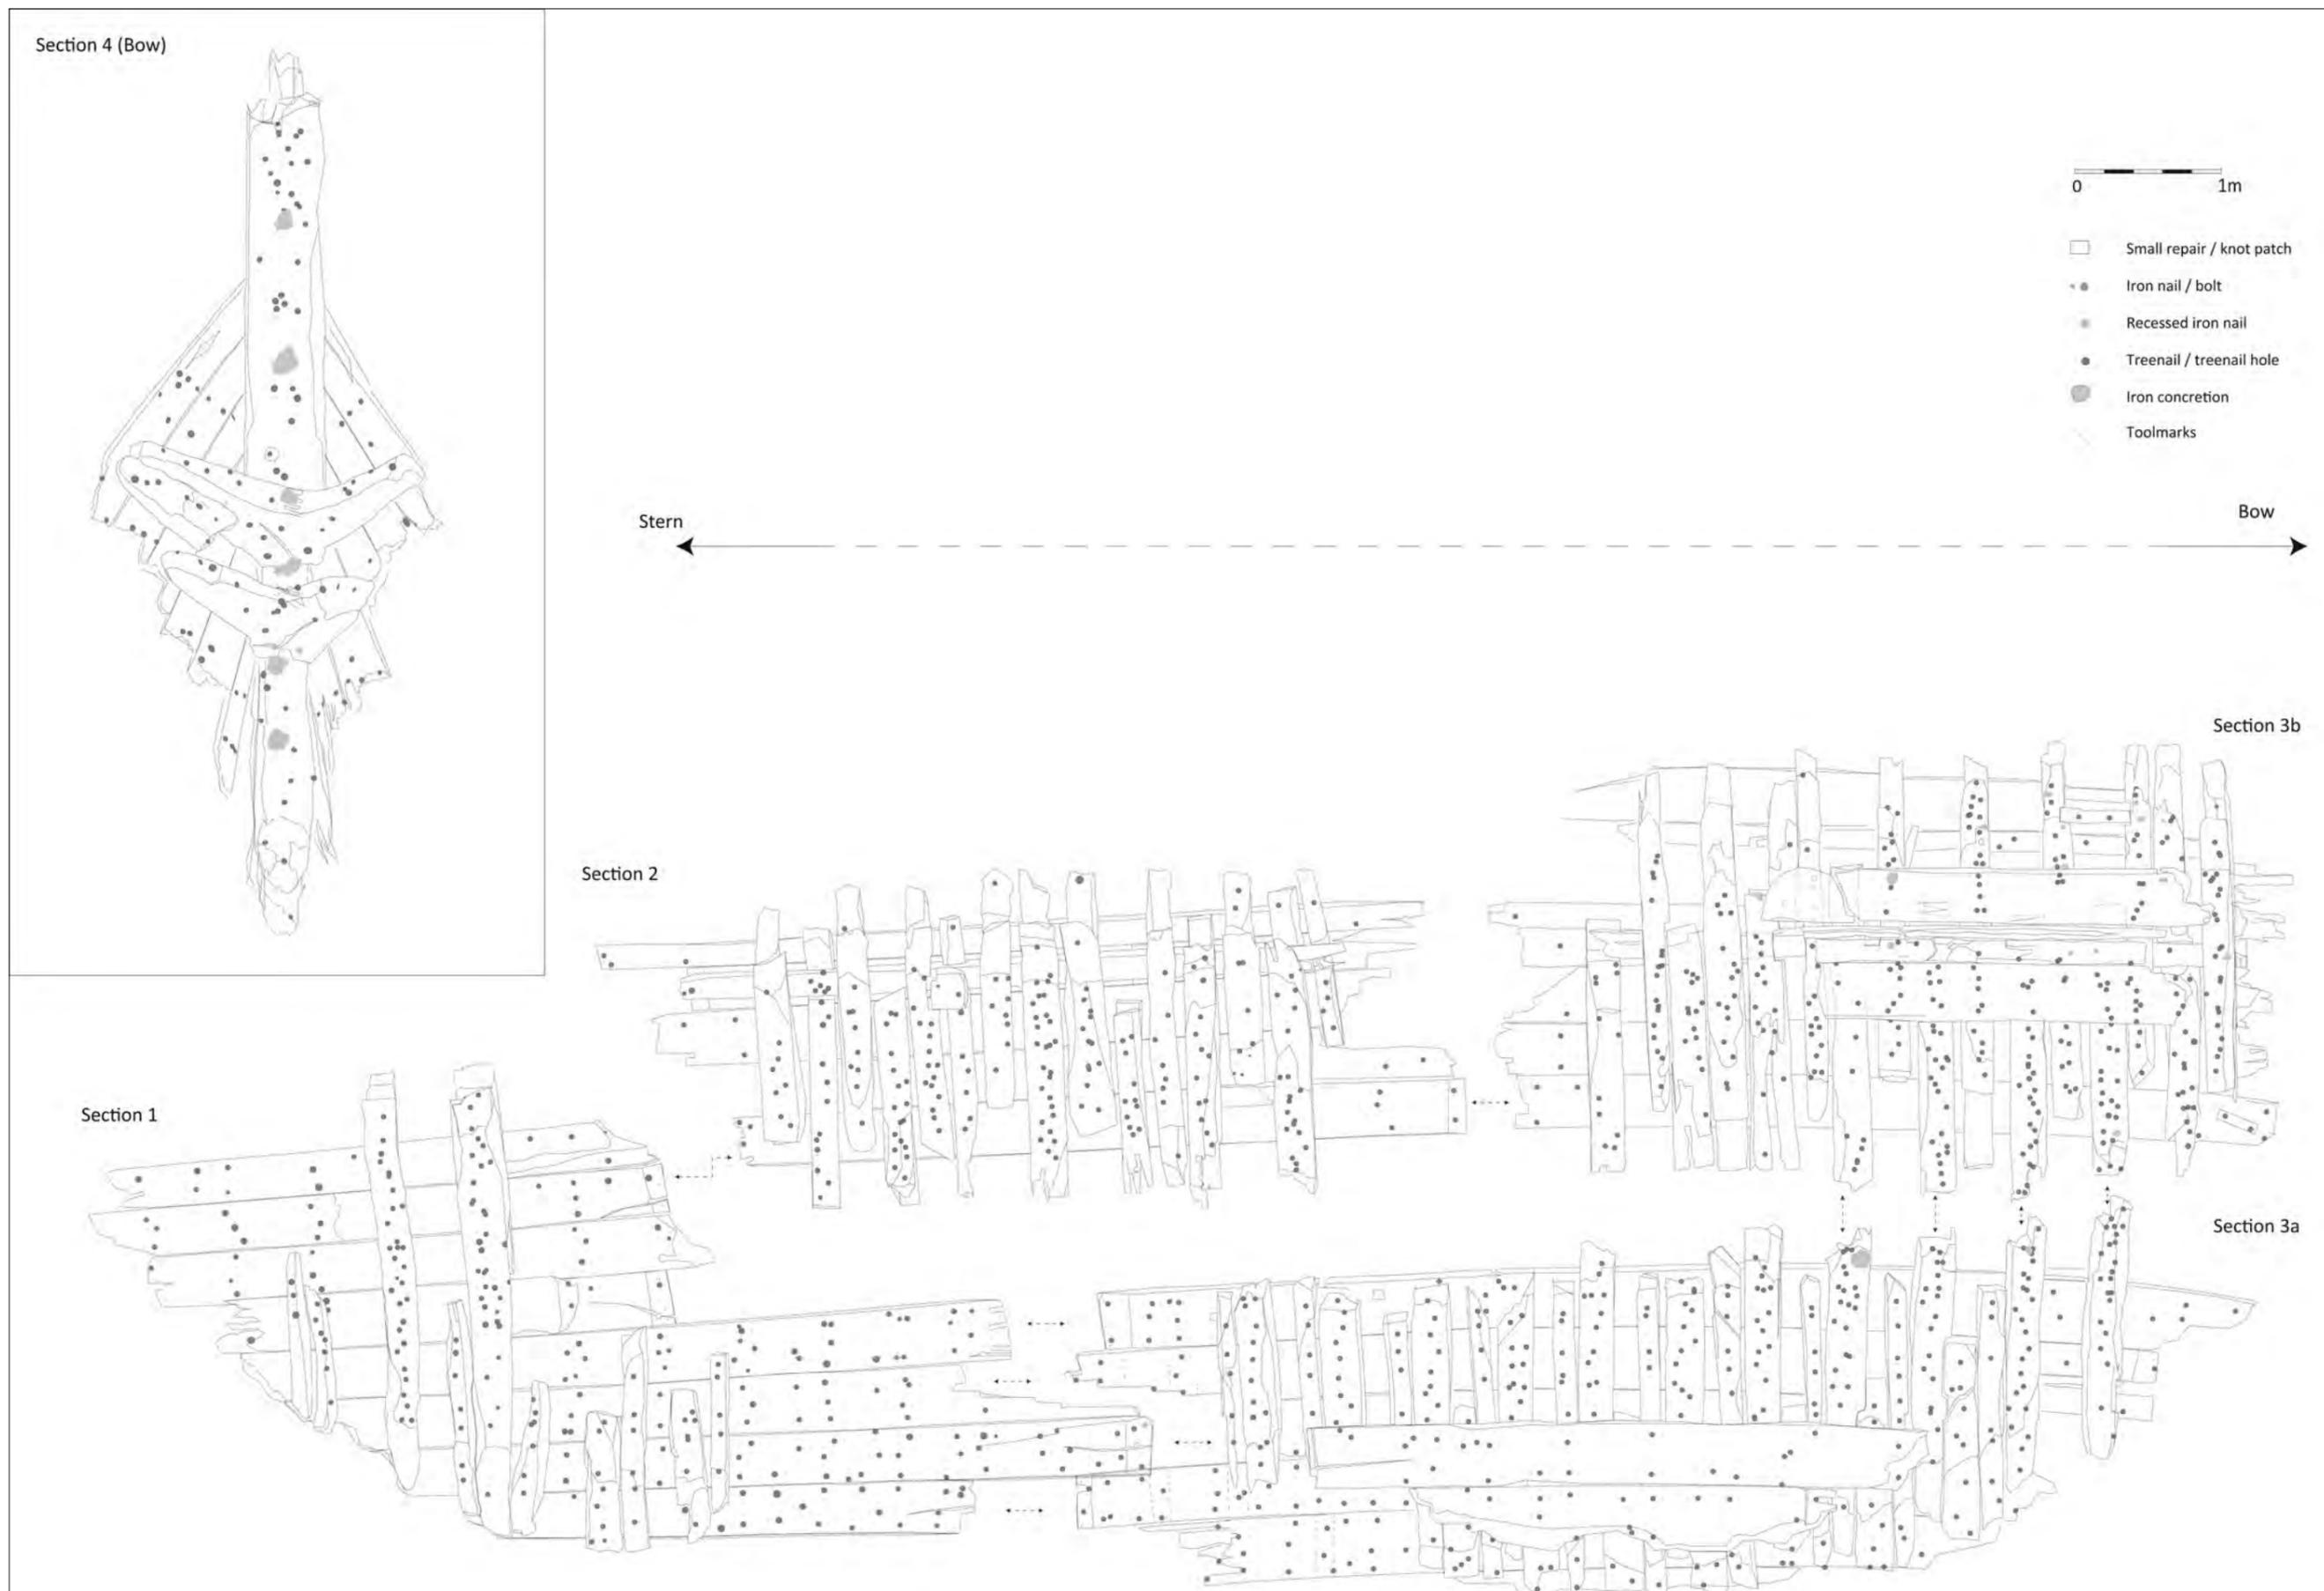
Figure 3-3: Plan of the wreck sections, inside view (J. Auer based on the original recording results and illustrations by Wessex Archaeology); section 4 (inset) was originally located forward of sections 3a and 3b

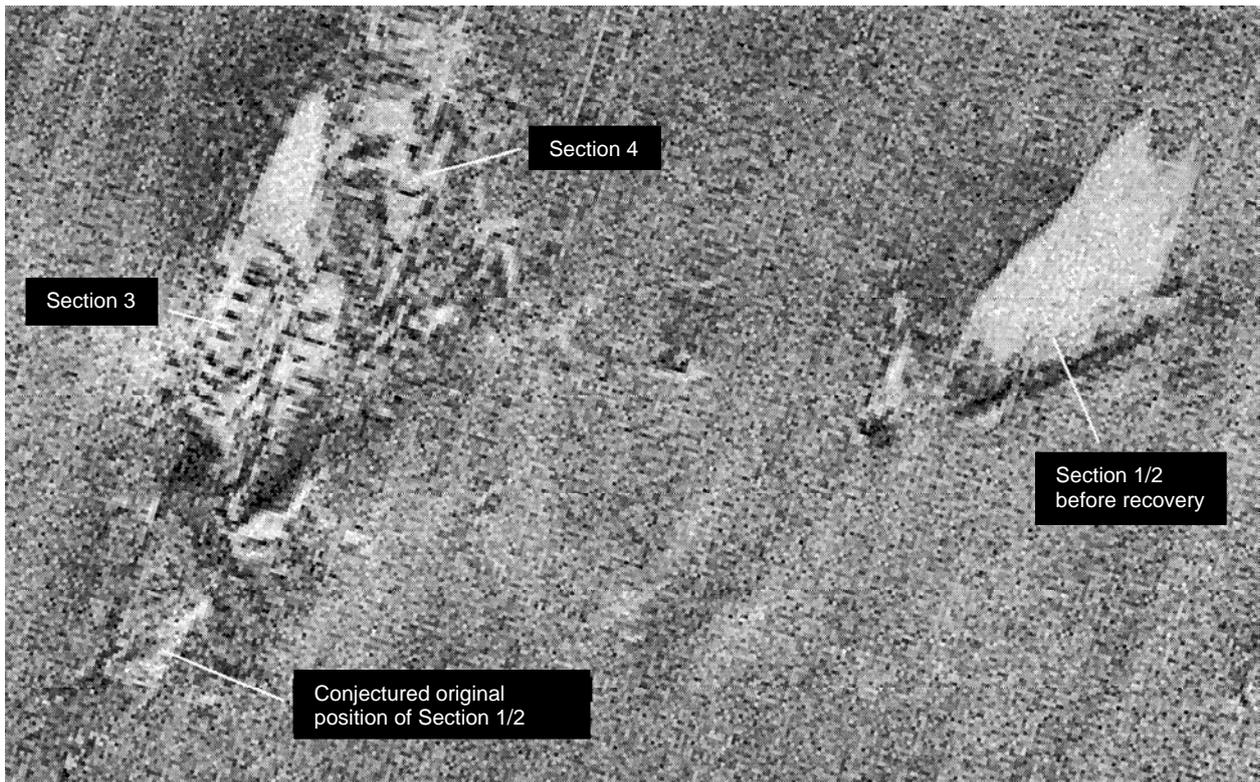
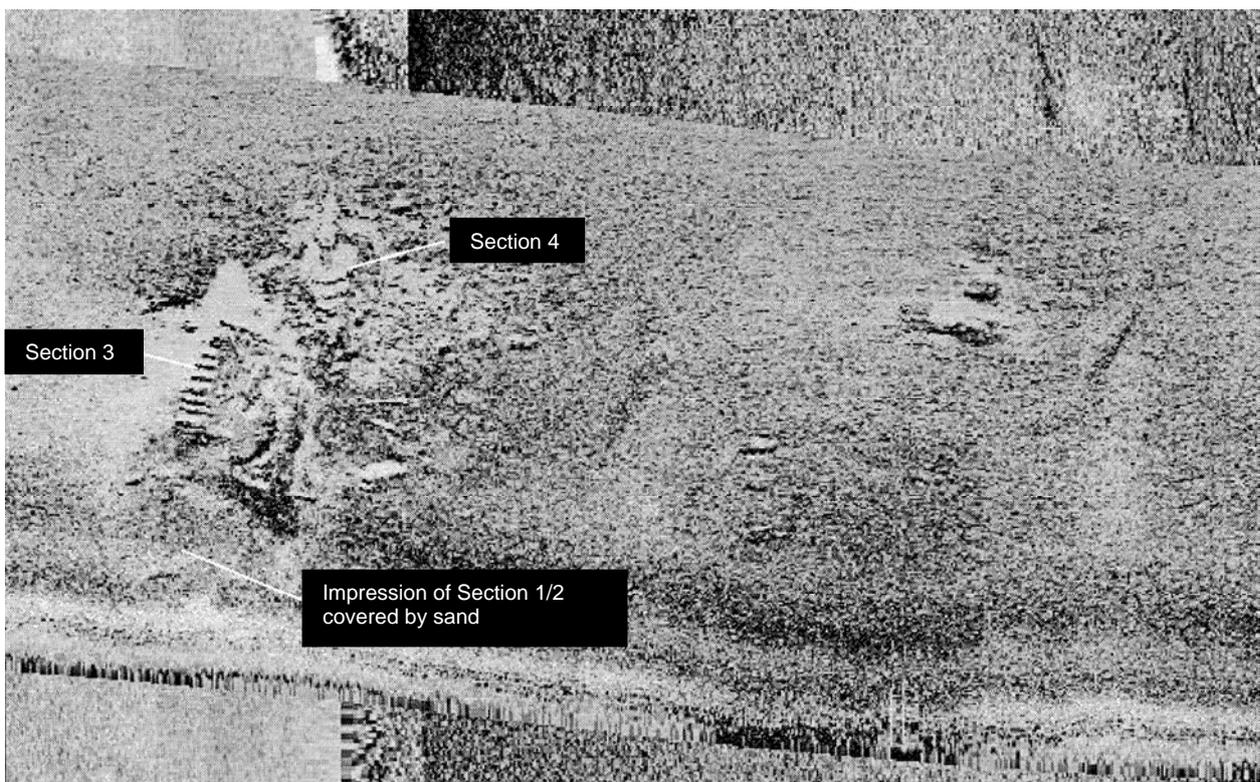
Figure 3-4: Sidescan images showing the wreck site in October 2003 (above) and May 2004 (below). The results of the dispersal attempts are clearly visible (K.J. Brandon, Wessex Archaeology)

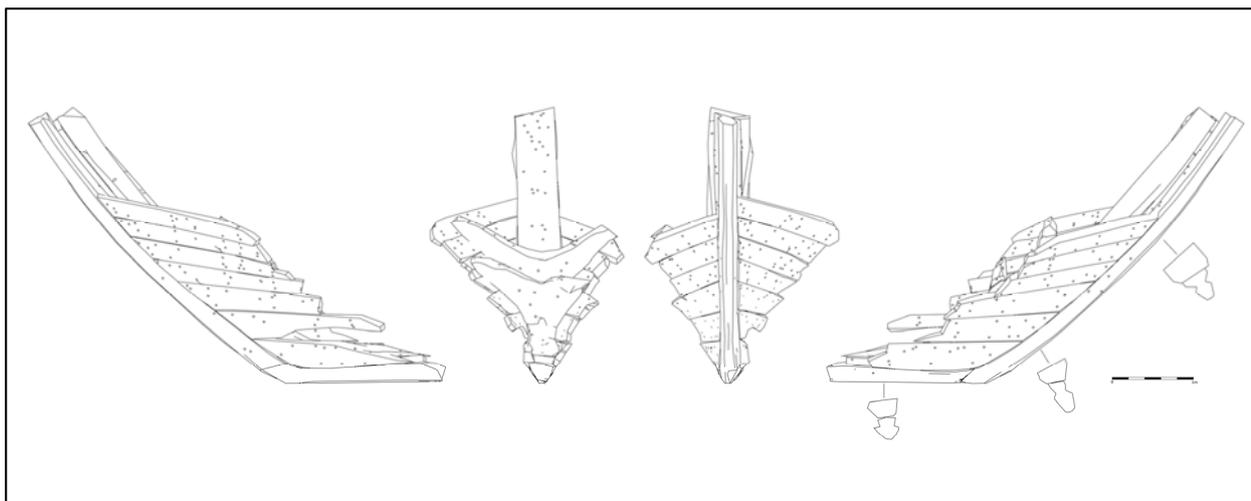
Figure 3-5: Different views of the bow (section 4) of the Princes Channel Wreck (M. Ditta, based on the original recording data by Wessex Archaeology). The scale is 1 metre

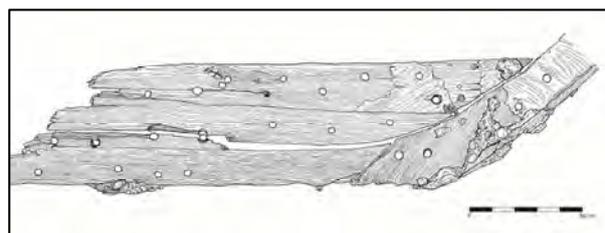
Figure 3-6: The joint between keel and stempost seen from the starboard side; the garboard strake is also depicted (R. Bangerter)

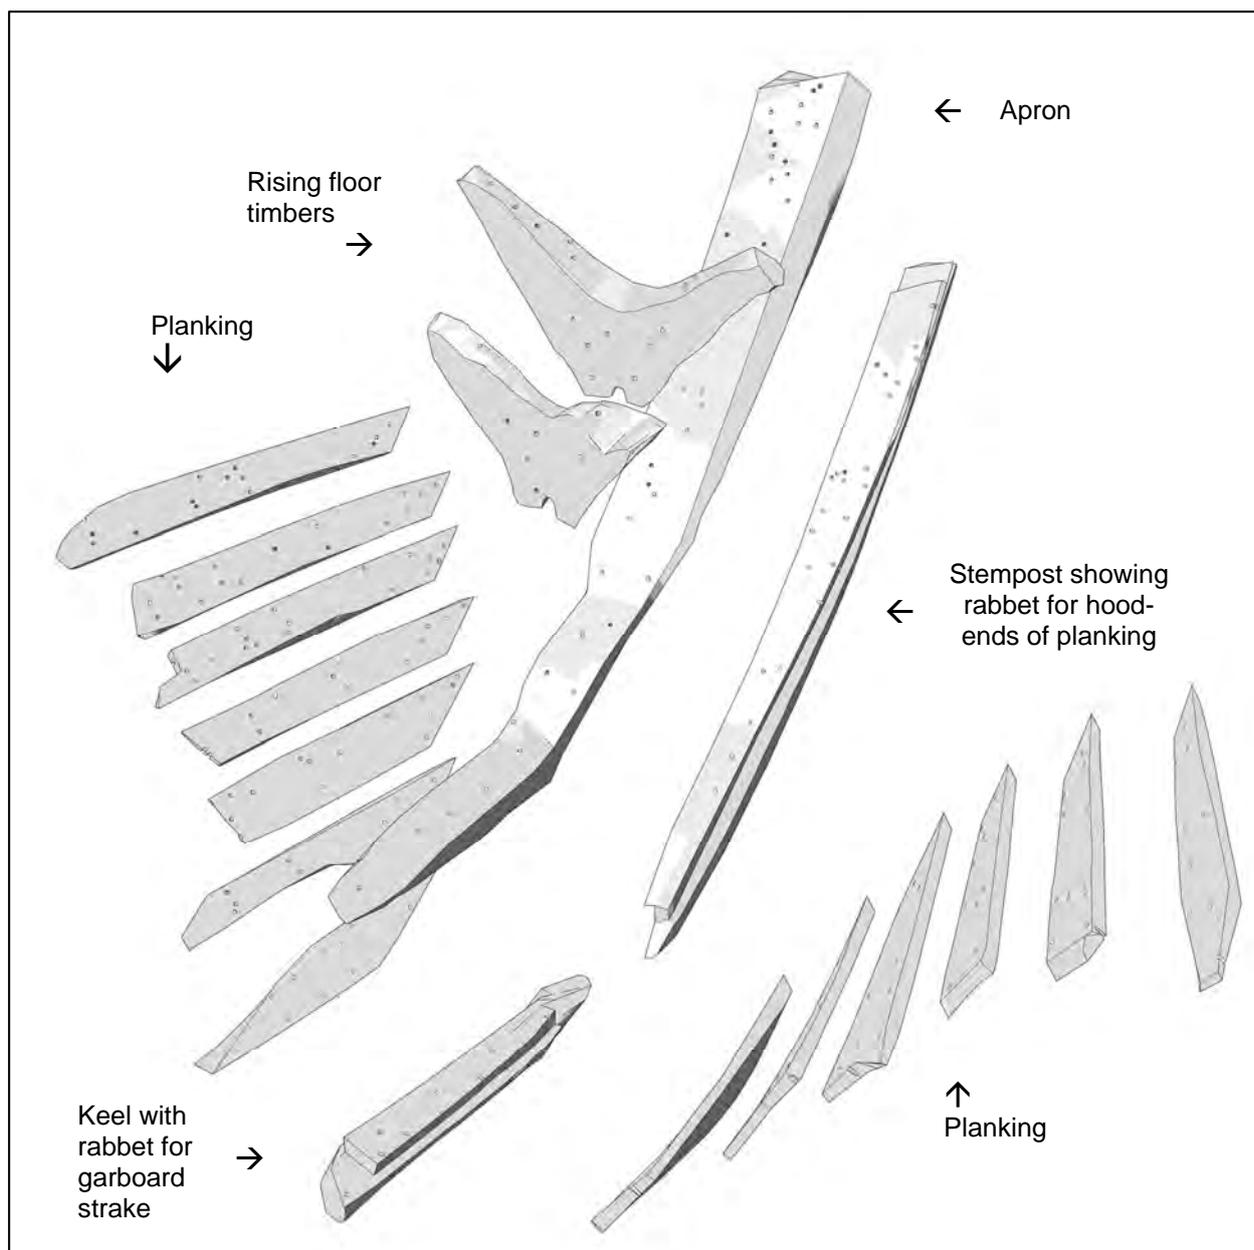
Figure 3-7: Exploded isometric view of the bow section showing the principal components (M. Ditta, based on data generated by M.H. Thomsen)

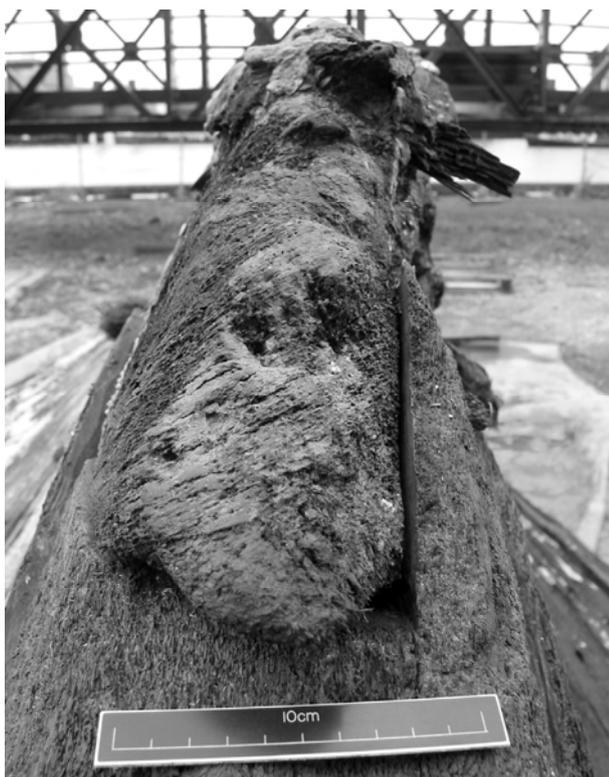
Figure 3-8: The joint between keel and stempost seen from underneath (J. Auer)

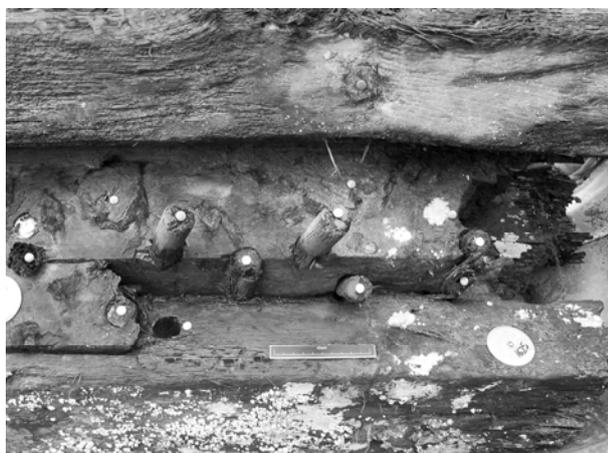
Figure 3-9: Cut trenails and tool marks indicate a change of the rabbet angle in the stempost (J. Auer). The scale is 10 cm

in beam caused by furring (Figure 3-9) (see Section 3.4, pages 41–3).

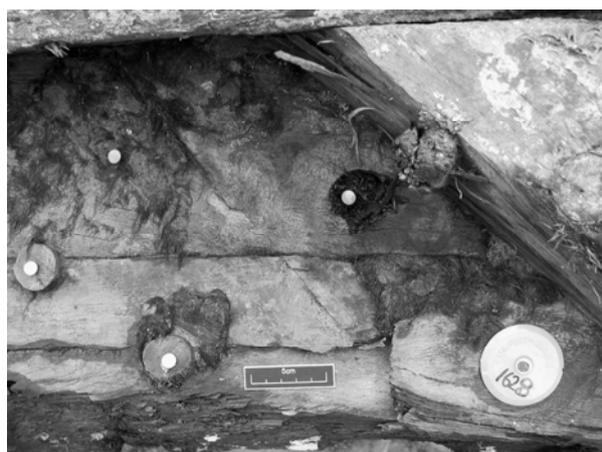
Figure 3-10: The gap between apron and stempost (at the bottom) was filled with wedges to form a smooth surface for the outer planking (J. Auer). The scale is 5 cm

To provide a smooth surface for the outer planking, the gap between apron and stempost was filled with small, wedge-shaped pieces of wood and caulking material (Figure 3-10).
