The Gresham Ship Project

A 16th-Century Merchantman Wrecked in the
Princes Channel, Thames Estuary

Volume I: Excavation and Hull Studies

Jens Auer and Thijs J. Maarleveld

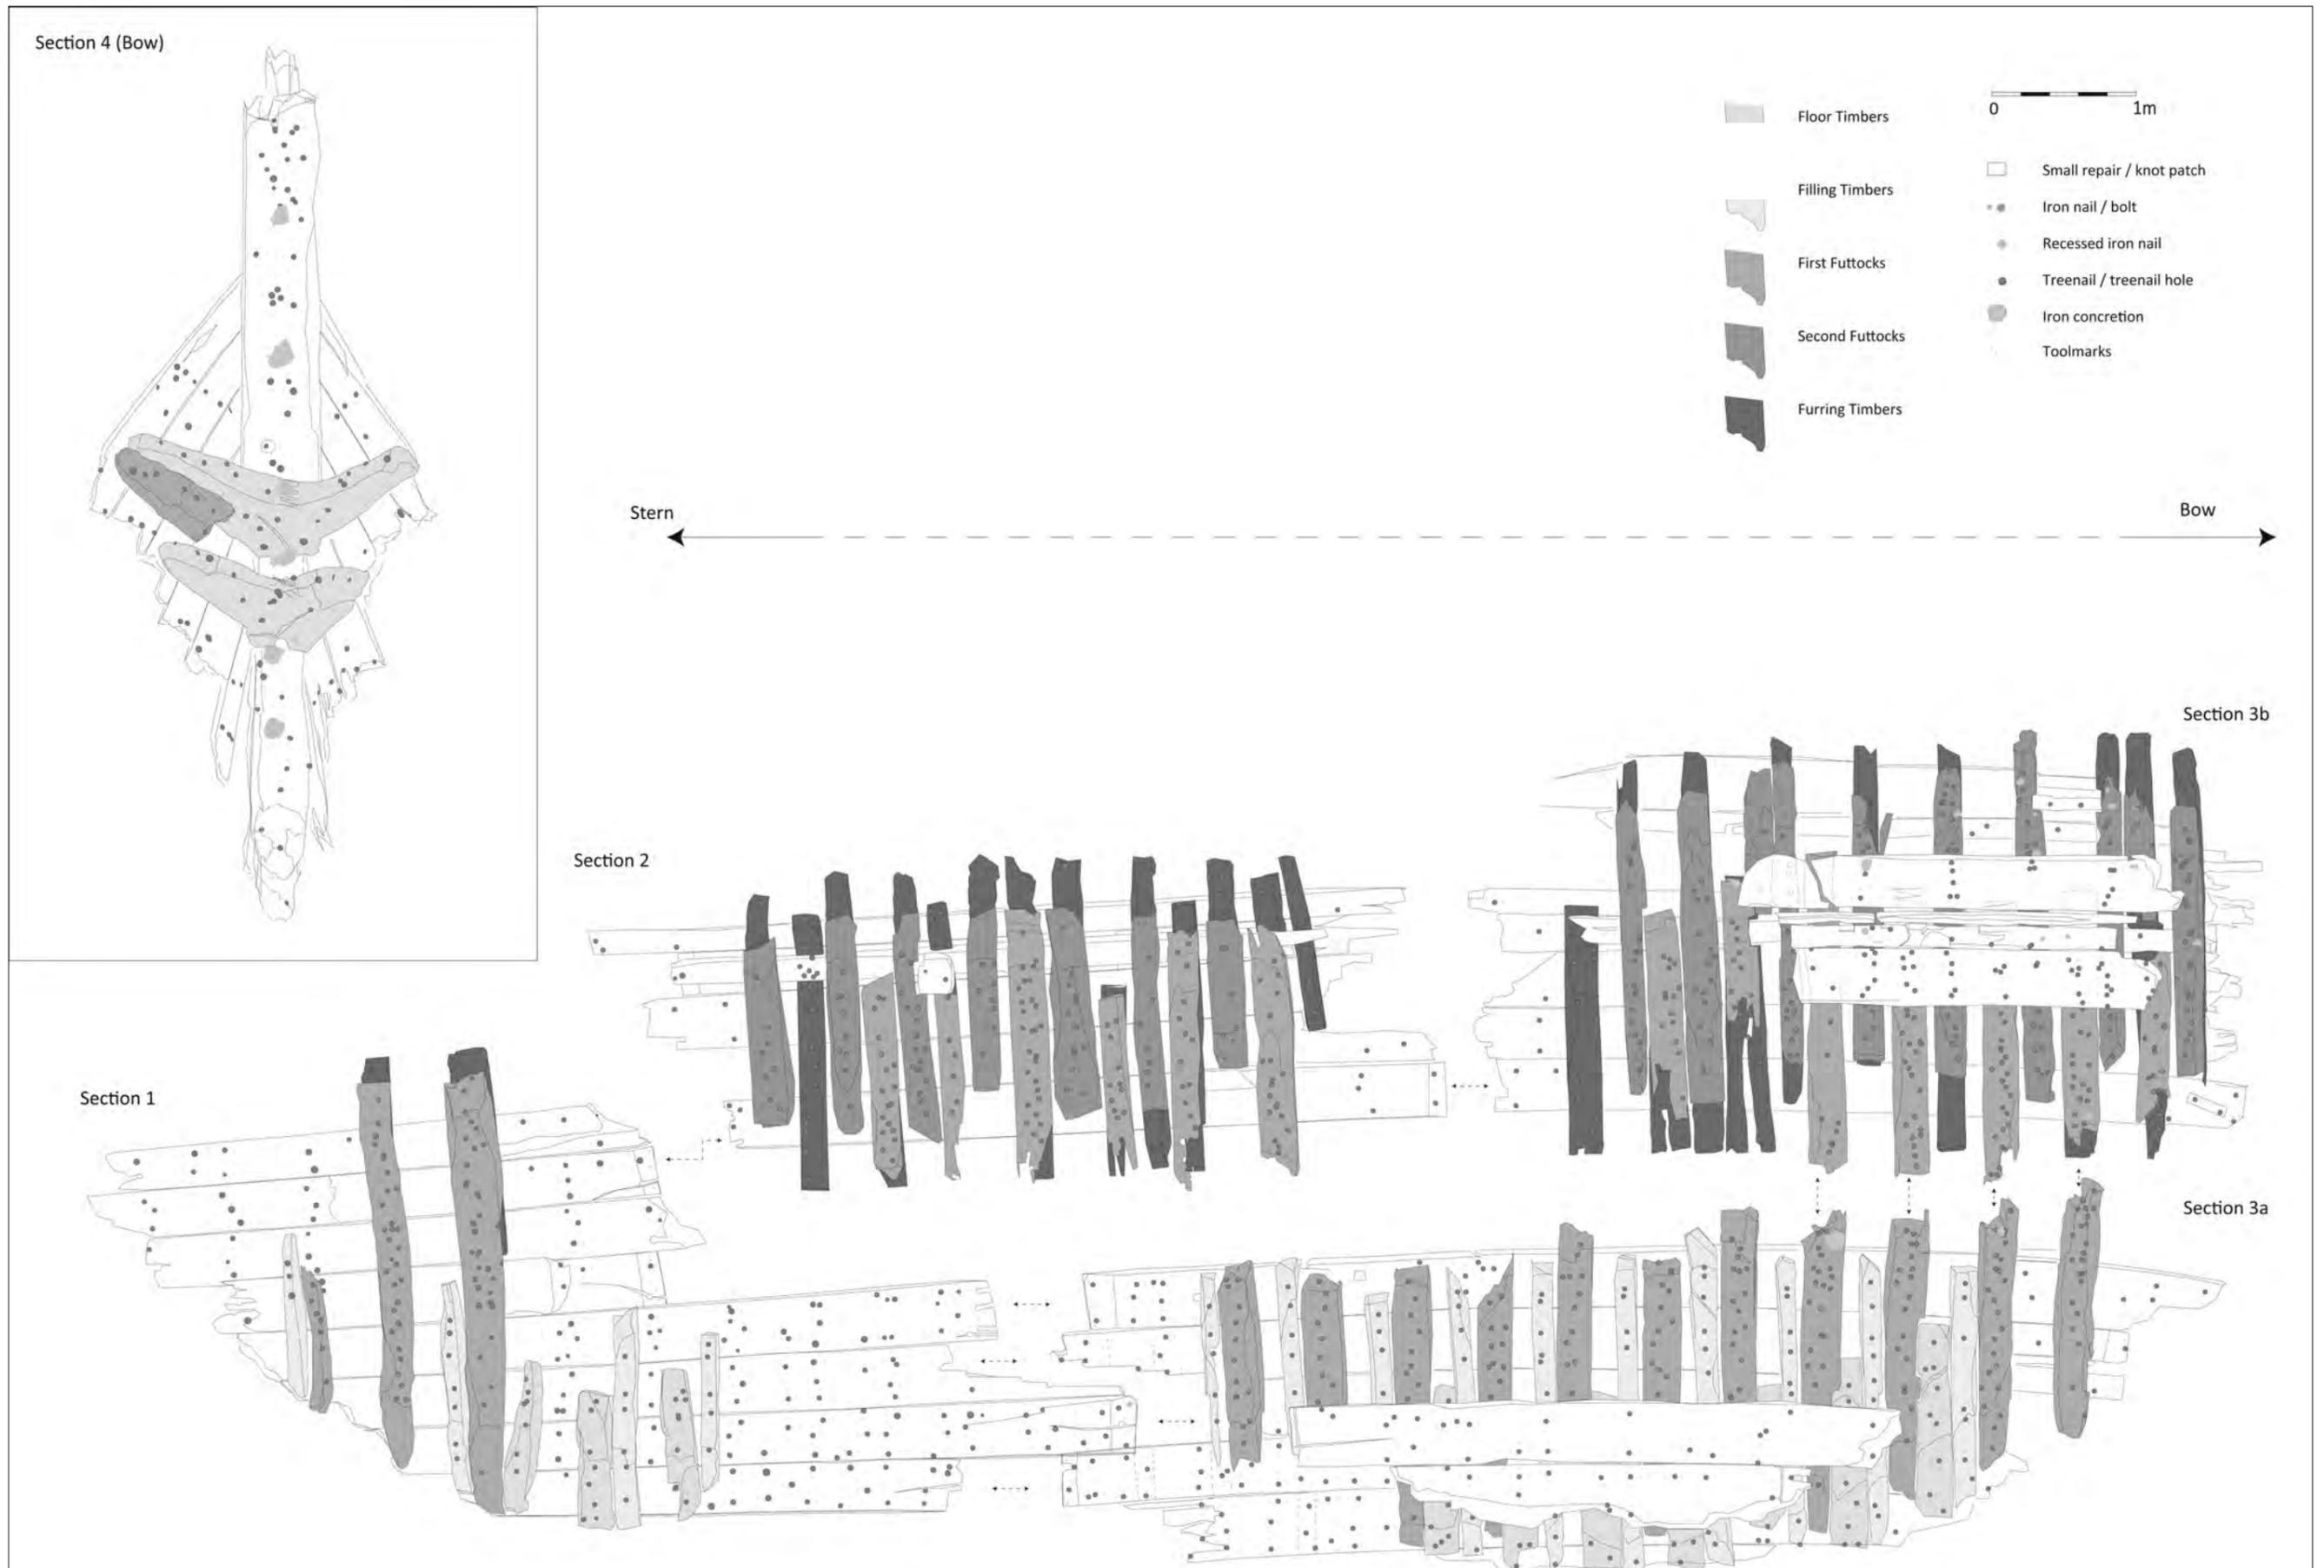
Figure 3-11: Inside view of the hull sections with the different framing elements marked (J. Auer, based on the original recording results and illustrations by Wessex Archaeology). Section 4 (inset) was originally located forward of sections 3a and 3b

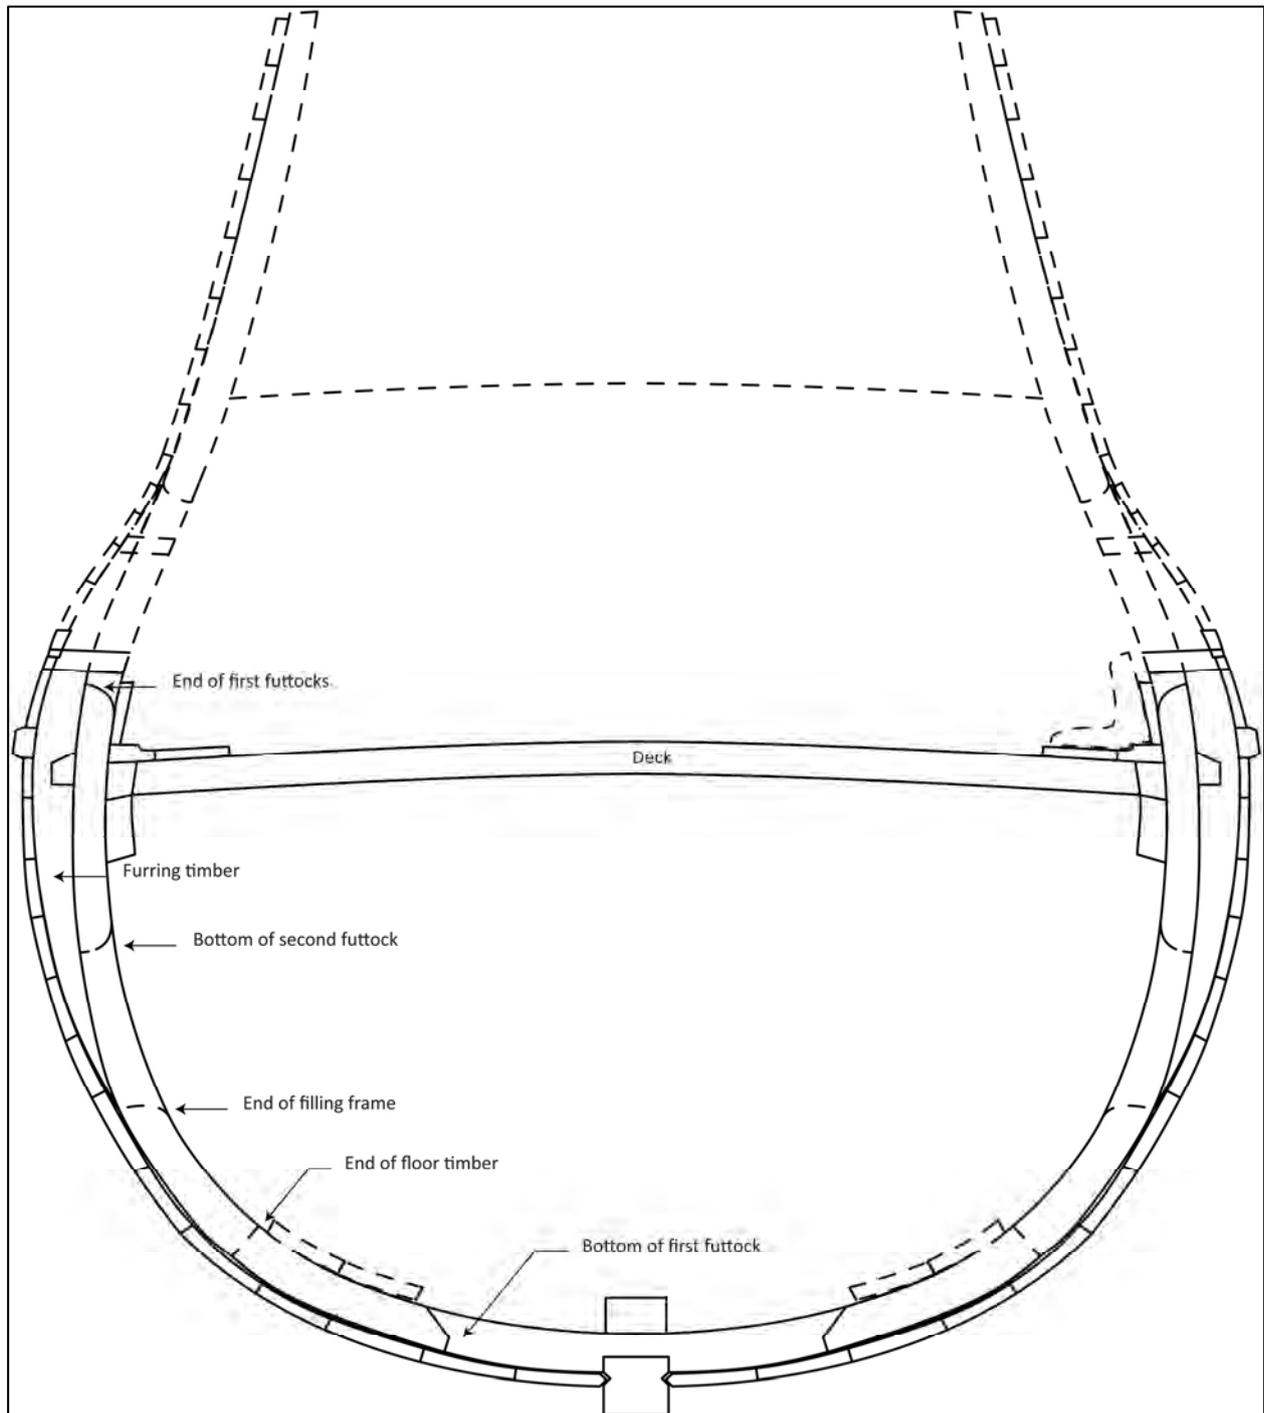
Figure 3-12: Reconstructed midships section showing the layout of framing timber (M. Ditta)

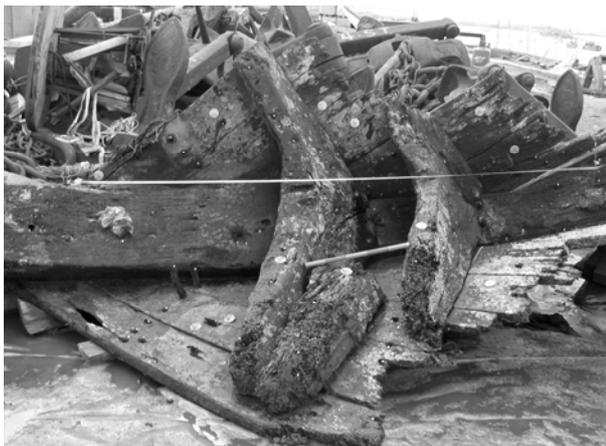
Figure 3-13: Inside view of the bow section with the two rising floor timbers in place (J. Auer)

Because of the state of preservation, it is unclear how long the floor timbers were and whether they crossed the keel. The only two fully preserved floors are the two crotches in the bow (Figure 3-13). These were v-shaped and placed on the apron at increasing angles. They have semi-circular grooves or channels in their upper face and roughly worked central limber holes at the bottom.

Moulded dimensions vary between 19 cm and 22 cm, with the crotches in the bow being up to 50 cm high due to their angle and shape. The floor timbers are sided to between 18 cm and 25 cm.

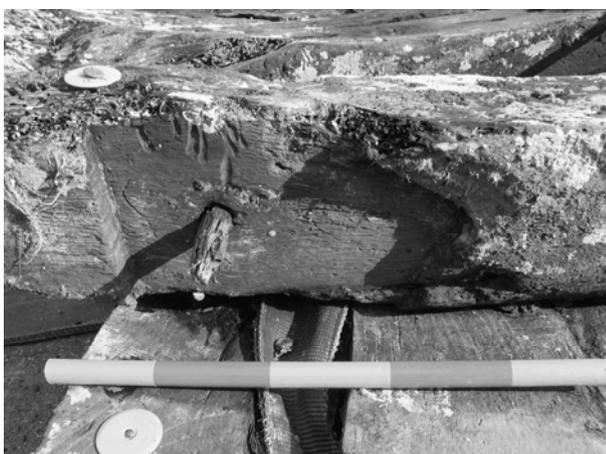
Figure 3-14: Broken dovetail joint in a first futtock on section 3a. The joint was secured with a trenail (J. Auer)

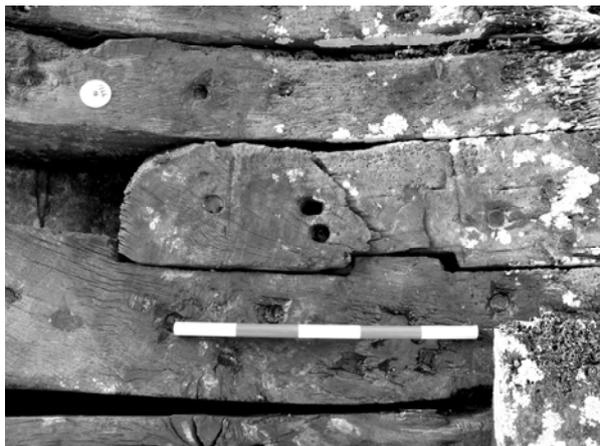
Figure 3-15: Floor timber and first futtock on section 3a connected with a double dovetail joint (J. Auer)

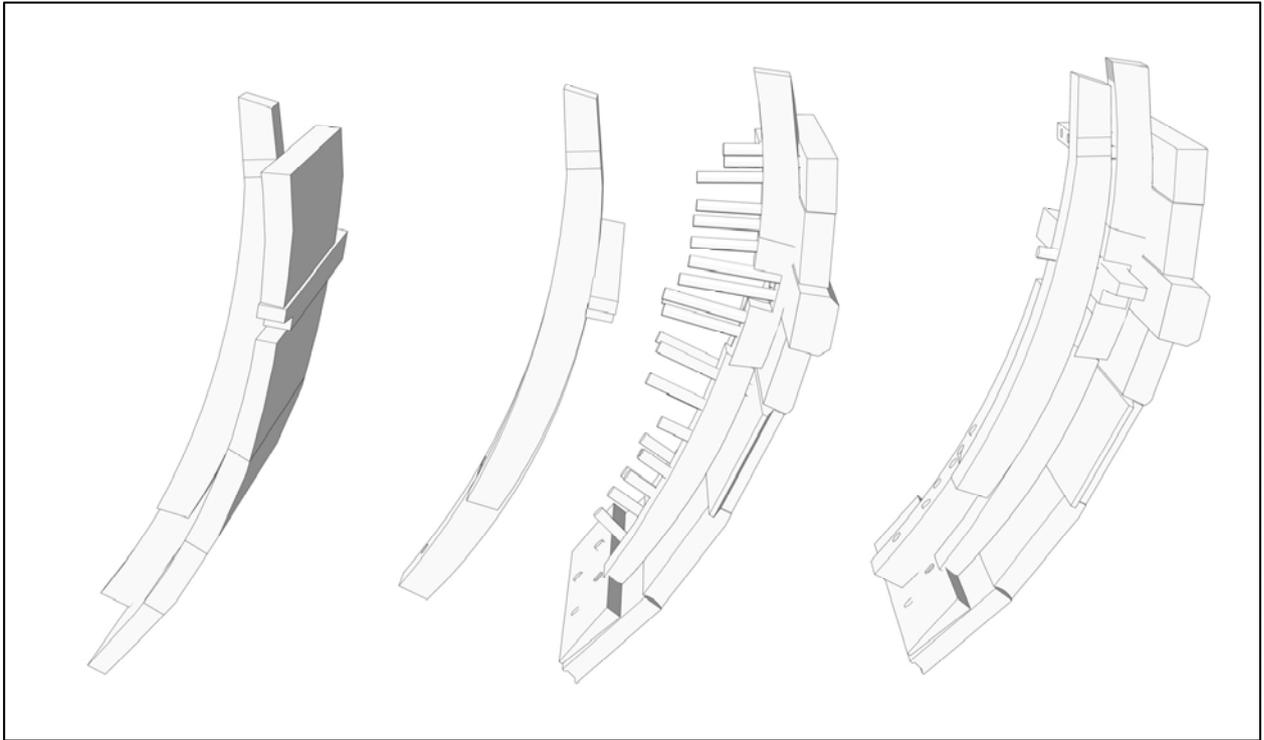
Figure 3-17: Diagram showing how furring timbers were applied to the outside of the existing frames on the Princes Channel wreck (drawing J. Auer)

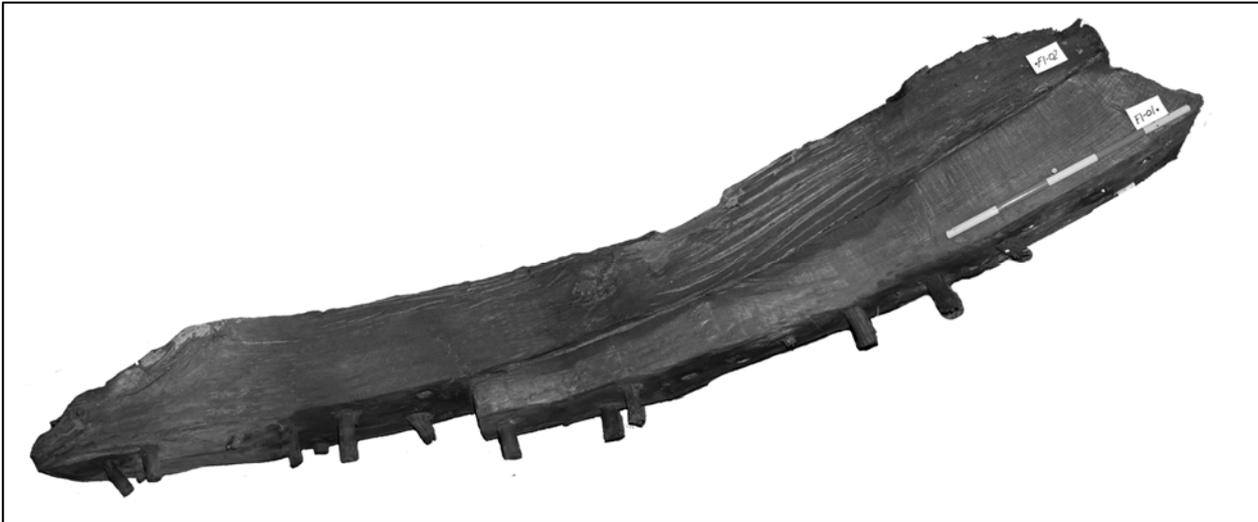
Figure 3-18: First futtock on section 1 with furring timber attached. The lower end of the furring timber would have rested on the triangular plank (photo J. Auer)

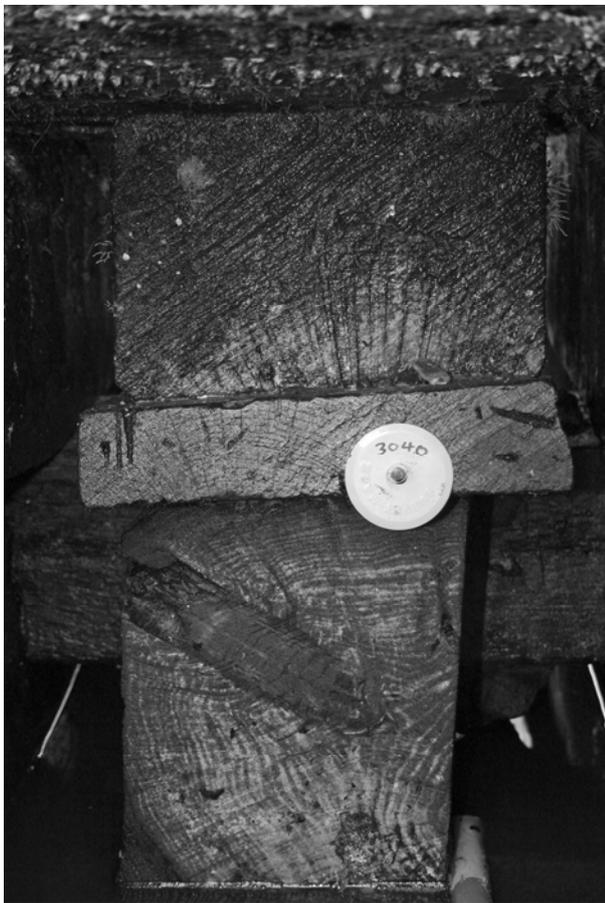
Figure 3-19: Wedges and filling timbers are used to achieve the desired moulded dimension on section 3b (photo J. Auer)

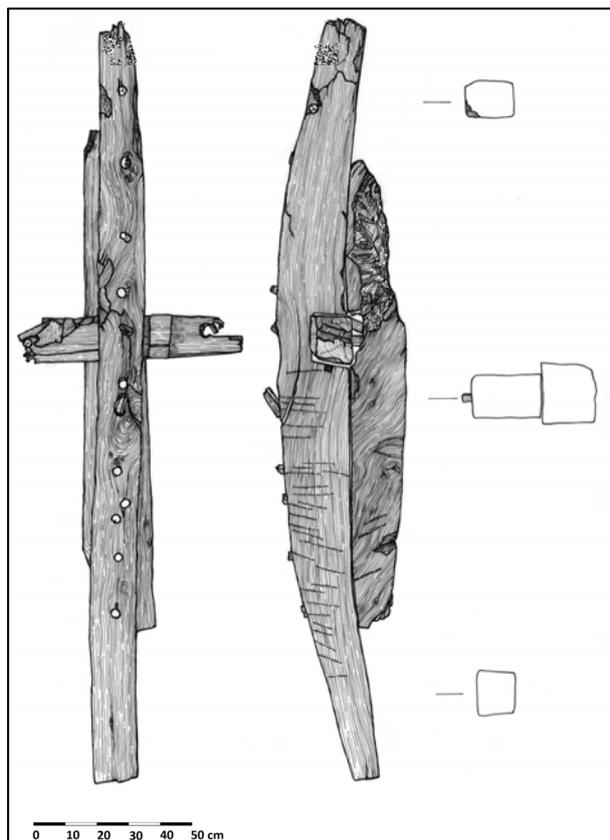
Figure 3-20: Drawing of a loose second futtock, which has a furring timber attached. The furring timber is recessed to fit around the former wale (R. Bangarter)

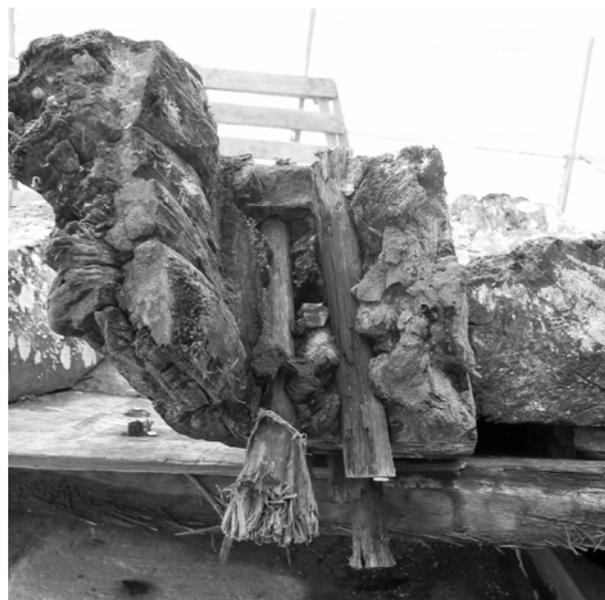
Figure 3-21: Break in a first futtock on section 3a. The integrity of the timber was compromised by the number of trenails driven through it. Trenails which were cut flush with the frame (marked with a drawing pin in the picture) are associated with the original construction (J. Auer)

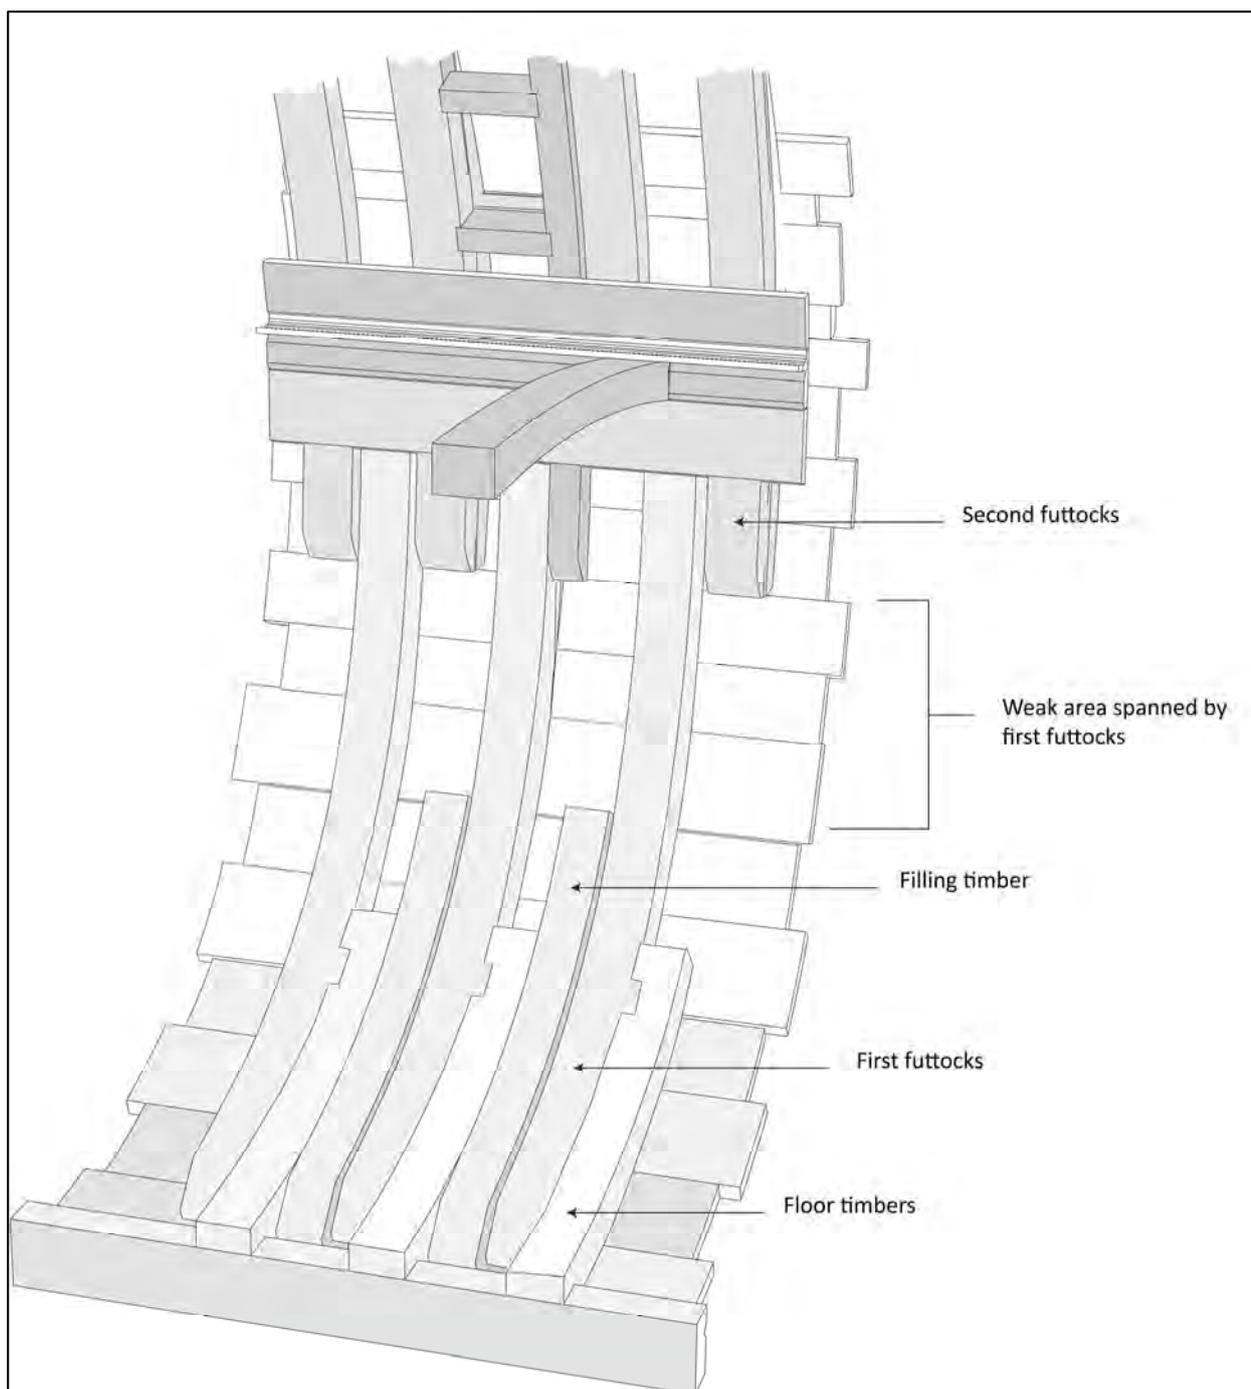
Figure 3-22: Diagram of the frame layout showing the weak area between the floor and bilge and the level of the deck (M. Ditta)

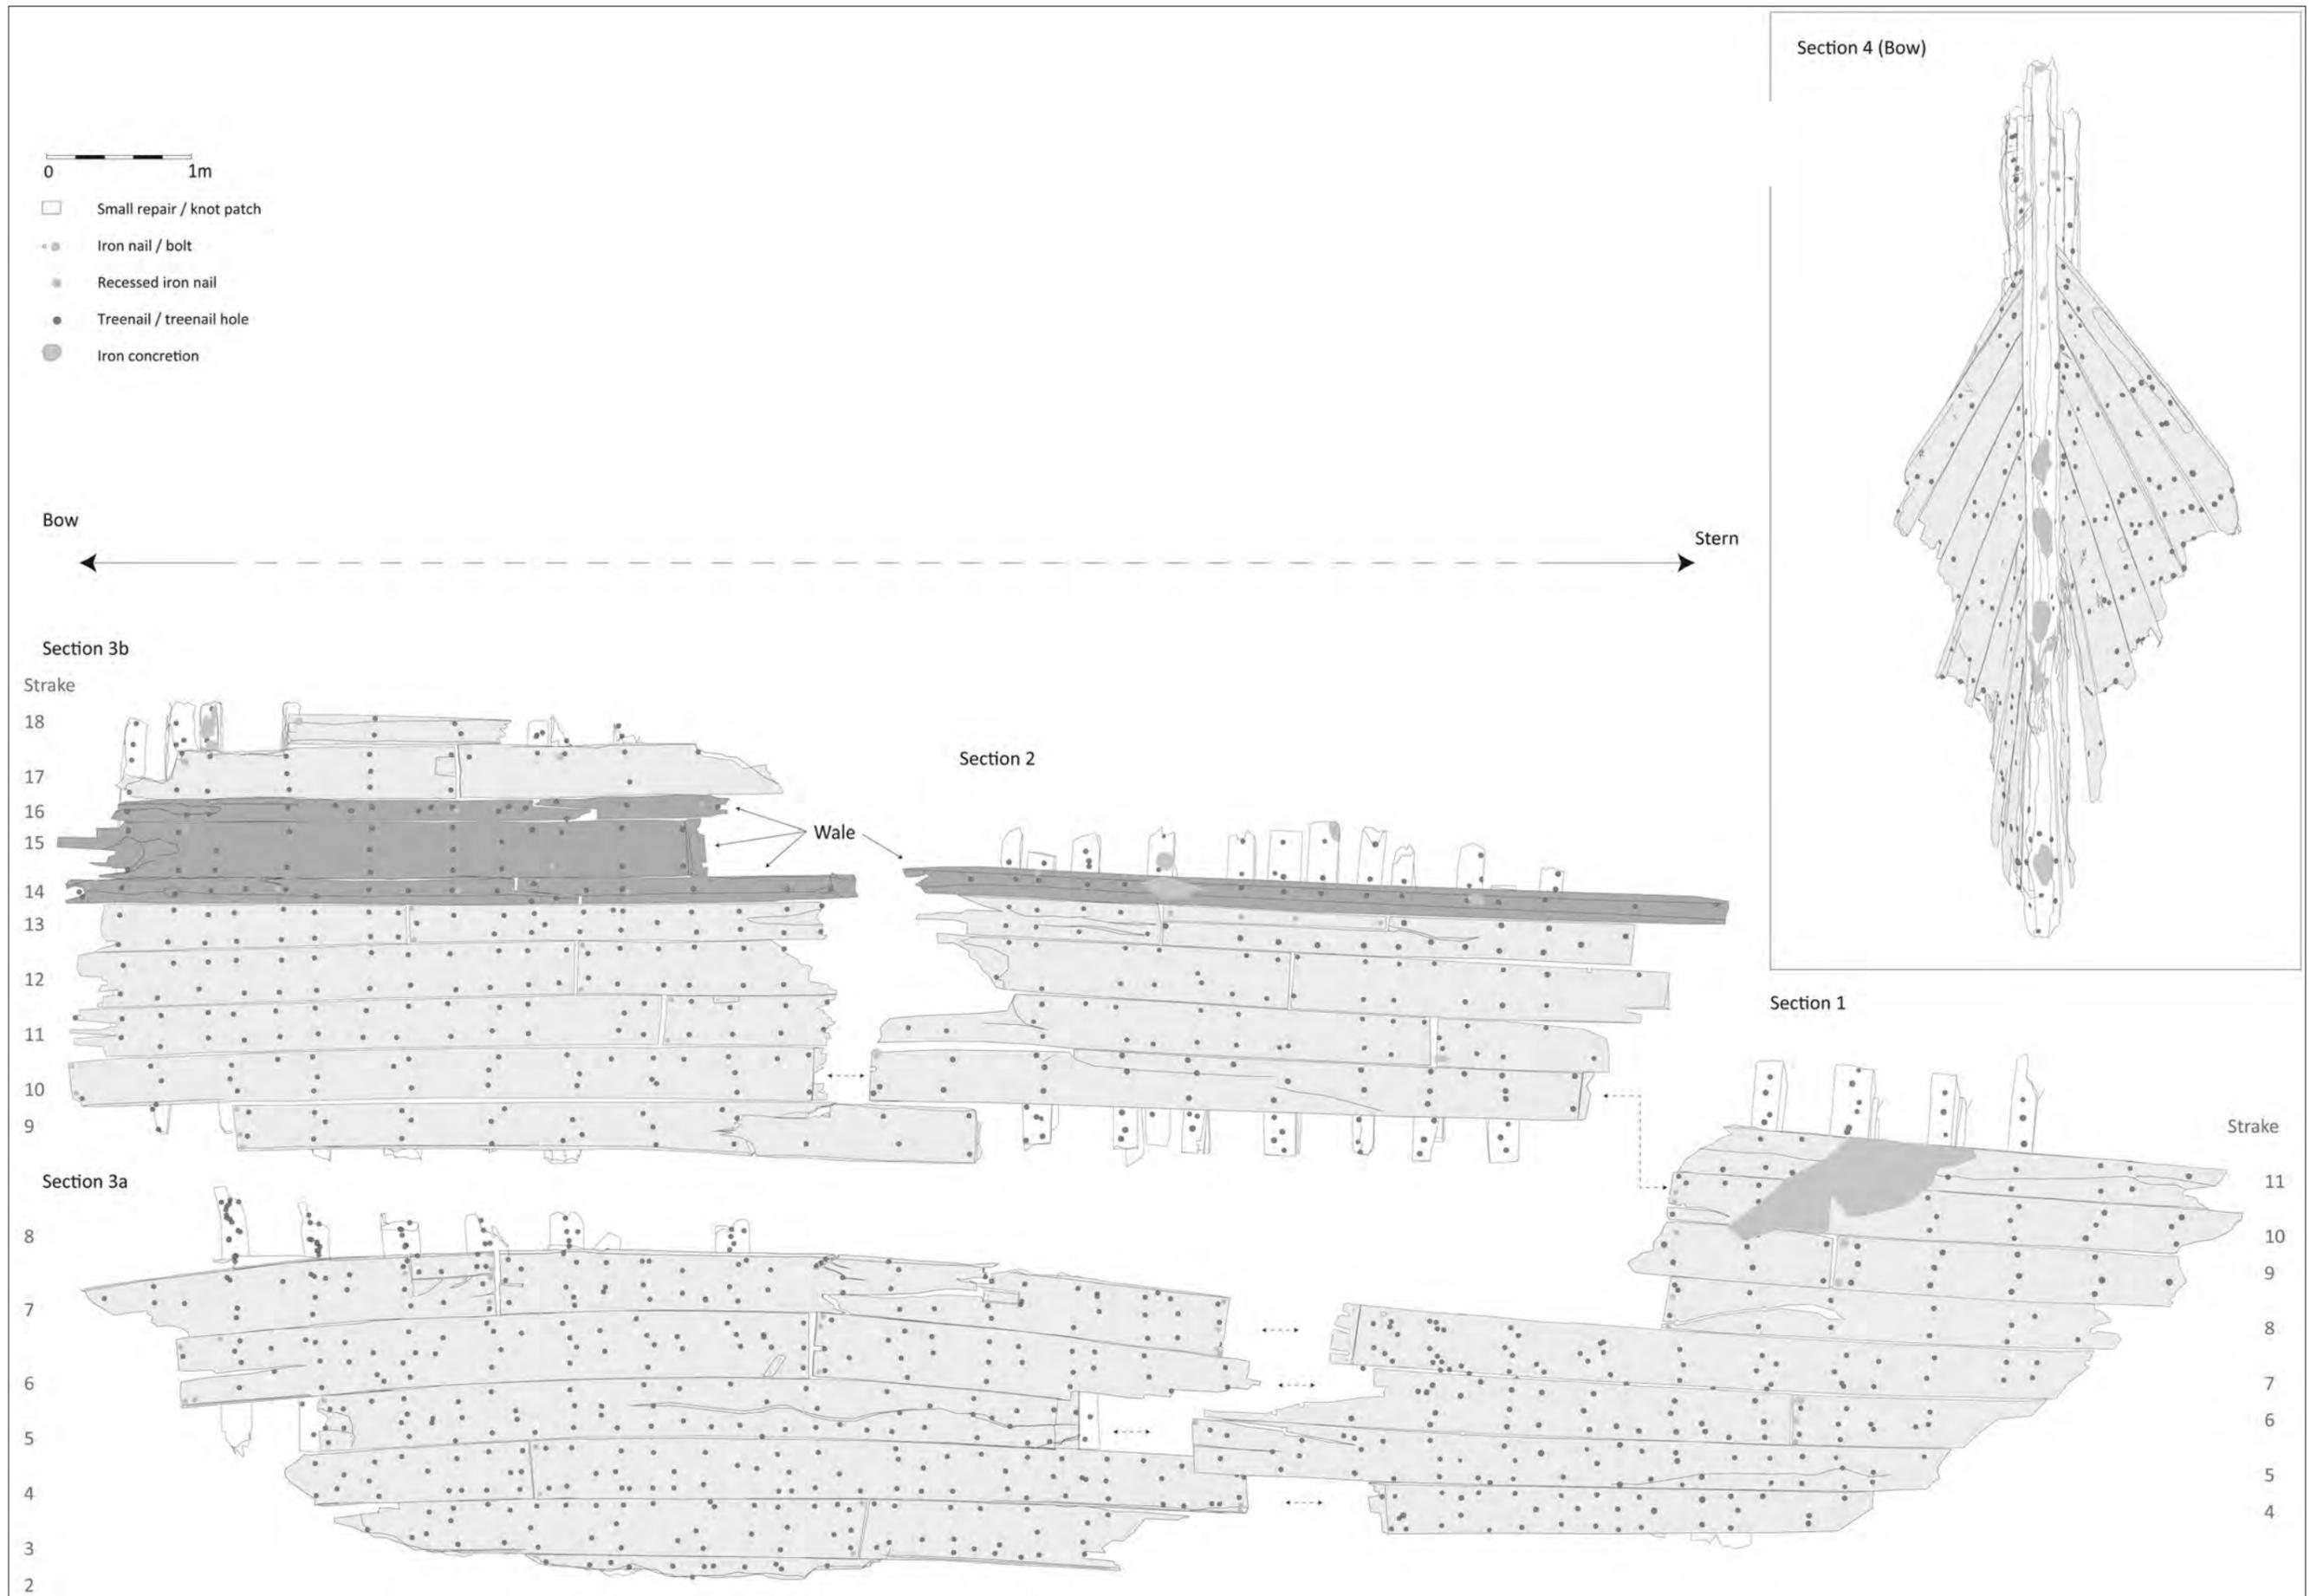
Figure 3-23: Outside view of the hull sections: strakes are labelled according to the reconstruction and the wale is marked in a darker shade of grey; as the connection between the bow section (4) and the remainder of the ship's side is not clear, outer planks are not labelled (J. Auer based on the original recording results and illustrations by Wessex Archaeology)

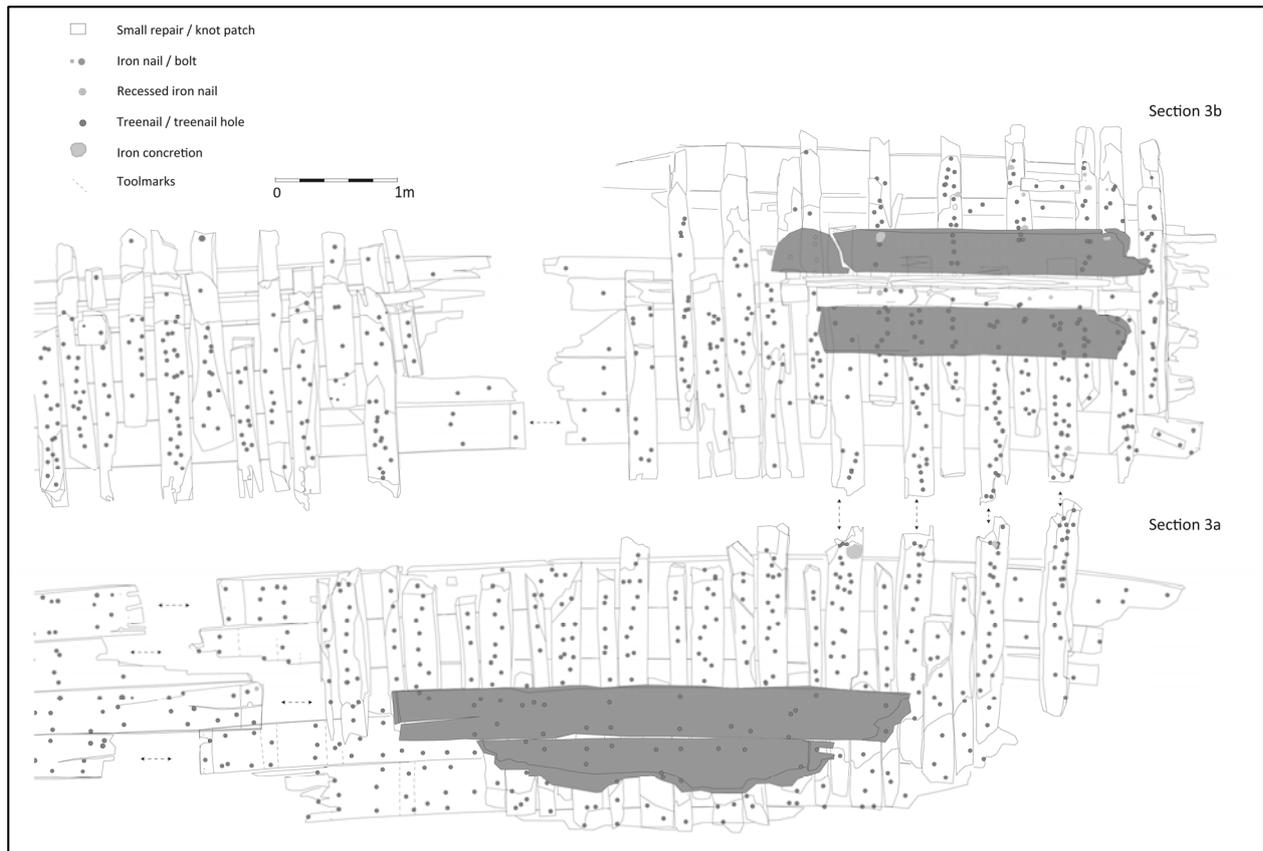
Figure 3-24: Inside view of the hull sections with the ceiling planks marked in grey (J. Auer based on the original recording results and illustrations by Wessex Archaeology)

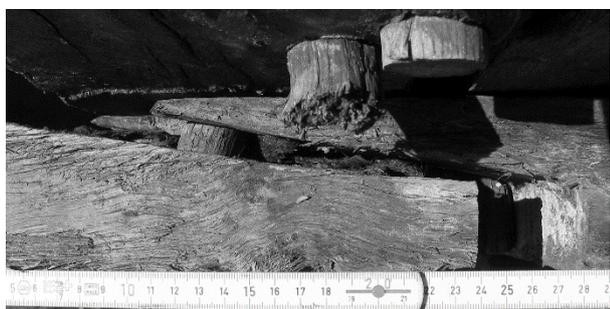
Figure 3-26: Vertical scarf joint between two outer planks on section 3a (J. Auer)

Remarkable is the joining of strake planks in vertical scarf joints. This is an unusual phenomenon in carvel shipbuilding. All the outer planks in the Princes Channel Wreck are connected with vertical scarf joints 15 cm to 22 cm long and 4 cm to 5 cm deep. The orientation of scarfs varies throughout the hull. The joints are secured with trenails, as well as up to four iron nails. They are staggered and spaced at least 2 m apart in neighbouring strakes in order to avoid weaknesses in the hull structure (Figure 3-25 and 3-26).

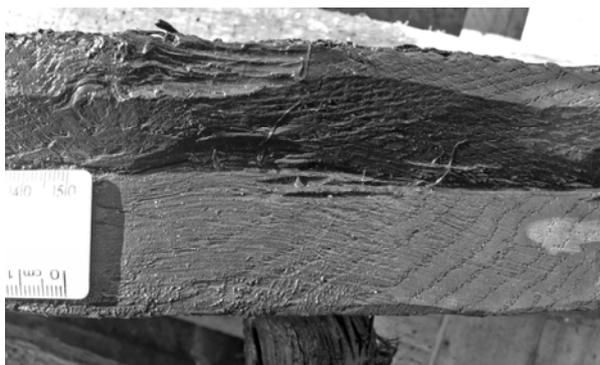
Figure 3-28: Waterproofing recess on the lower edge of a garboard plank (photo J. Auer)

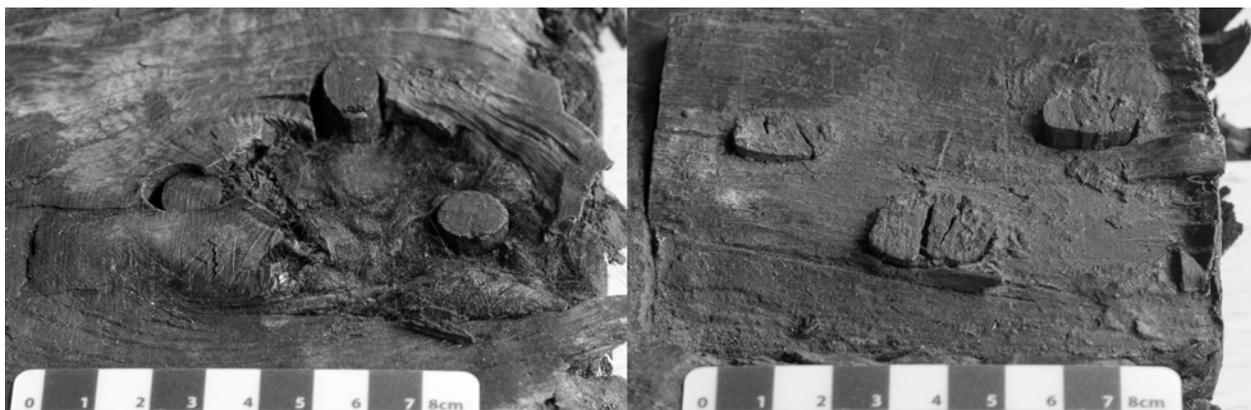
Figure 3-30: Knot patch in one of the loose planks seen from the inside (left) and outside (right); small wedged trenail heads are visible around the patch (J. Auer)

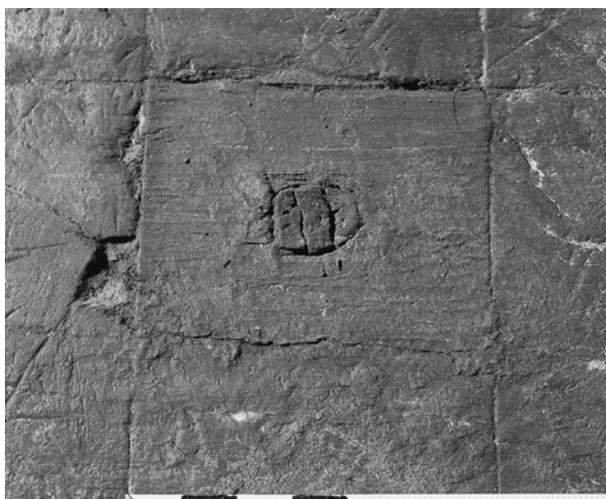
Figure 3-31: The position of a knot patch marked on one of the outer planks (J. Auer)

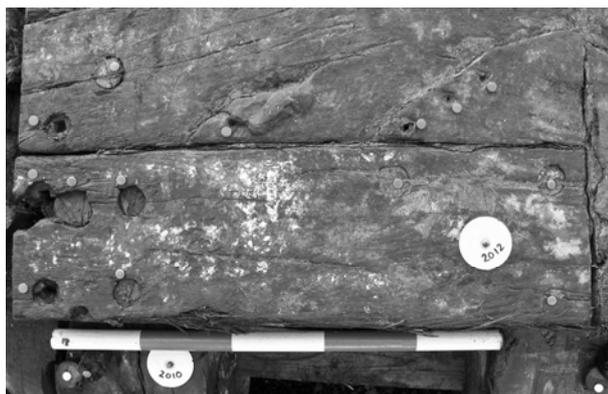
Figure 3-32: Graving piece near a scarf joint in a plank on section 3a; underneath the graving piece (above in the photograph), a splinter was re-attached with small iron nails (J. Auer)

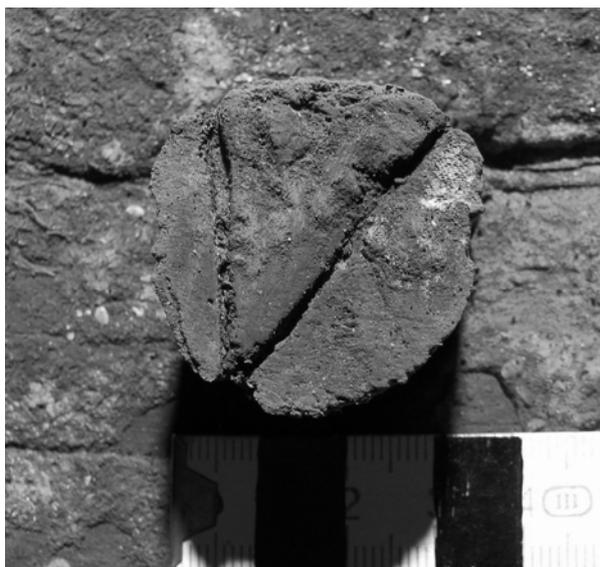
Figure 3-33: Caulked oak trenail in the outer hull planking (J. Auer)

Wooden nails are the most common type of fastening used during the construction of the Princes Channel Wreck. These are cleft oak trenails, which were shaved but not mooted (Goodburn, 2004). The outboard ends were split with two blows to form a 'V' or an 'X' and then caulked (Figure 3-33).

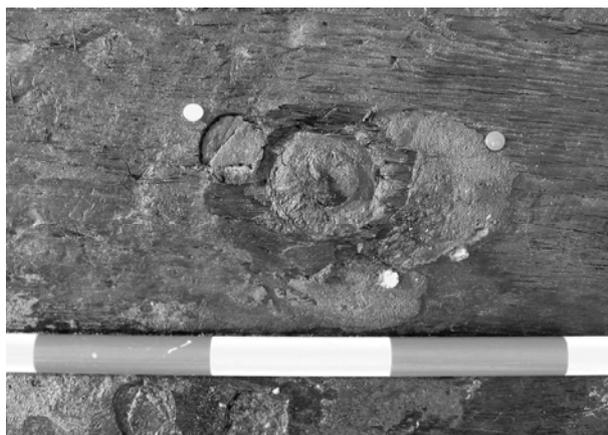
Figure 3-34: Head of an iron bolt next to a caulked oak trenail in the wale on section 3b (J. Auer)

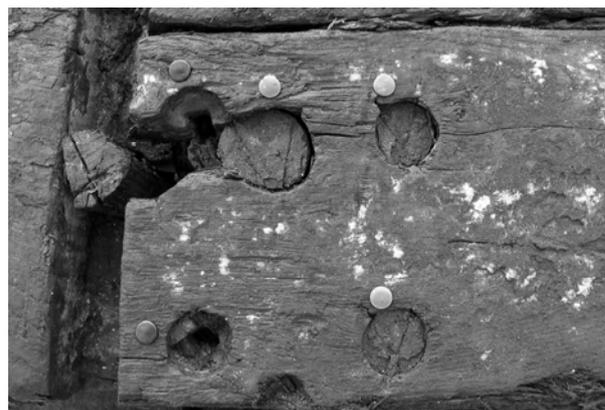
Figure 3-35: Two countersunk iron nails and four trenails in a repair at a scarf joint between two outer hull planks on section 3a; the nails have corroded and the resinous material in the holes has been removed (J. Auer).

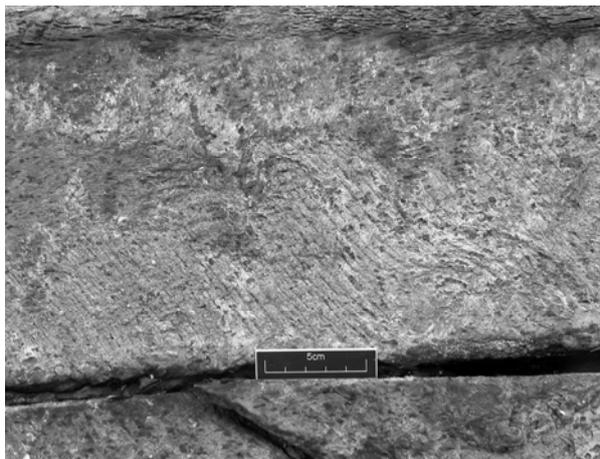
Figure 3-36: Detail of the surface covering on the outside of the bow, section 4 (J. Auer)

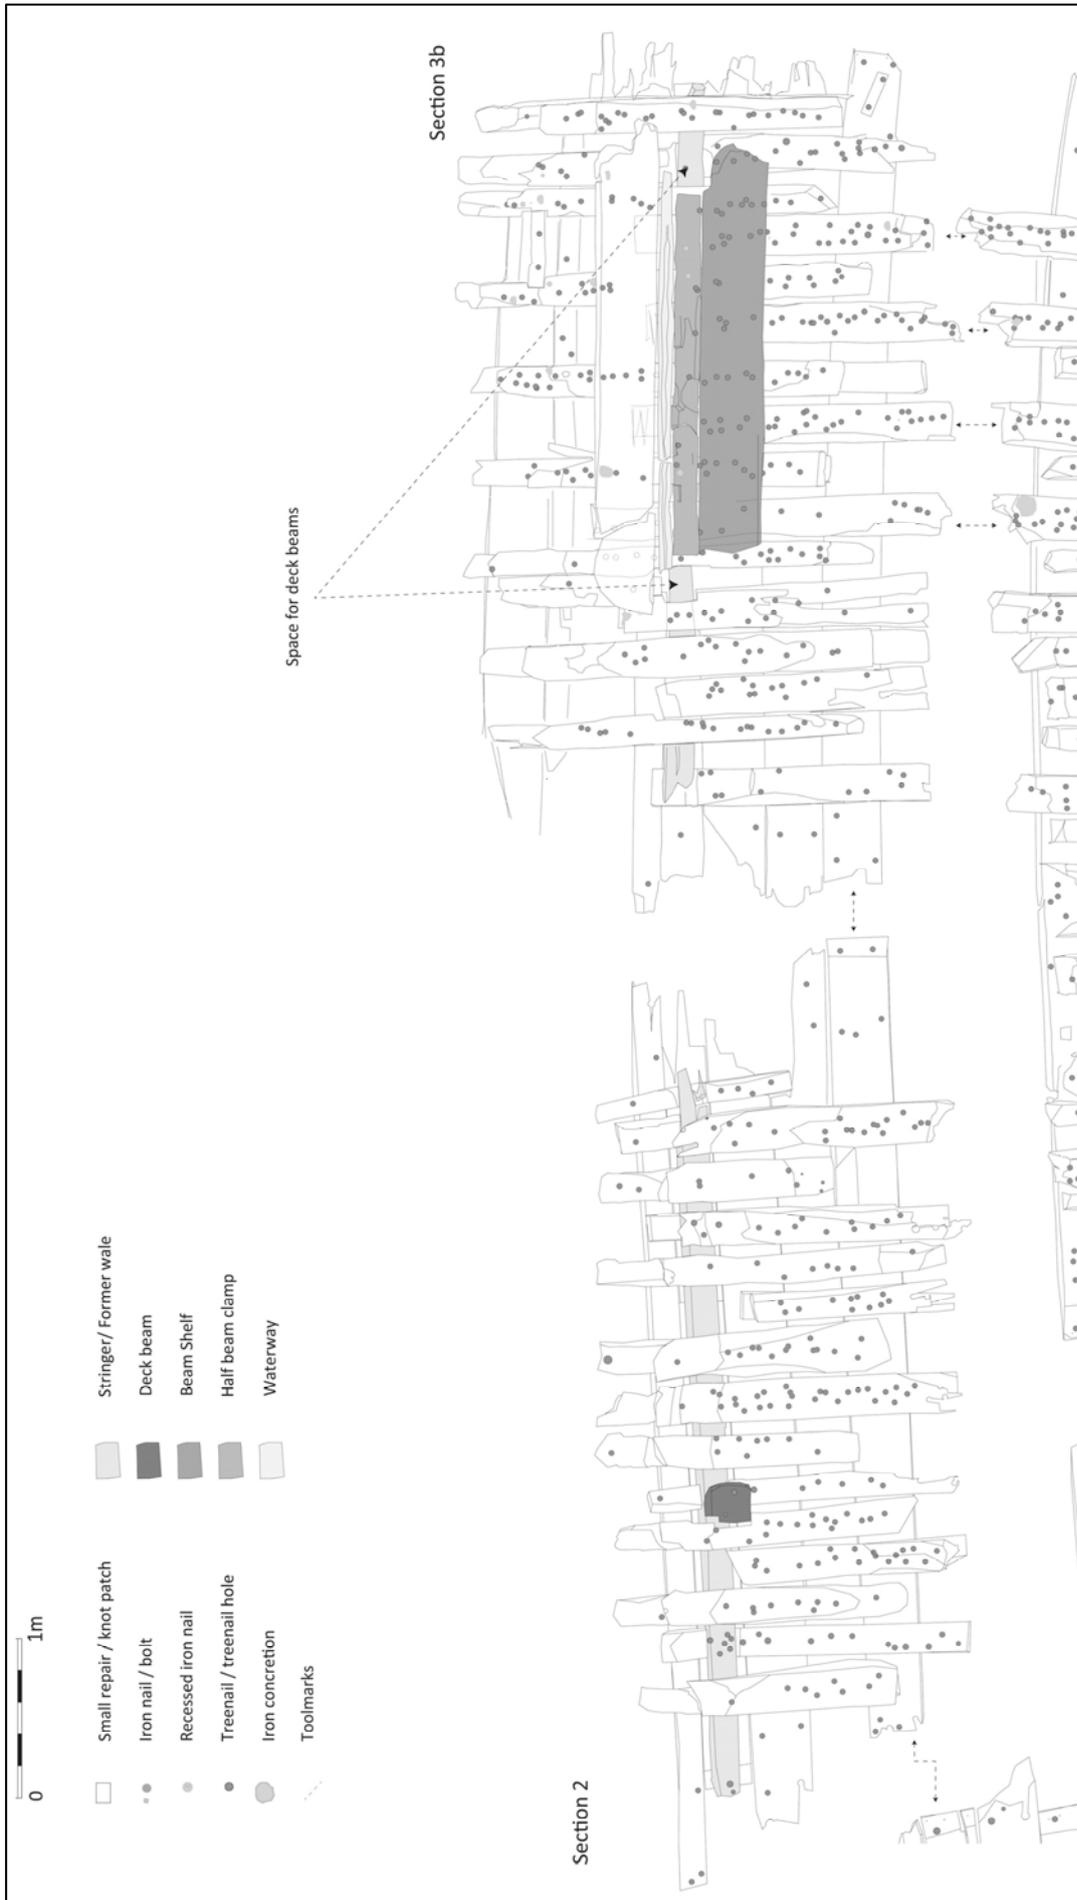
Figure 3-37: Inside view of the hull sections with the elements relating to the deck construction marked in different shades of grey (J. Auer based on the original recording results and illustrations by Wessex Archaeology)
