The Gresham Ship Project

A 16th-Century Merchantman Wrecked in the
Princes Channel, Thames Estuary

Volume I: Excavation and Hull Studies

Jens Auer and Thijs J. Maarleveld

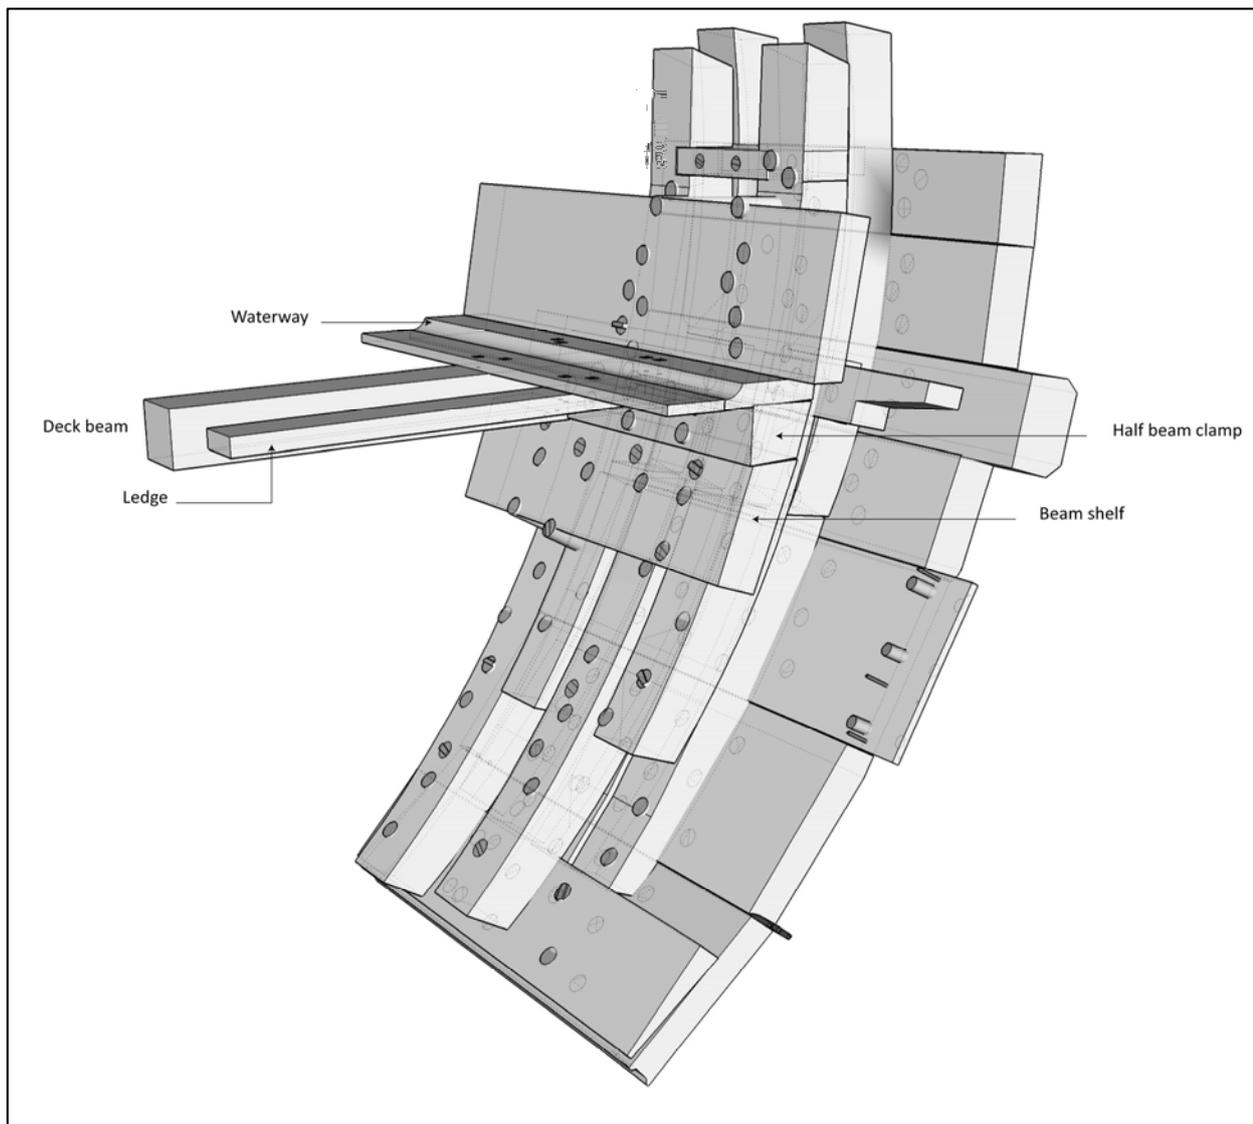
Figure 3-38: Isometric view of the reconstructed deck construction; the knee has been omitted for clarity (J. Auer)

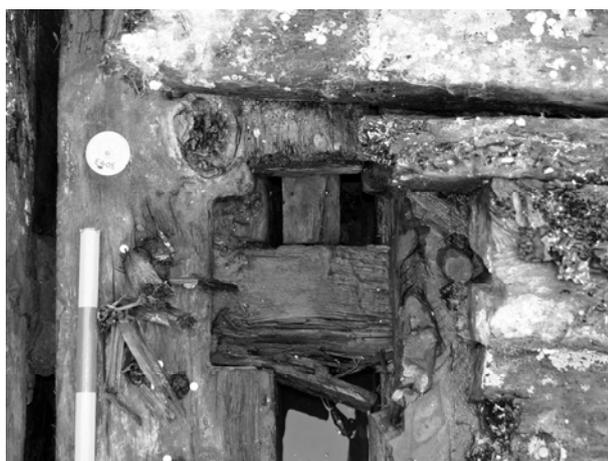
Figure 3-39: Space for a deck beam on section 3b; the frames on either side of the beam are recessed to make space for the beam; on the right hand side the eroded ends of (from the top) overlying ceiling plank, waterway, half beam clamp and beam shelf can be seen (J. Auer)

The deck was supported by oak beams spaced 2.6 m apart (Figure 3-39). On section 2, the heavily eroded end of a deck beam was preserved, while on section 3b beam positions are only indicated by recesses in beam shelf and framing. The preserved beam end measured 23 cm x 24.5 cm in section, while recesses measure approximately 25 cm by 25 cm. The preserved beam end was rebated to interlock with a neighbouring second futtock into which another rebate was cut. Beam recesses

On section 3b, a section of the beam shelf 2.5 m long is preserved (Figure 3-39). This is an oak plank 39 cm wide and 7 cm thick, which is chamfered along the bottom edge. The plank is recessed at the top edge to fit around the beams. It is held in place by trenails, the ends of which were expanded with small oak wedges.

Above the beam shelf and between the beam recesses, a heavily eroded half beam clamp remains in situ on section 3b (Figure 3-39). The beam clamp consists of two rectangular oak timbers, 80 cm and 1.54 m in length respectively, which are connected with a scarf joint. The ends on both sides are sawn off and would have butted against the deck beams. The clamp is 16.5 cm wide and has a thickness of 14 cm. The bottom edge is chamfered. It was fastened with a combination of iron bolts and trenails. Along the top edge of the timber, a series of mortises indicate the position of half beams or ledges. The mortises are spaced 34 to 37 cm apart and vary in size and shape. The foremost mortise is 16 cm wide and 4 to 5 cm deep. This is followed by a mortise 6 cm deep, which measures 10 cm along the bottom edge and 14 cm along the top edge. The last visible mortise is 10.4 cm long and 4 cm deep.

Above the half beam clamp, the eroded remains of the outermost deck plank, the waterway, were observed (Figure 3-39). This is an L-shaped oak timber, which was fastened to deck beams, half beams and ledges, presumably with iron nails. The vertical height of the timber is 9 cm and the thickness of the horizontal part was 4 cm. As only about 2 to 3 cm of the horizontal part are preserved, the width of the waterway is unclear. The waterway was part of the water management system of the ship and would have allowed water to flow along the sides of the vessel to a point where it could be led down to the bilge and the pumps.

The uppermost preserved component of the deck assembly is an oak ceiling plank 37 cm wide and 8 cm thick, which was fastened on top of the waterway (Figure 3-39). The top edge of the plank is chamfered. The plank is fastened with a combination of caulked and wedged trenails and iron nails. On both ends of the ceiling plank,

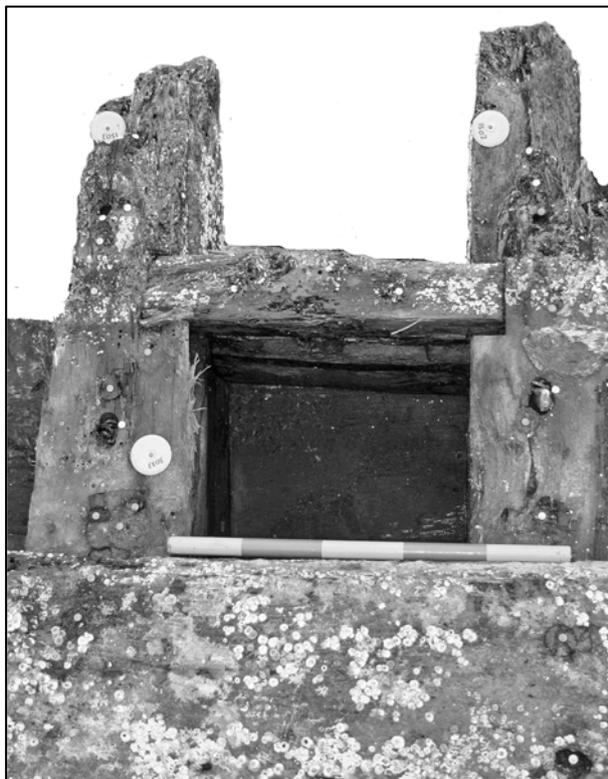
Figure 3-40: Gunport on section 3b. The doubled up lower sill is still in place, but the upper part of the gunport is eroded (J. Auer)

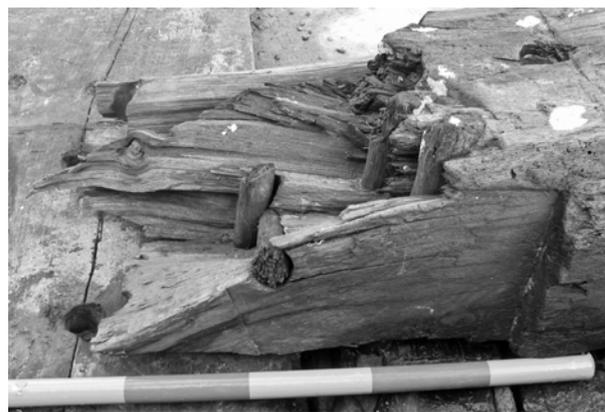
Figure 3-41: A trenail, which connects floor timber and first futtock is cut by a nail attaching the outer planking on section 3a (J. Auer)

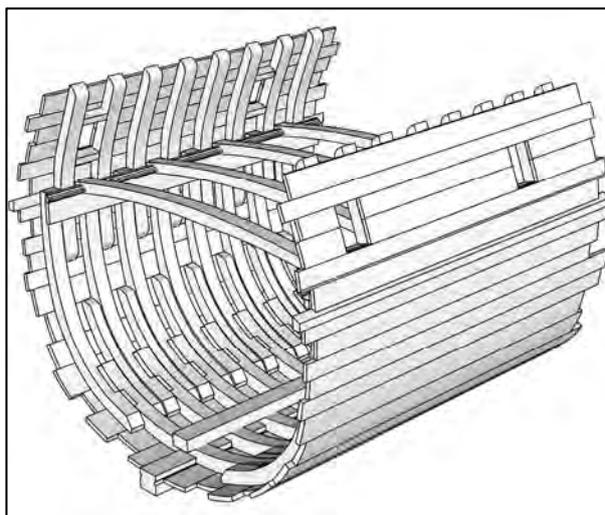
Figure 3-45: Outer planking and framing advance alternately. The remaining deck construction, including the beam shelf, could also be added at this point (M. Ditta)

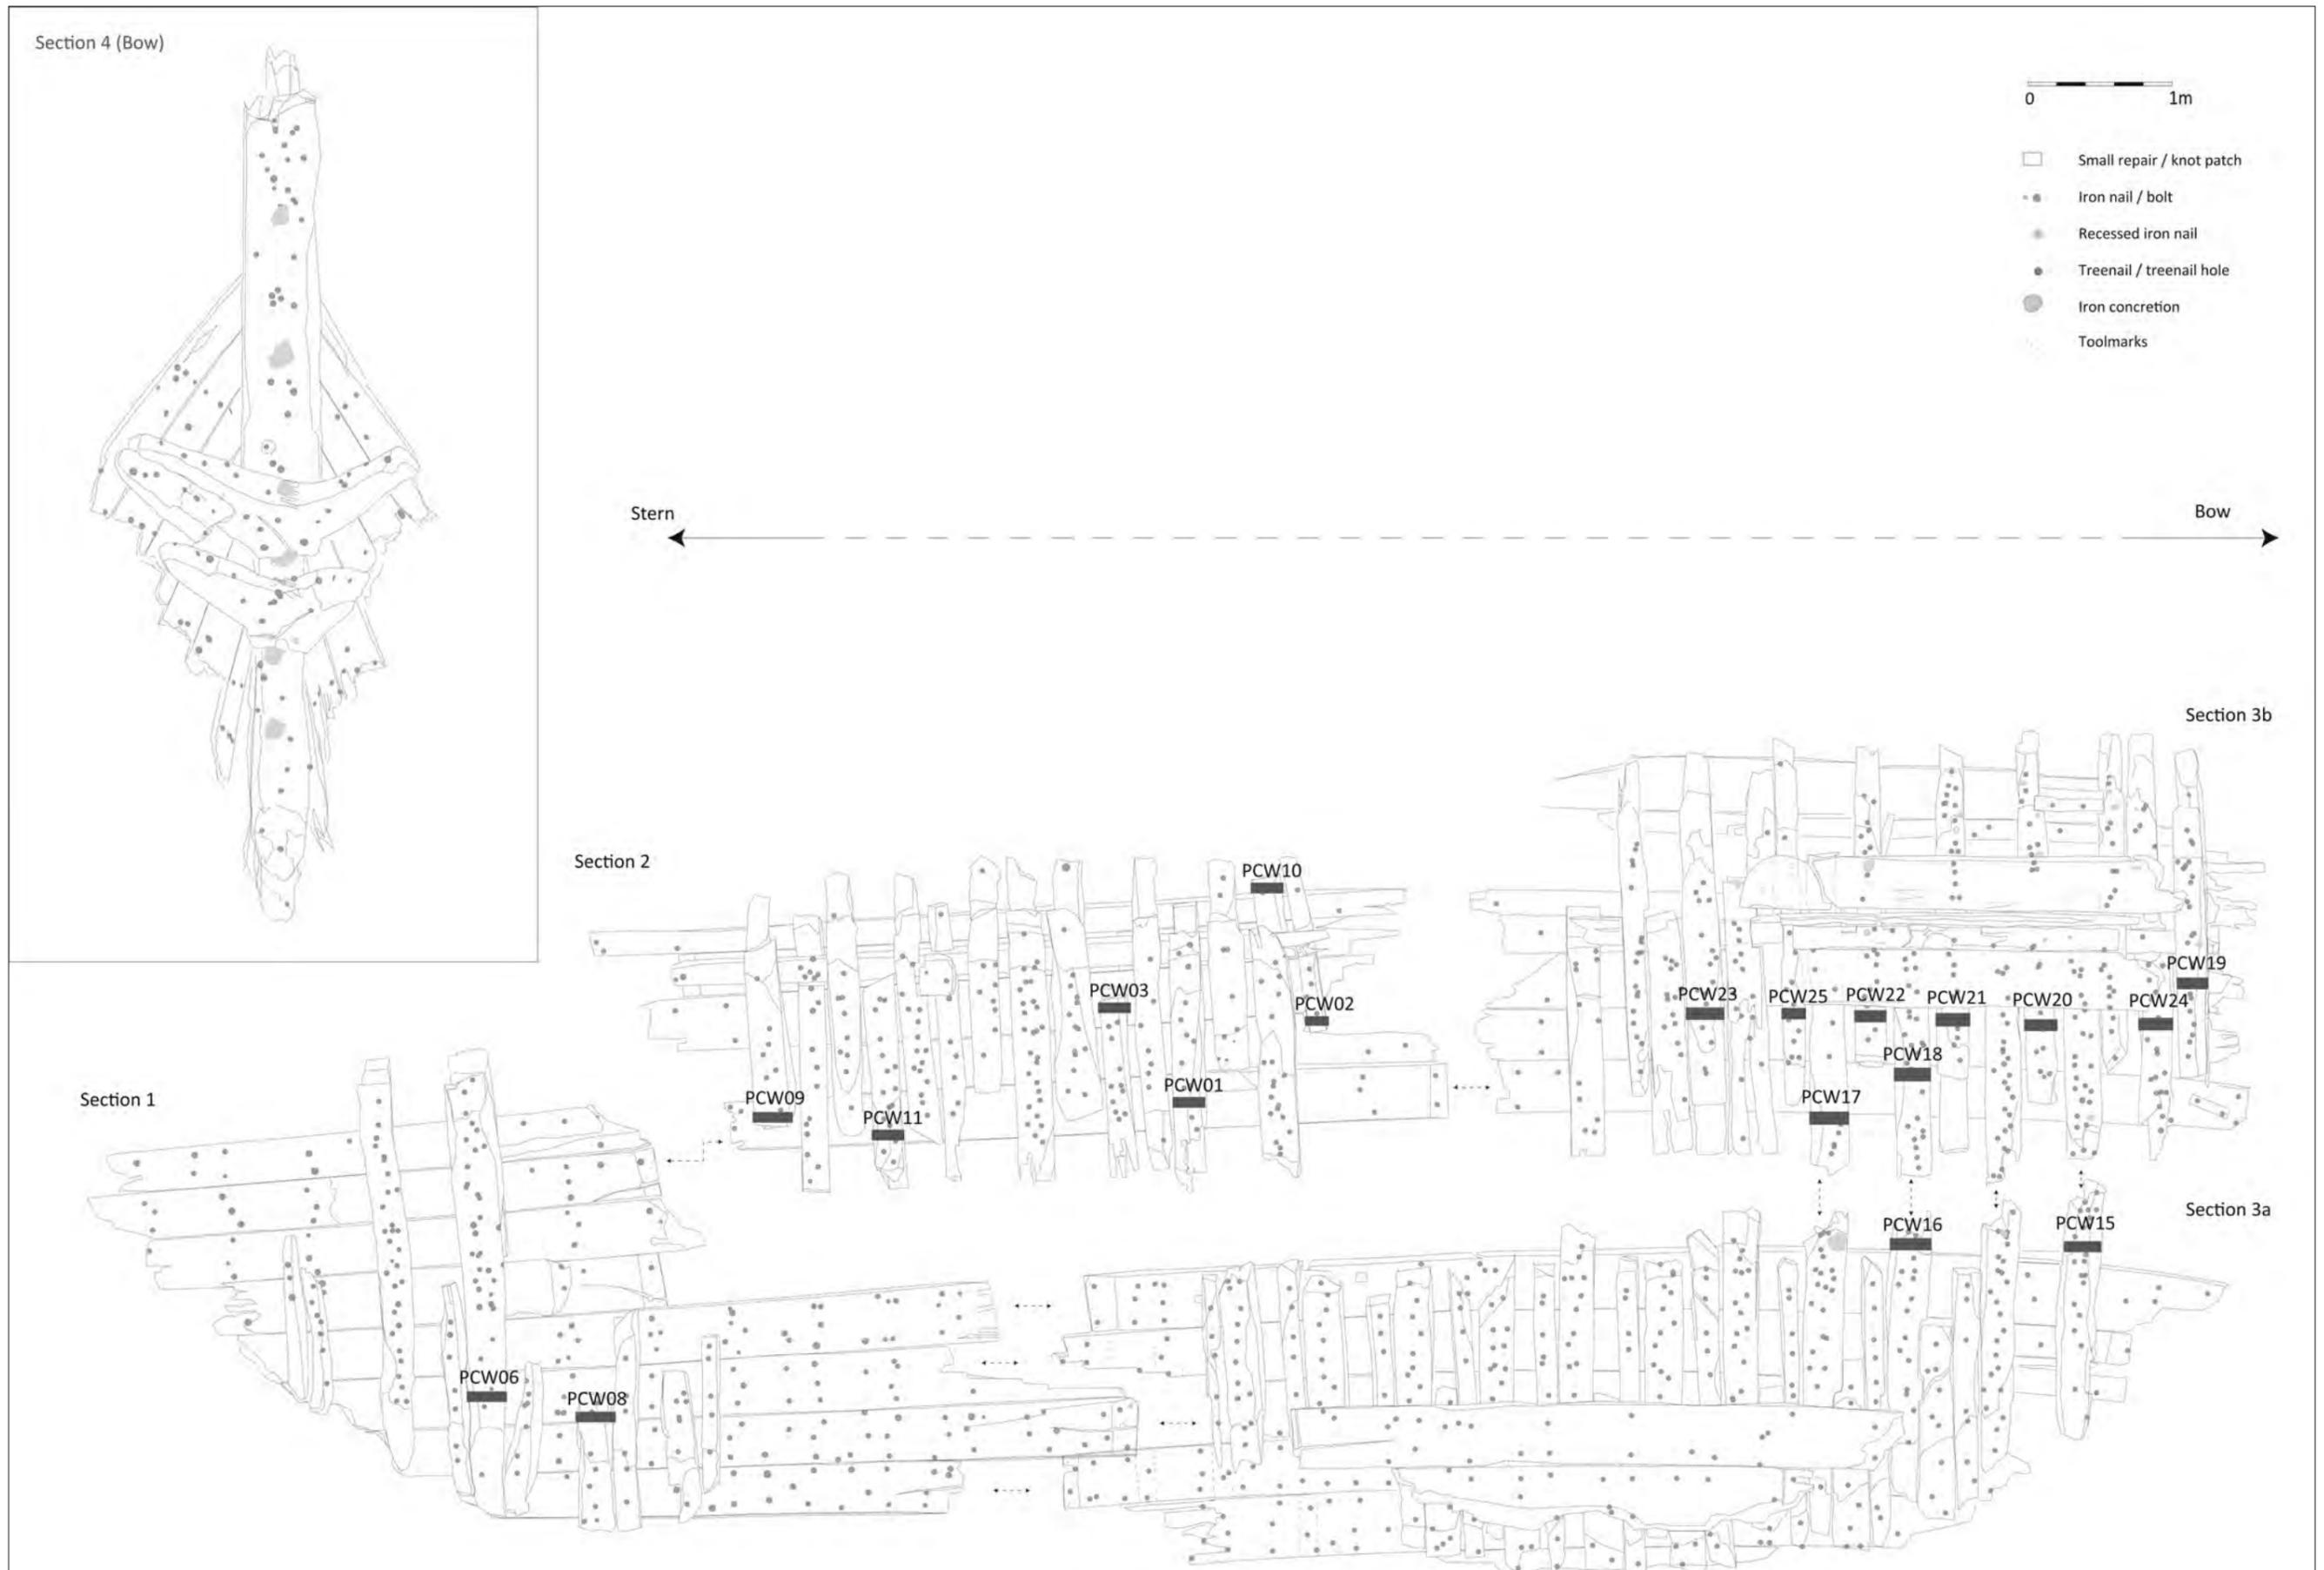
Figure 3-50: Inside view of the hull sections with the positions of dendrochronological samples marked (J. Auer, based on the original recording results and illustrations by Wessex Archaeology); section 4 (inset) was originally located forward of sections 3a and 3b

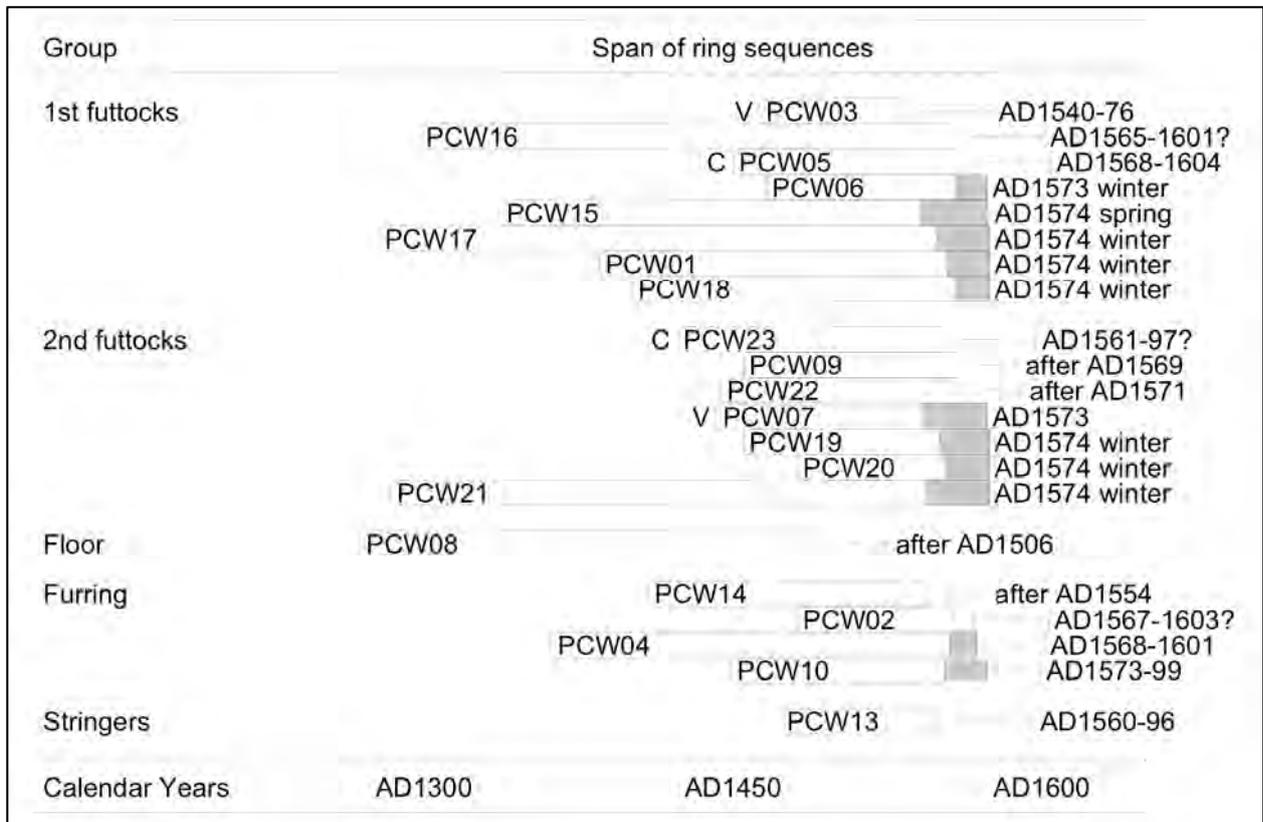
Figure 3-51: Bar diagram showing the chronological positions of the dated timbers from the Gresham Ship; sapwood is shaded and the estimated felling period for each sequence is also shown (N. Nayling)

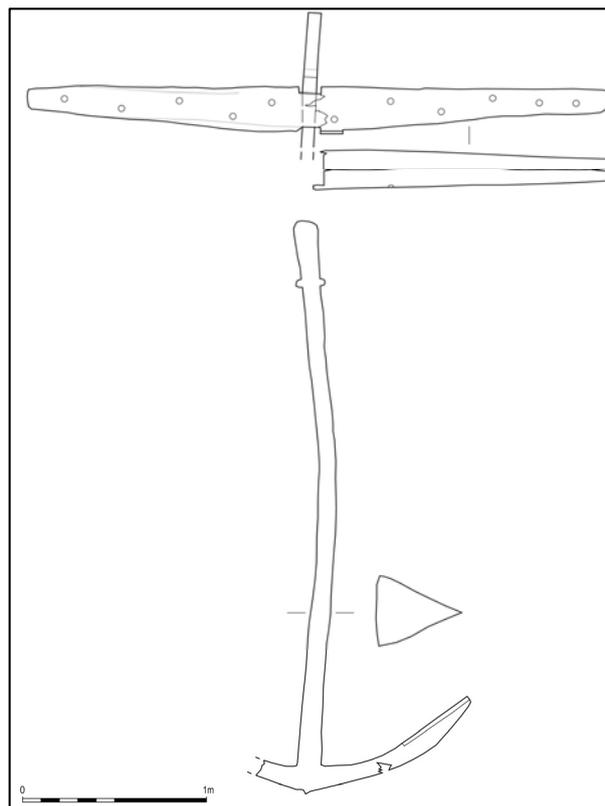
Figure 3-52: The anchor found on the *Princes Channel Wreck* (K. Brandon, Wessex Archaeology)

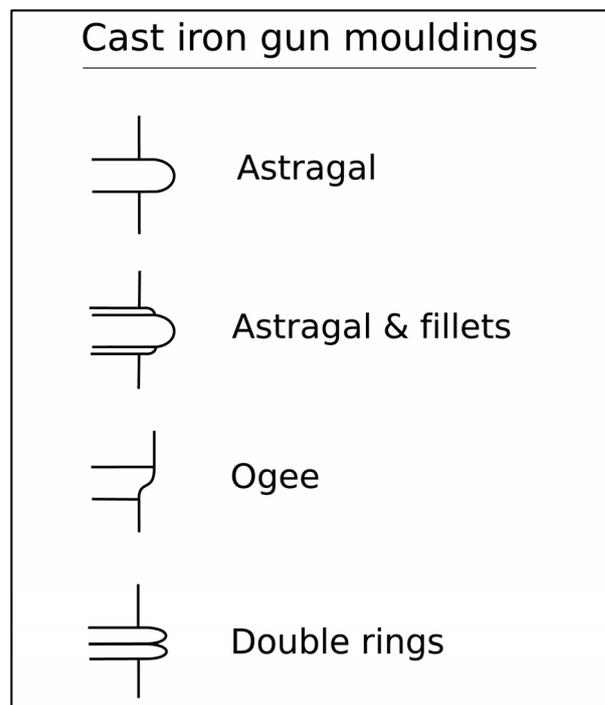
Figure 4-1: Cast iron gun decorative mouldings (drawing D. Ní Chíobháin)

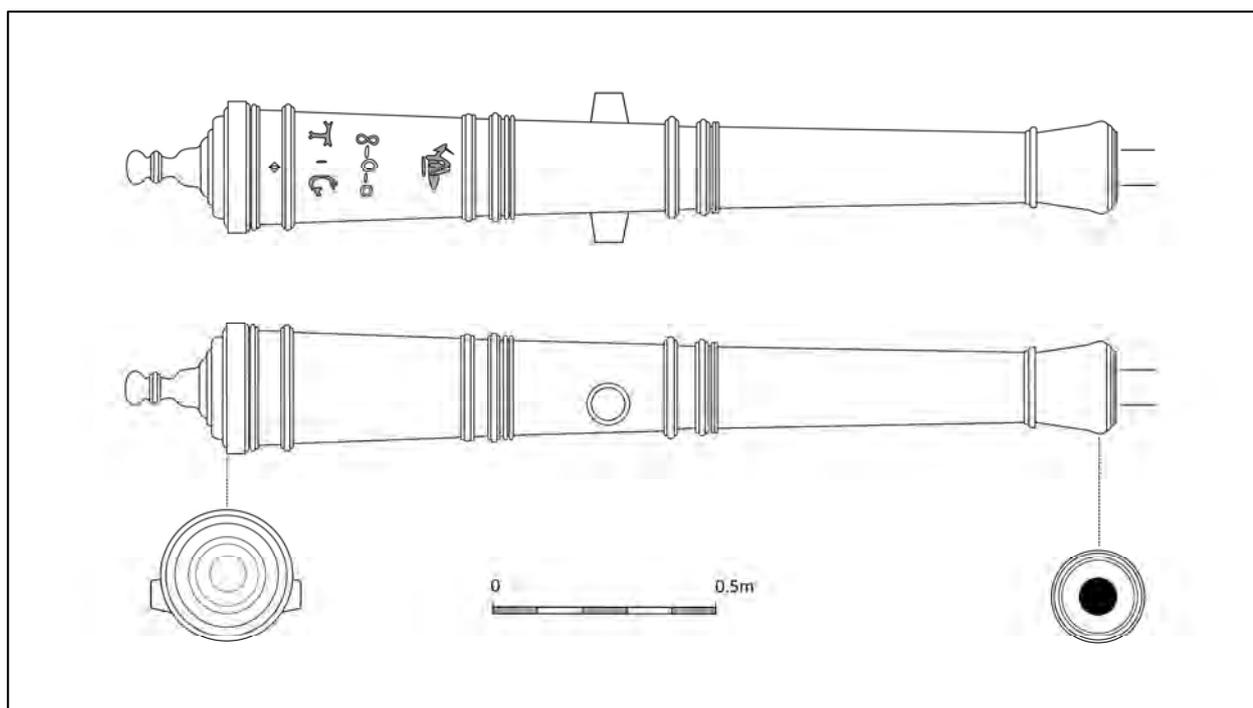
Figure 4-2: Drawing of PCI (D. Ní Chíobháin)

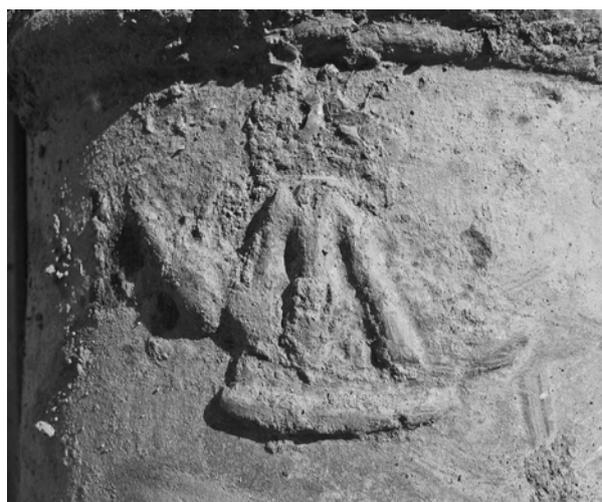
Figure 4-3: Detail of the grasshopper motif on PCI shortly after de-concretion (J. Auer, Wessex Archaeology)

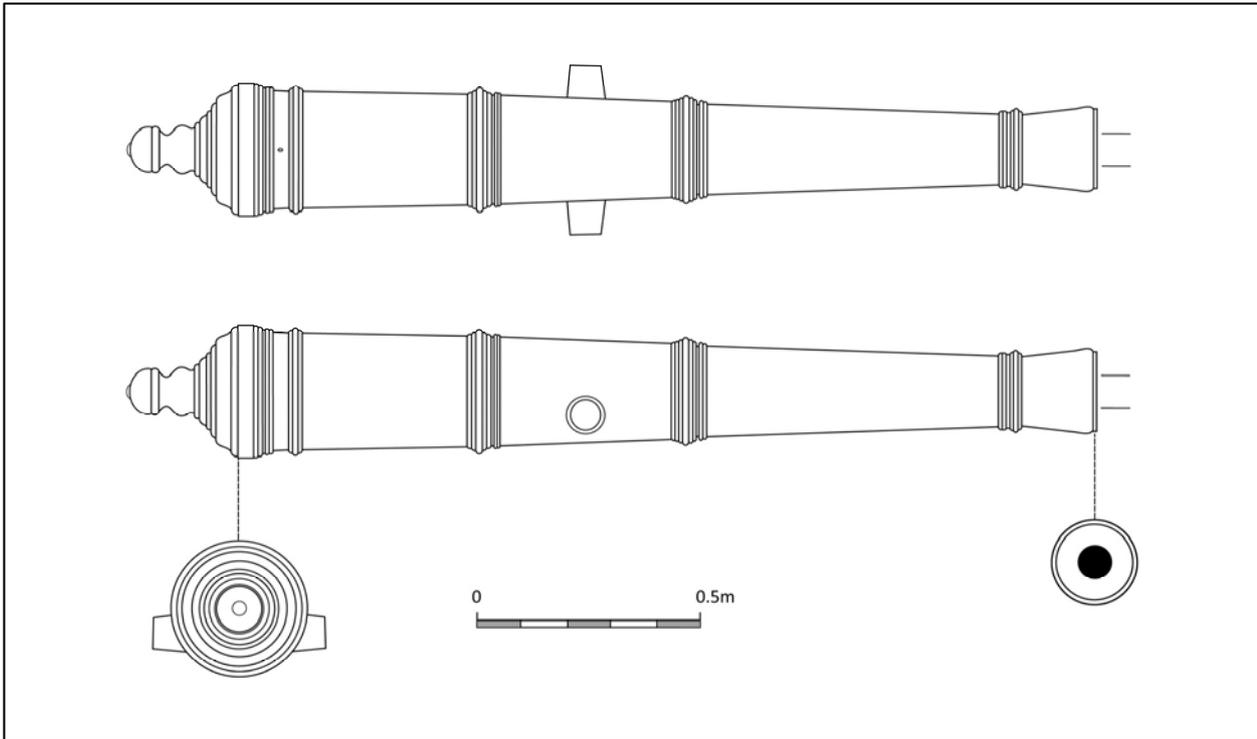
Figure 4-4: Drawing of PC2 (D. Ní Chíobháin)

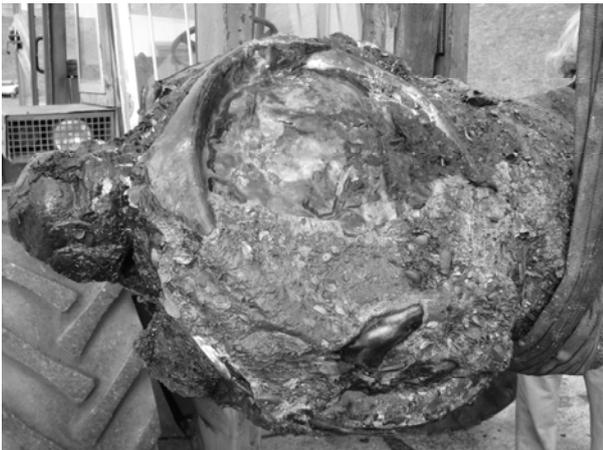
Figure 4-5: Copper alloy plate concreted to PC2 (Royal Armouries, Fort Nelson)

PC2 is a cast-iron gun-barrel (Figure 4-4). The gun was within a concretion when it was found; this was later removed by staff at Fort Nelson where it has been undergoing conservation since. The concretion enclosed a copper-alloy plate (Figure 4-5) and a ceramic jar (Figure 4-6). The condition of the metal is fair with some concretion remaining around the cascable and some erosion on the surface layer of iron.

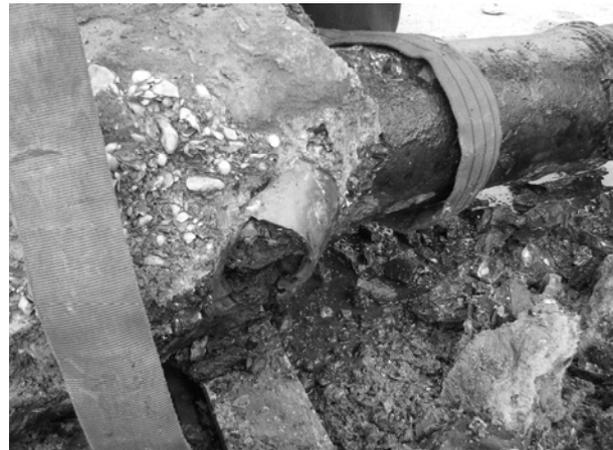
Figure 4-6: Ceramic jar uncovered during the de-concretion of PC2 (Royal Armouries, Fort Nelson)

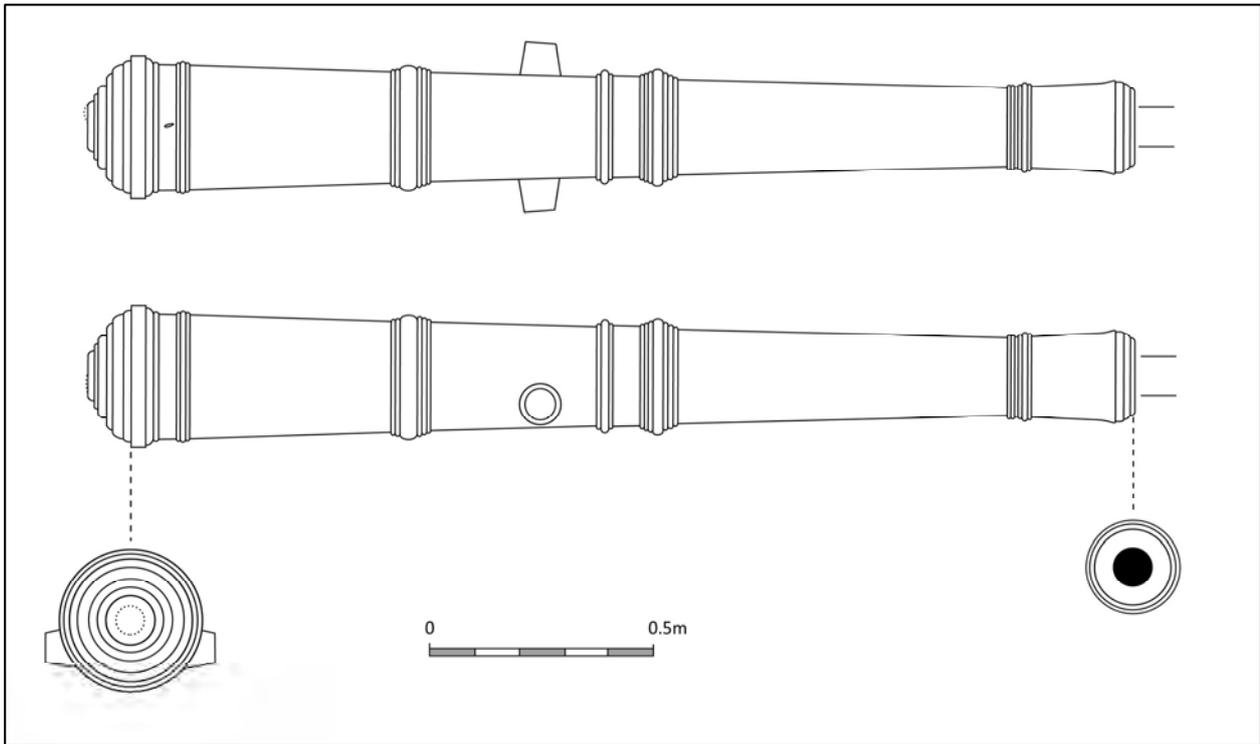
Figure 4-7: Drawing of PC3 (D. Ní Chíobháin)

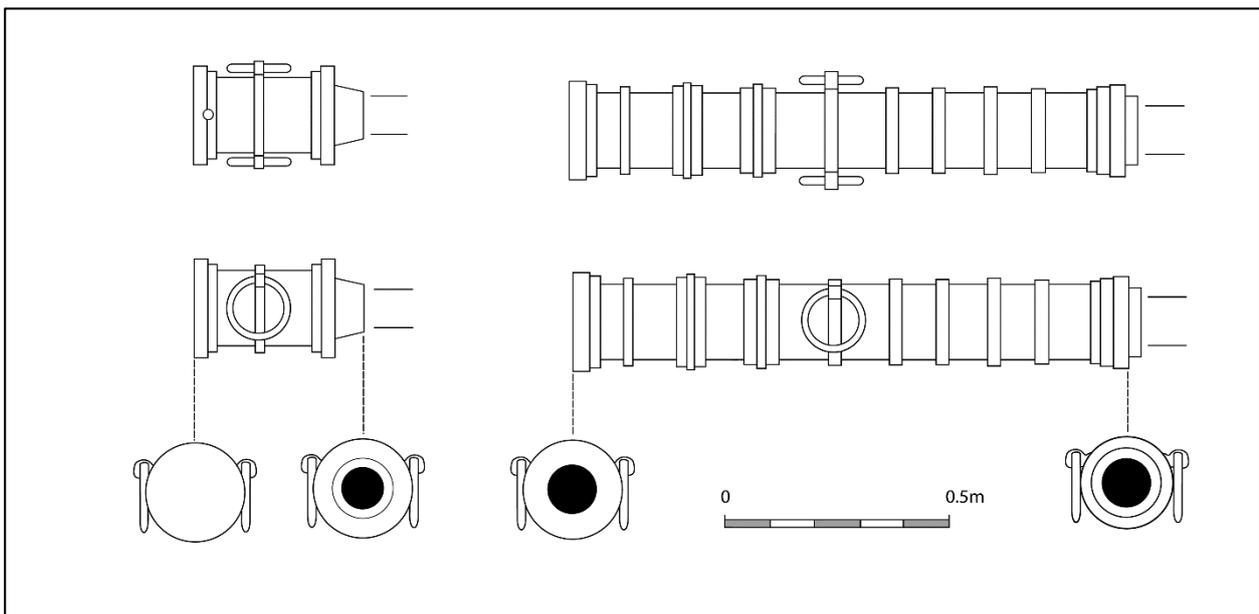
Figure 4-8: Drawing of PC4 (D. Ní Chíobháin)

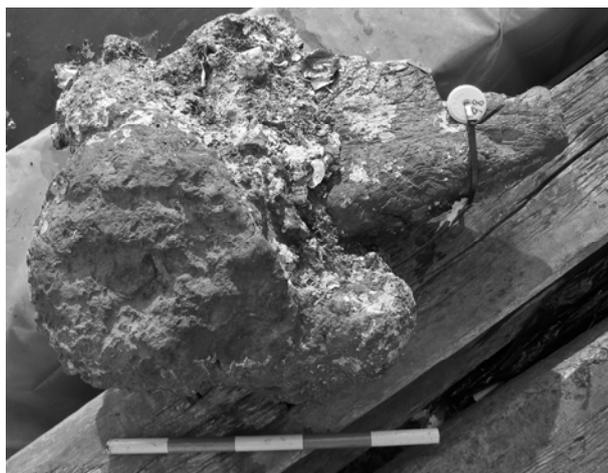
Figure 4-9: Gun carriage cheek from the Princes Channel Wreck (J. Auer, *Wessex Archaeology*)

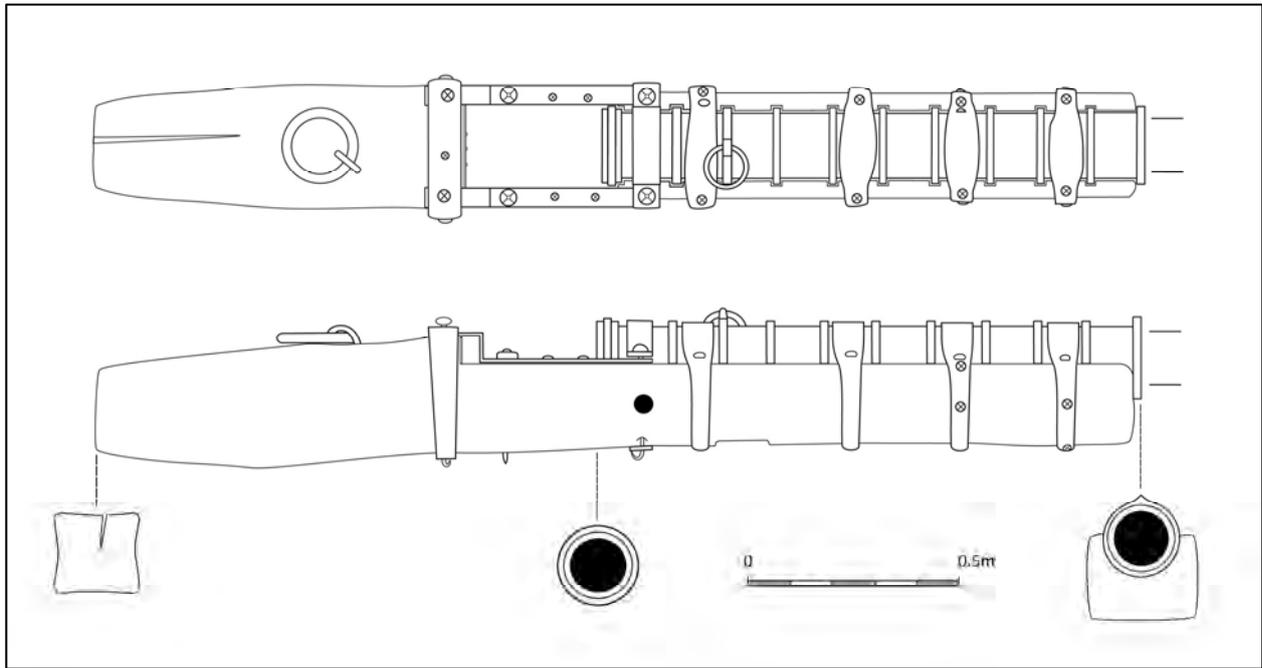
Figure 4-10 Wrought iron-port piece HH4 from the Wittenbergen Wreck (1671) still mounted on wooden bed (D. Ní Chiobháin)

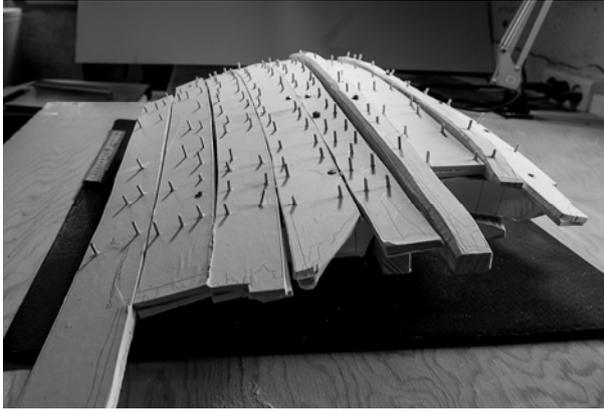
Figure 5-2: The cardboard planks on section 3b fastened with toothpick trenails (C. Thomsen)

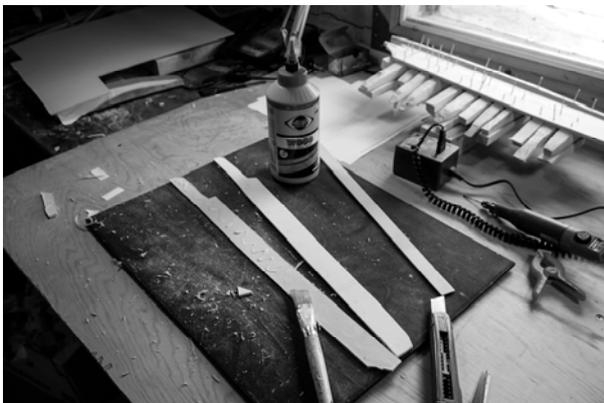
Figure 5-3: Cardboard planking under production (C. Thomsen)

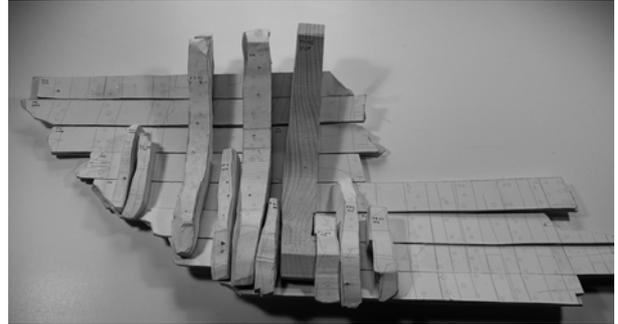
Figure 5-4: The finished scale model of section 1 (C. Thomsen)

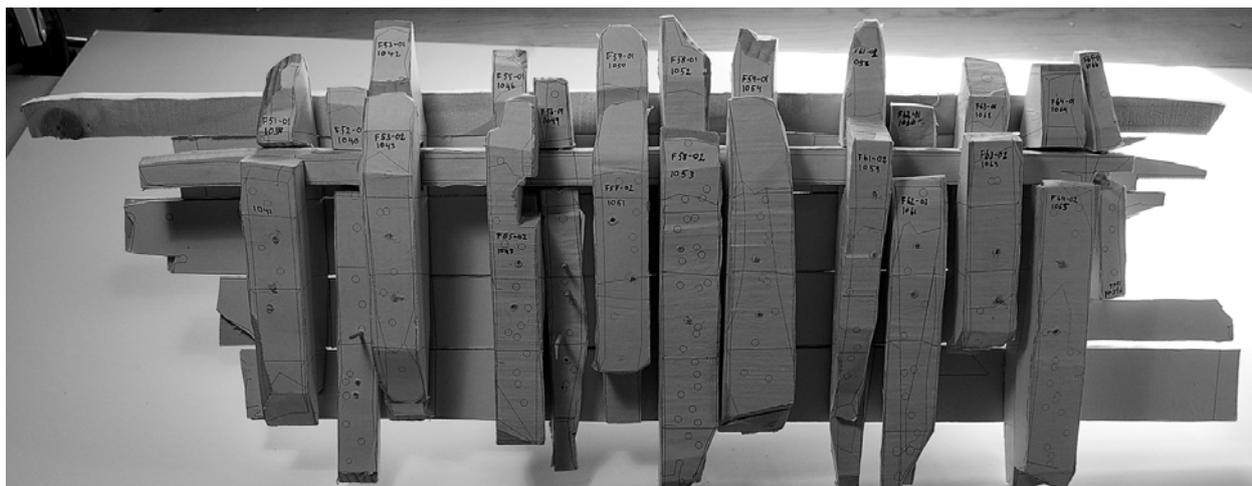
Figure 5-5: The finished scale model of section 2 (C. Thomsen)

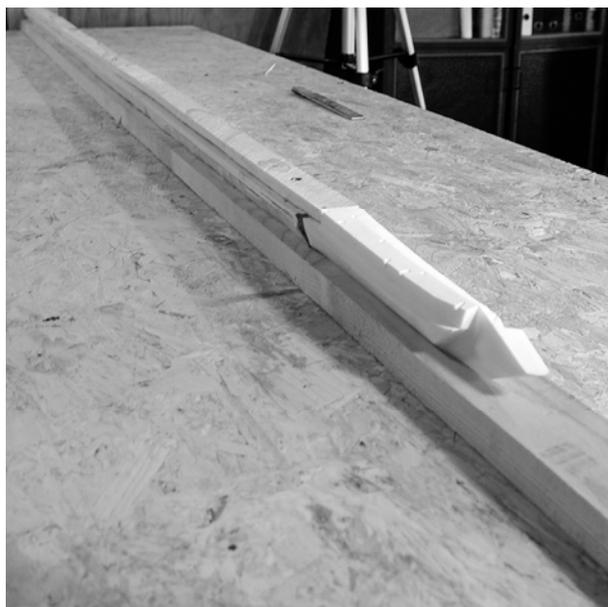
Figure 5-8: The keel has been laid, consisting of the laser sintered preserved part and a wooden extension (C. Thomsen)

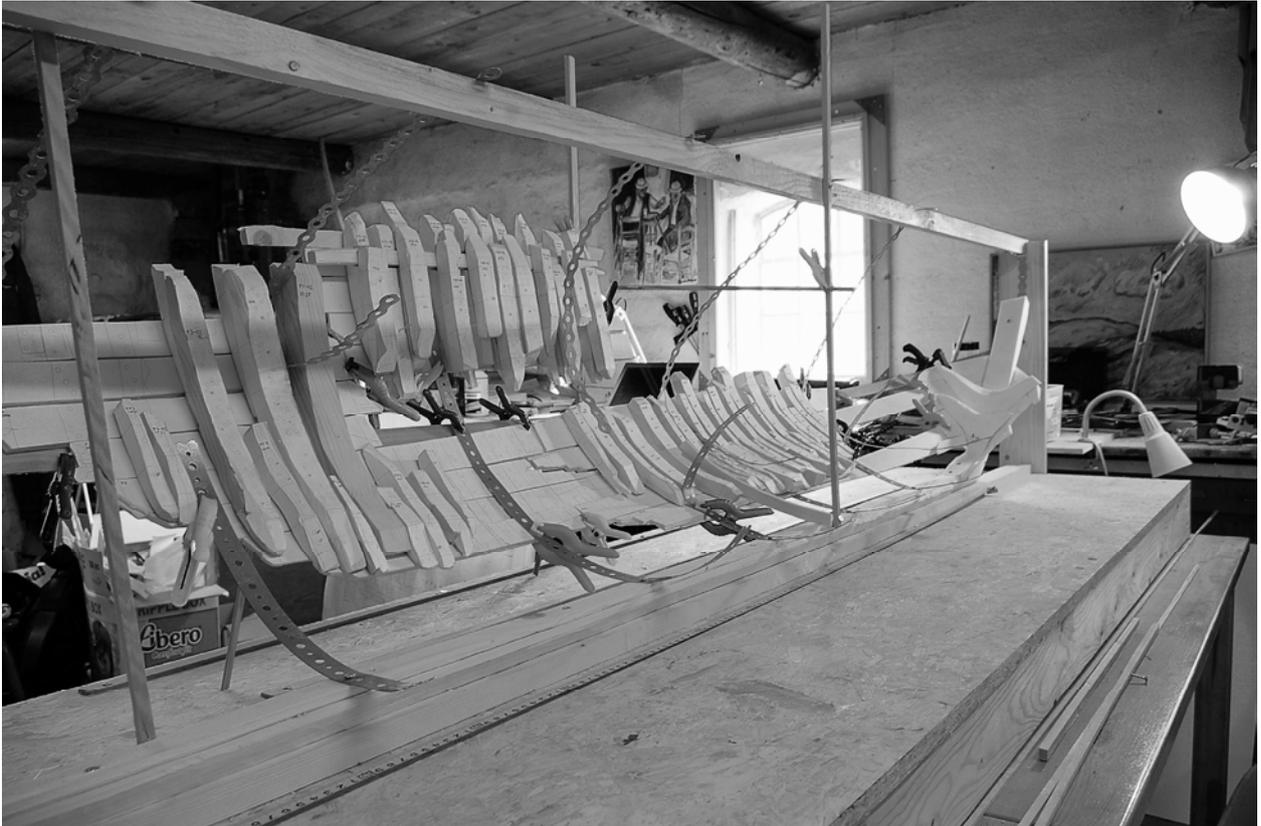
Figure 5-9: Preliminary alignment of the pieces clamped to metal battens, which were attached to the frame. This solution of the model frame was not stable enough and the way in which the sections were fastened was changed several times (C. Thomsen)

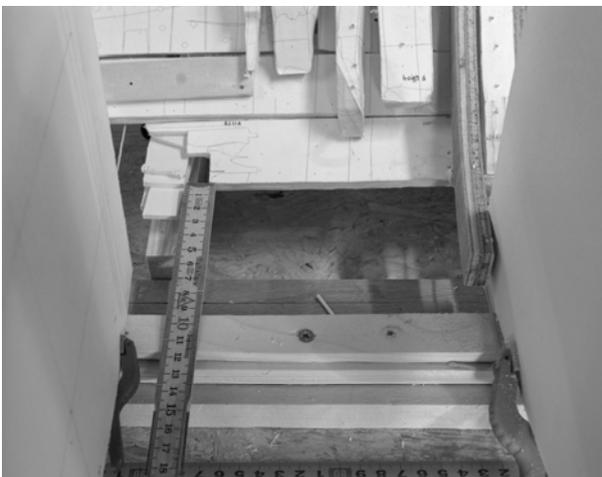
Figure 5-10: The distance between keel and the lower edge of the third strake on section 3a (C. Thomsen)

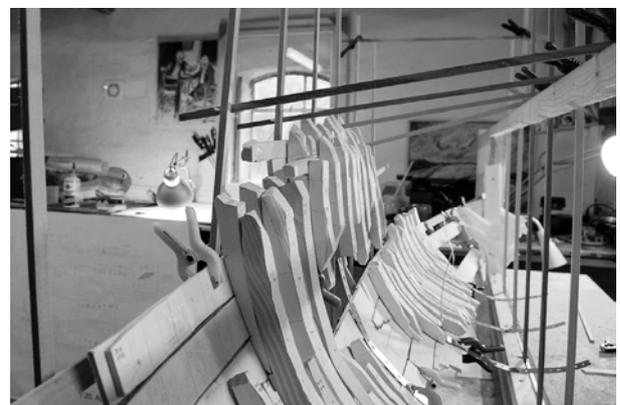
Figure 5-11: Broken first futtocks and furring timbers on section 1 aligned with the sandwiched wale on section 2 (C. Thomsen)

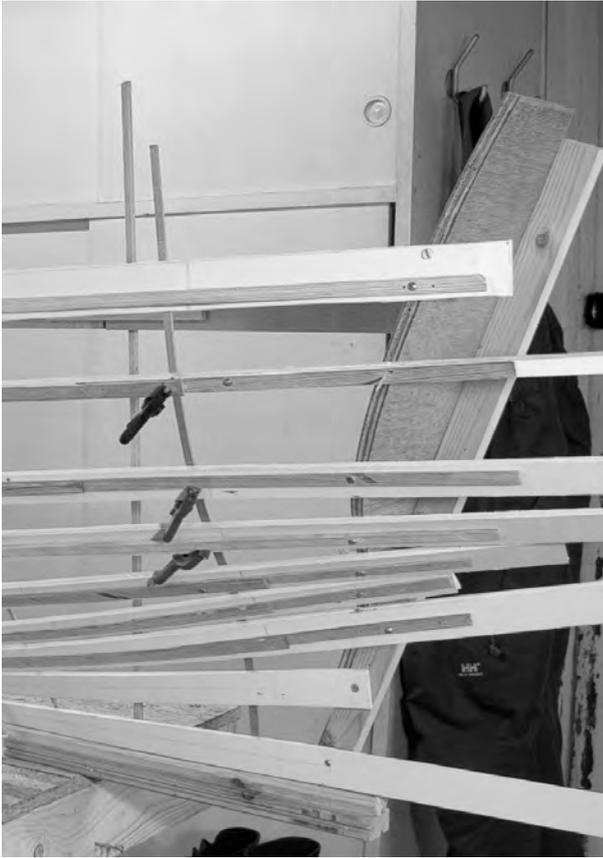
Figure 5-12: A view of the sternpost and transom with the flexible battens extending out (C. Thomsen)

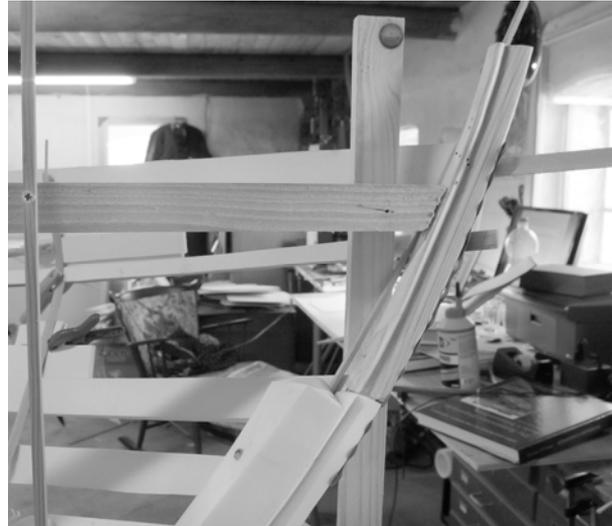
Figure 5-13: The bow section with the prolonged stempost (C. Thomsen)

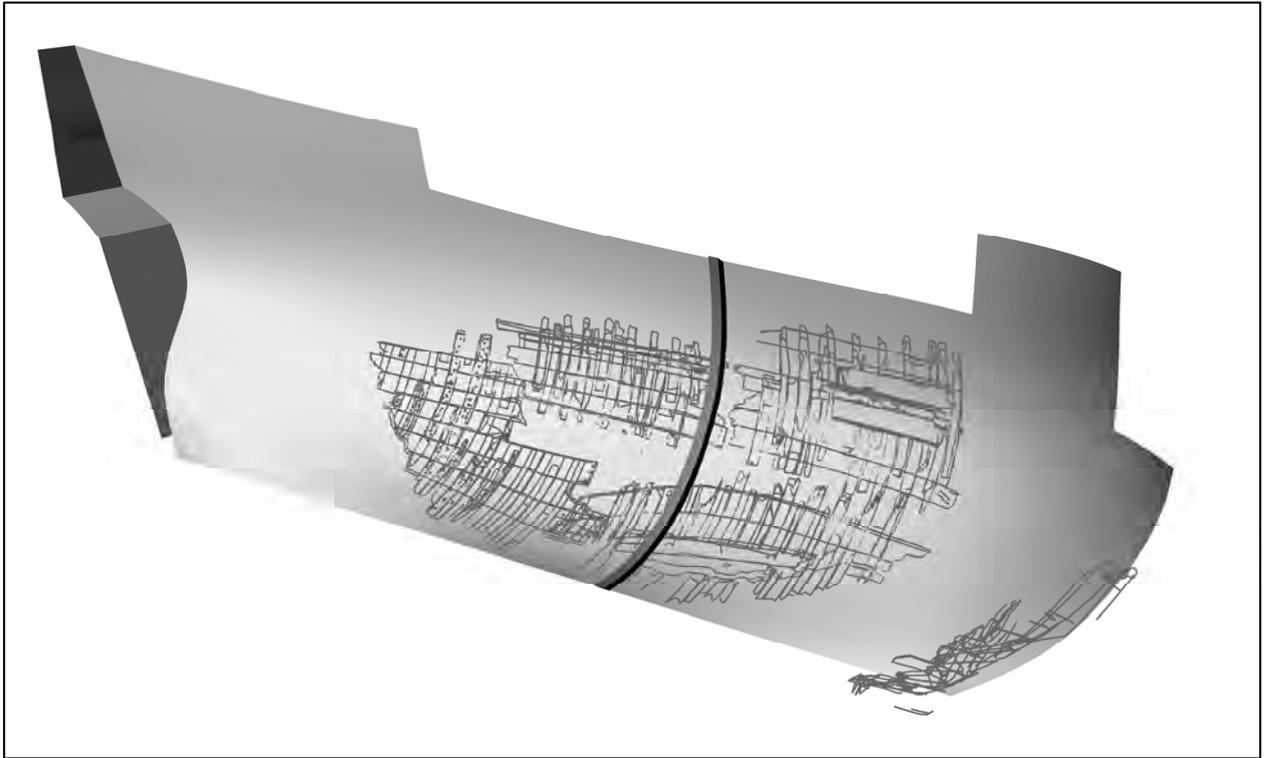
Figure 6-1: The location of the master frame in the reconstructed shape of the hull (M. Ditta)

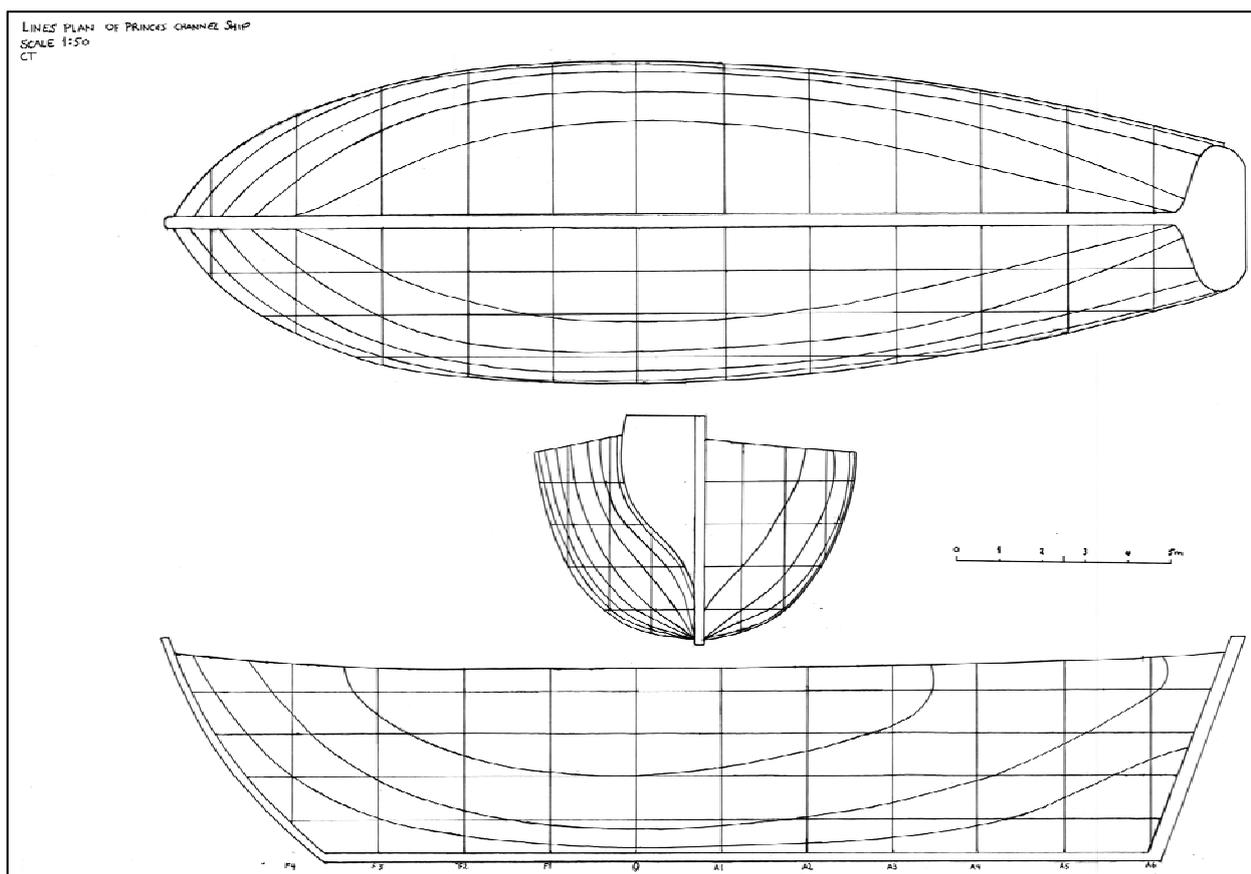
Figure 6-2: The initial lines plan, a result of digital recording and fairing by hand using splines (C. Thomsen)
