The Gresham Ship Project

A 16th-Century Merchantman Wrecked in the
Princes Channel, Thames Estuary

Volume I: Excavation and Hull Studies

Jens Auer and Thijs J. Maarleveld

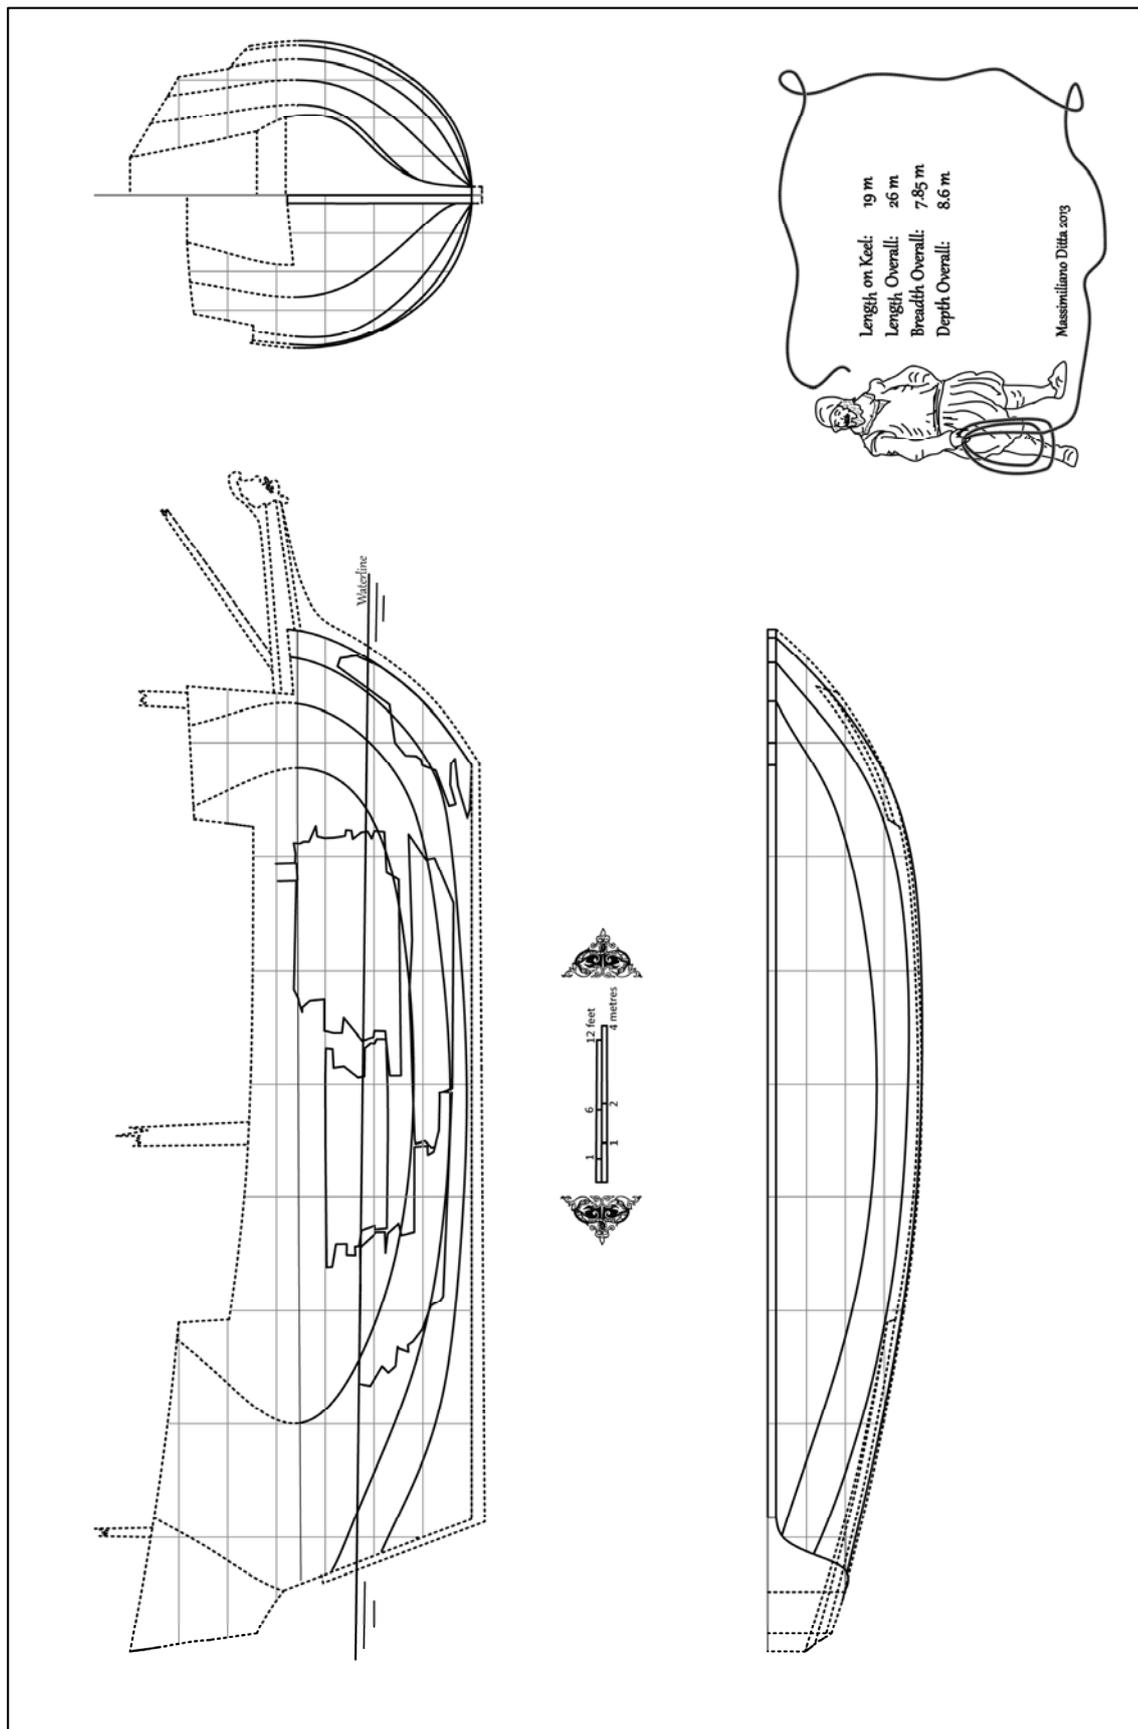
Figure 6-3 Final adjusted lines plan of the furred hull. The dotted outline of the upperworks is derived from the drawing of the Emanuell in 'Fragments of Ancient English Shipwrighty' (M. Dittia)

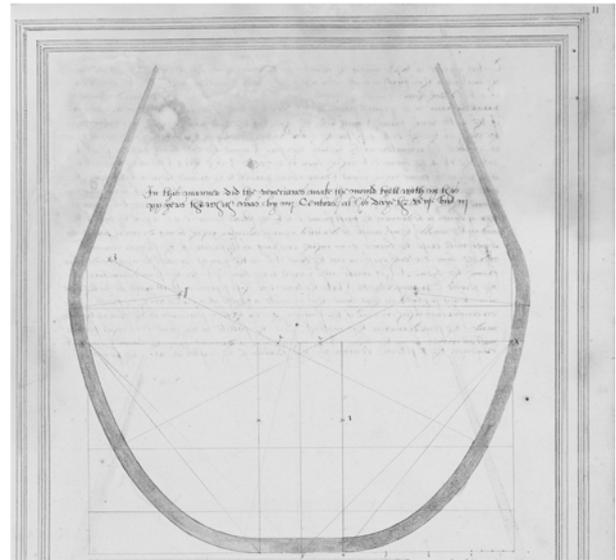
Figure 6-5: The Venetian four-arc method as shown in Matthew Baker's 'Fragments of Ancient English Shipwrightry' (Pepys Library MS 2820, p. 11), by permission of the Pepys Library, Magdalene College, Cambridge

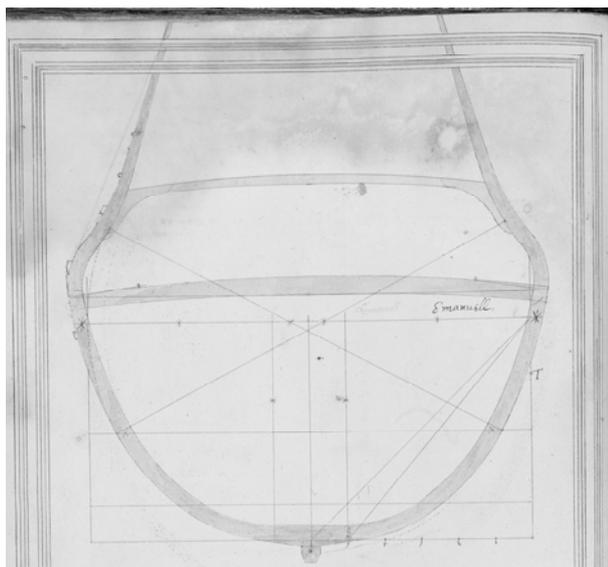
Figure 6-6: The midship section of the merchant vessel Emanuell constructed using the four-arc method. A simpler two-arc method is superimposed as a dotted line at the left hand side of the image (from 'Fragments of Ancient English Shipwrigthry', Pepys Library MS 2820, p. 10, by permission of the Pepys Library, Magdalene College, Cambridge)

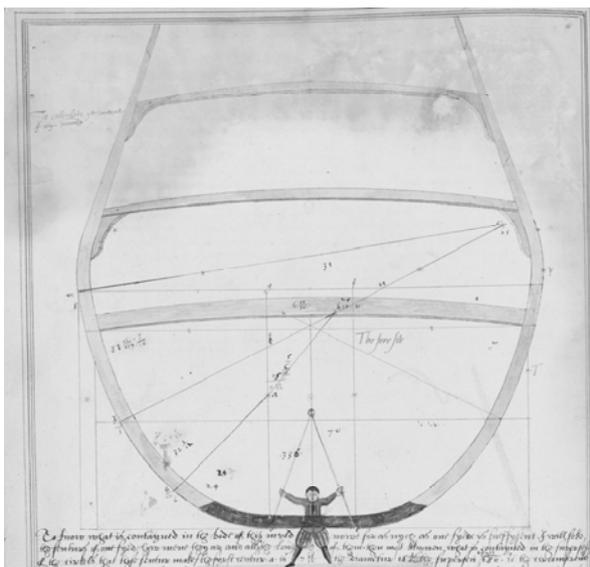
Figure 6-7: The midship section of the Foresite, designed by Baker in 1570 (from 'Fragments of Ancient English Shipwrigthry', Pepys Library MS 2820, p. 14, by permission of the Pepys Library, Magdalene College, Cambridge)
