Young America 1853 – POB 1:96

Part 4 – Hold Down Bolts

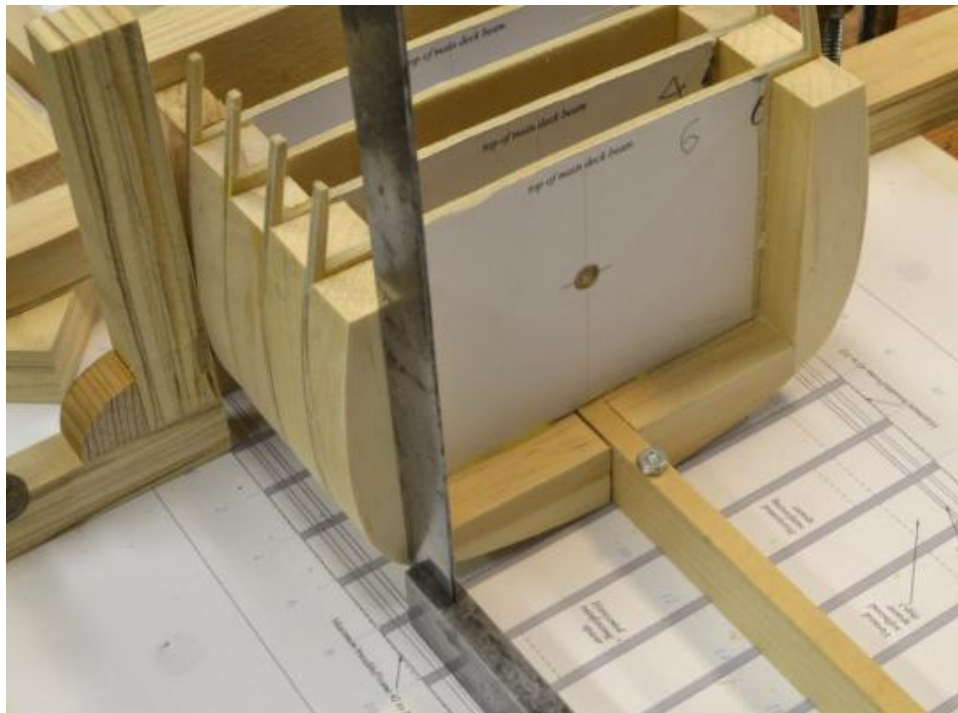
Some additional structural work needs to be done as the bulkhead erection proceeds. Nuts for hold down bolts need to be permanently embedded in the structure at three locations. These were set out on the drawings on odd-numbered frame lines so they would fall midway between plywood bulkheads which are set only at the stations – the even numbered frame lines. The spine and shipway were drilled at these locations earlier and threaded rods installed as shown below.

The bolt in this picture is on frame line 9. The picture was taken before bulkhead 8 was installed (and before the numbers on the patterns were moved toward the center). The next picture shows this nut encased.

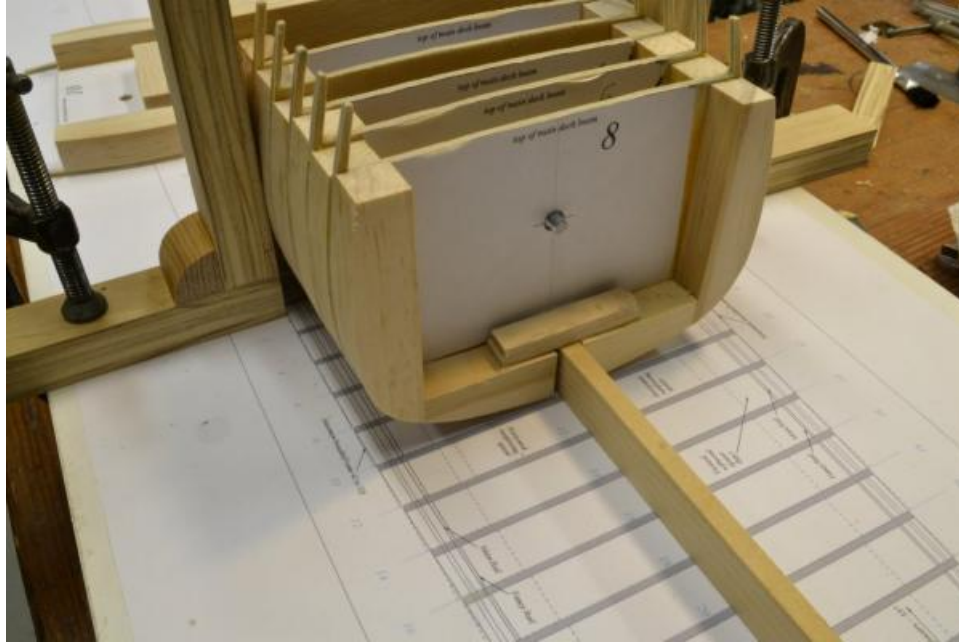
The nut is encased in the lower of the two hardwood strips glued to the top of the horizontal spacers. The lower strip is shown in the next picture, before the hole was filed to fit the nut.

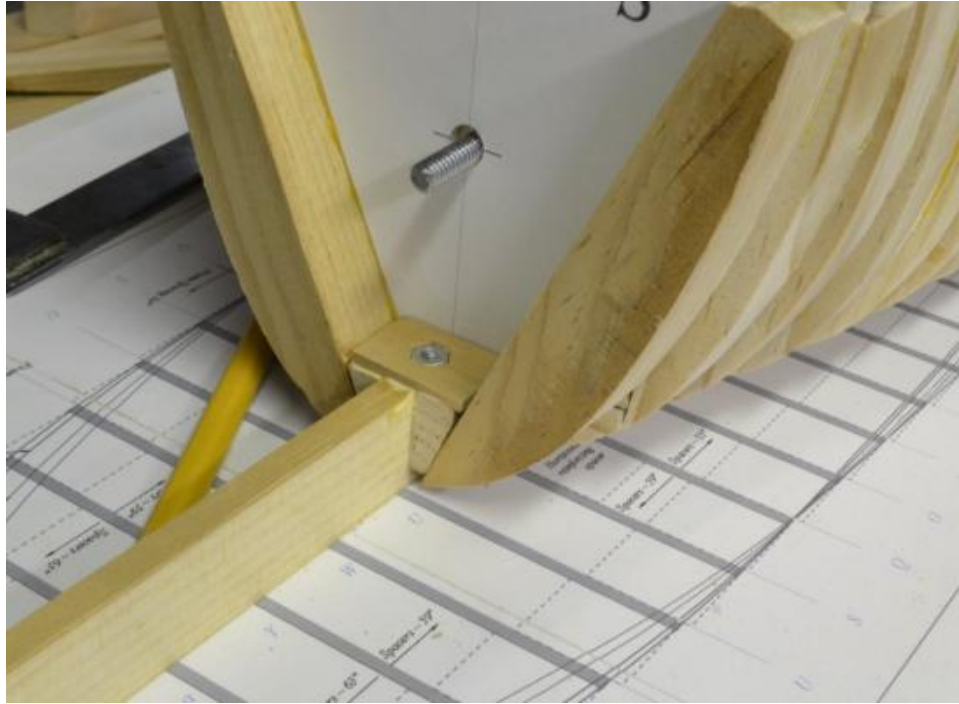
In this case two triangular blocks were glued to the spine and the strip encasing the nut is glued to it. In the next picture the assembly is capped with another fitted block.

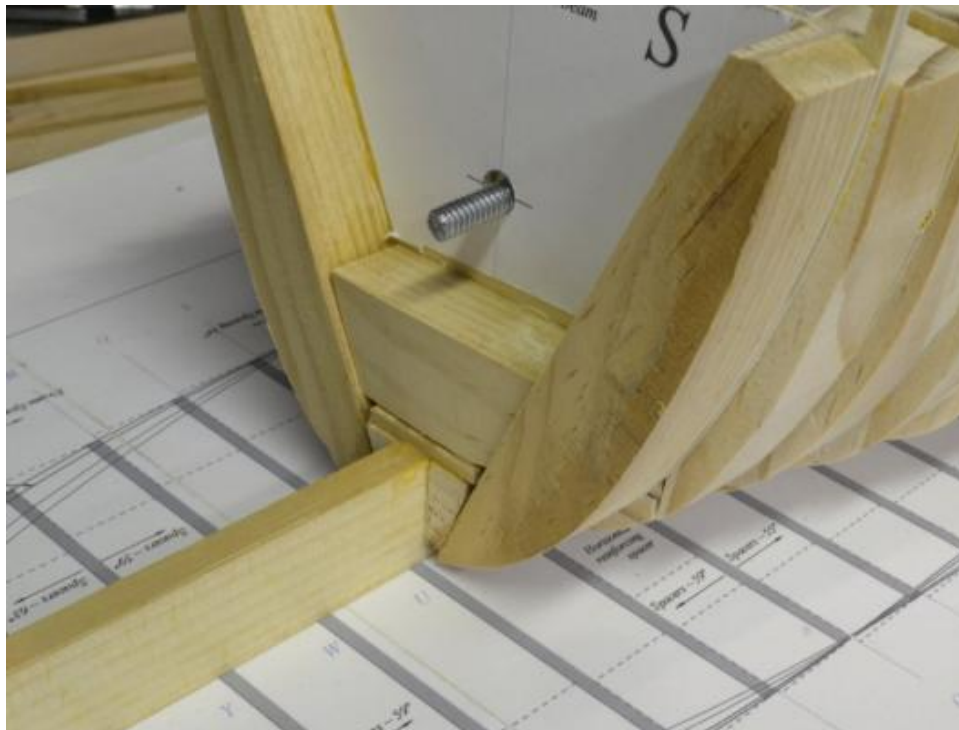
Although each of the three installations of these is slightly different, in every case there is a cap to hold in the nut and to act as a stop when the stud bolt is threaded in. All the parts are glued to the plywood as well as the side spacers, the assemblies are very strong. Next the mast steps.
