## Young America 1853 – POB 1:96

### Part 14 – Stem/Keel/Sternpost 3

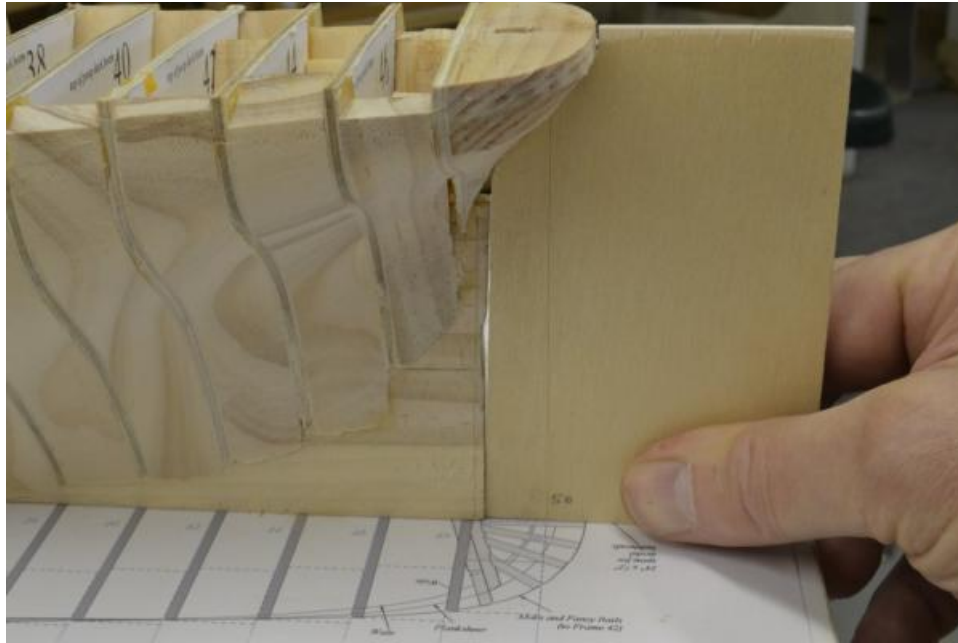
Before attaching the keel/stem assembly to the hull, the sternpost had to be installed. In the first picture a template is being used to check the hull for fitting the post.

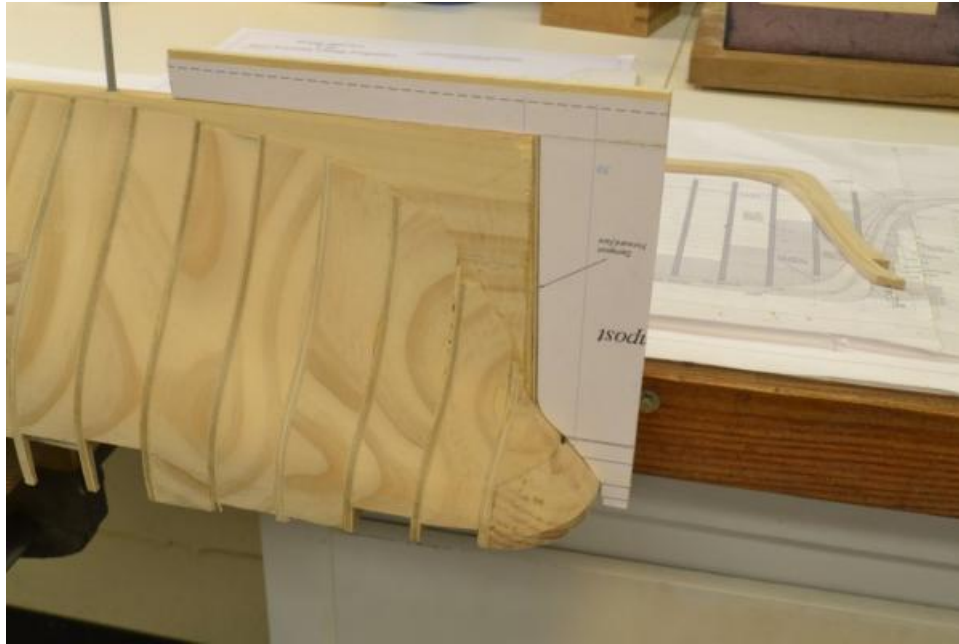
The template is aligned at station 50. The picture shows the need for a filler piece. In the next picture the hull has been cut back for the filler, it has been installed, and the hull is being checked again with a different template.

The filler piece provided a straight, flat surface on which to bed the sternpost – assuring a good joint and clean surface for shaping the deadwood into the sternpost rabbet. In the next picture, with the hull plumbed, the sternpost centerline is being marked on the filler.

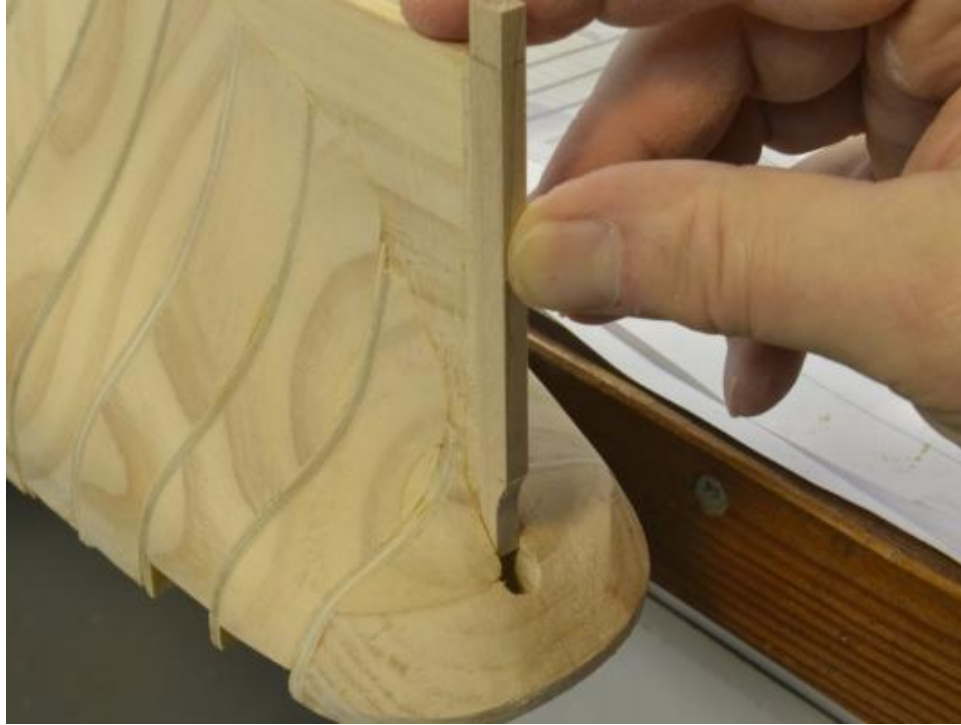
In the next picture the hull has again been inverted and the sternpost is being fit up.

Holes for locating pins were drilled with the post in position. The bottom of the post was then cut off flush with the bottom of the hull. In the next picture the sternpost rabbet is being scraped out using the vise as a guide.

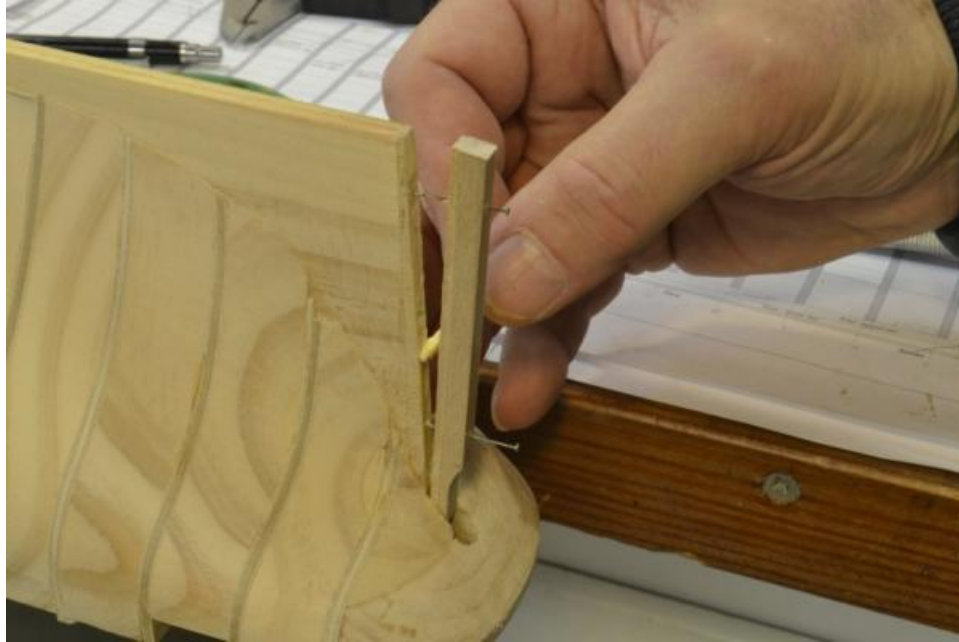
The rabbet was formed on both sides in this way – all the way to the bottom of the post up to the intersection with the hull at the top. In the next picture the post is being glued to the hull.

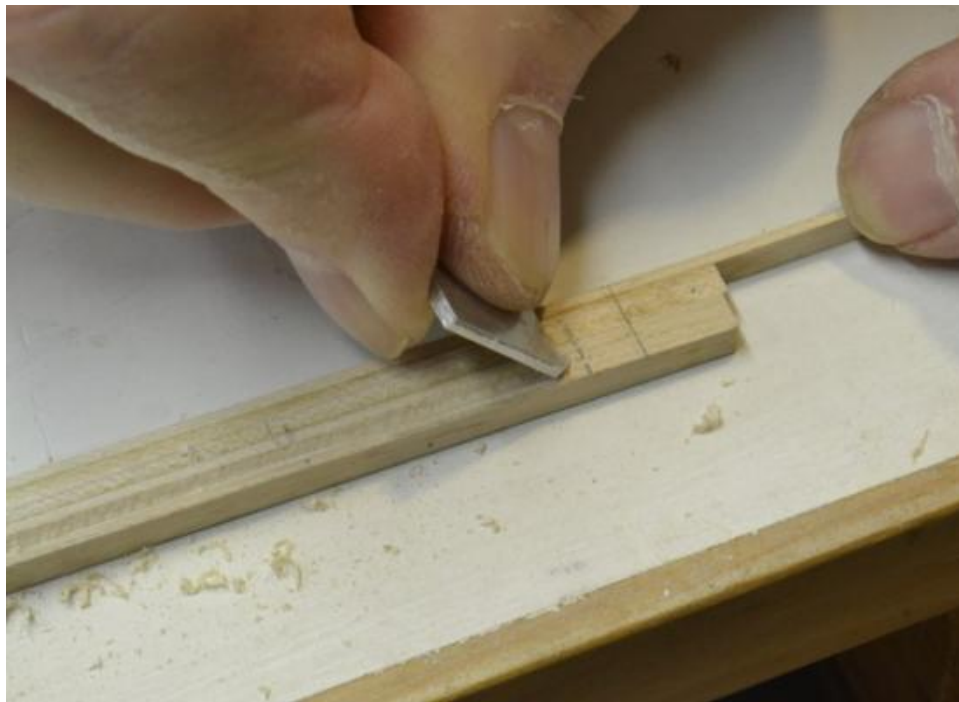
The keel assembly rabbet was extended only back to the inner line of the post, as shown below, deferring final rabbeting until after assembly.

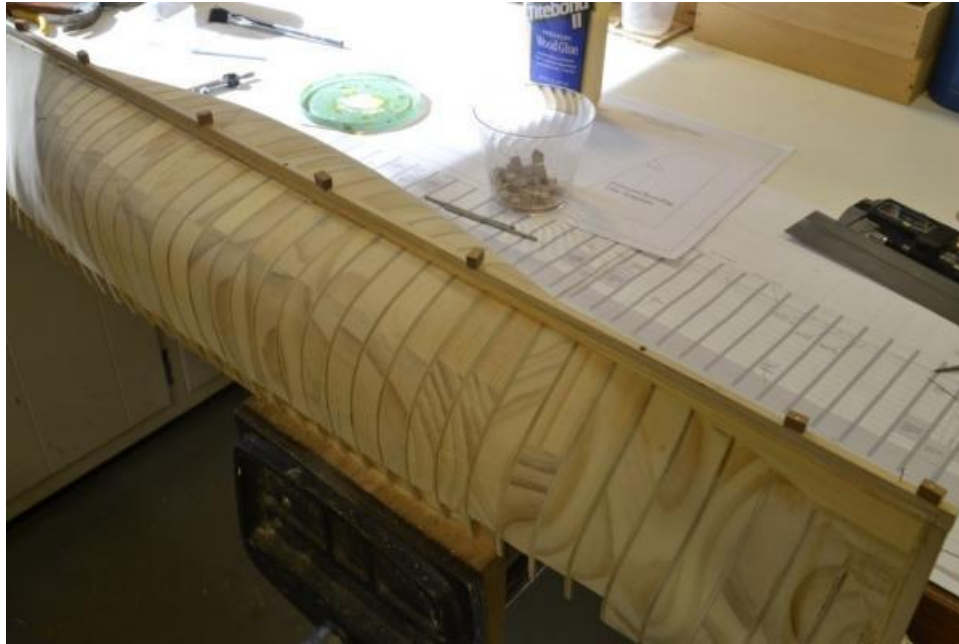
In the last picture the stem/keel assembly is being glued to the hull and held in place with pins driven through wood blocks.

The hold down bolts were in position for the gluing/clamping, but were removed to avoid them being glued in.
