THE INFLUENCE OF THE WAR OF 1812 ON GREAT LAKES SHIPBUILDING

A Thesis

Master of Arts in History

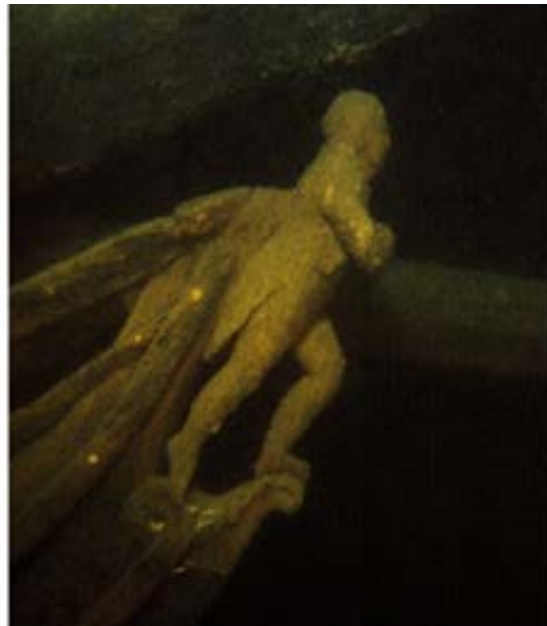
Figure 3-8: Figure of Lord Horatio Nelson on the prow of the *Scourge* (originally *Lord Nelson*) (Cain 1983: 55).

Both vessels demonstrated elaborate figureheads that embellished their bows. *Scourge* (originally *Lord Nelson*) displayed the striding figure Admiral Horatio Nelson on the prow of the vessel (Figure 3-8). Nelson died at the Battle of Trafalgar in 1805 and was the most celebrated contemporary naval hero. Although it was a well-known fact that Nelson lost his right arm in 1797, the figurehead was depicted with both arms. The striding pose of the figurehead is common in the 19th century (Cain 1983: 55). The figurehead of *Hamilton* (originally *Diana*) represented the classical goddess of the hunt and motherhood, Diana. On her left side, the goddess is portrayed with only her quiver and its strap, while she is portrayed in Empire dress on the right. Her hairstyle is suggestive of an ancient warrior's helmet. Partially-clad goddess figureheads were common throughout the 19th century, though typically in classical rather than contemporary dress (Cain 1983: 40).
