THE ANALYSIS AND CONSERVATION
OF TWO 18-POUNDER CARRONADES
FROM THE U.S. NAVY SCHOONER *SHARK*

A Thesis

Major Subject: Anthropology

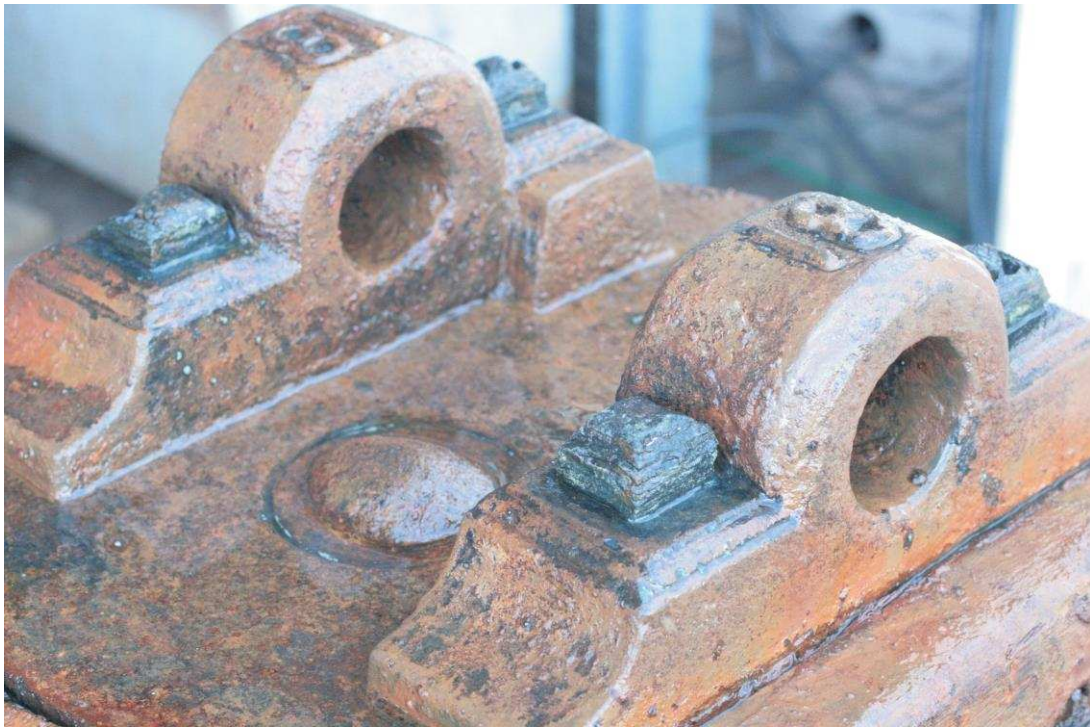
Figure 35. Joint chock with chock fastening bolts and molded 18 pound designation.
(Bajdek 2012)

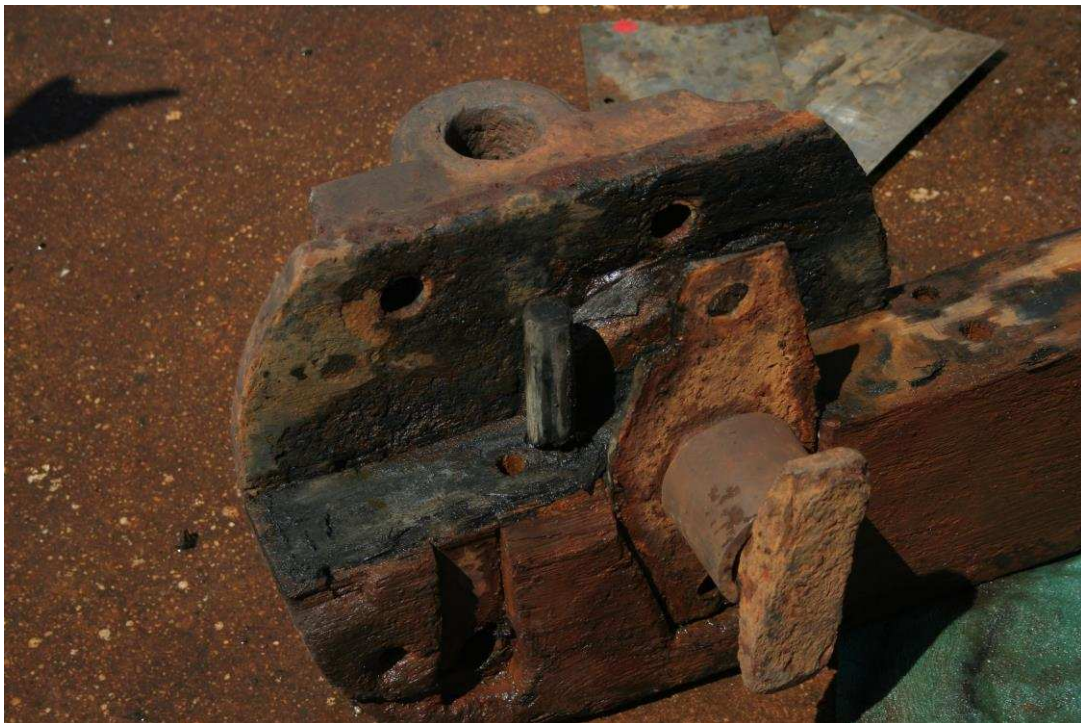
Figure 36. One half of carriage bed with gudgeon, slide bolt and underside iron plating.
(Bajdek 2012)

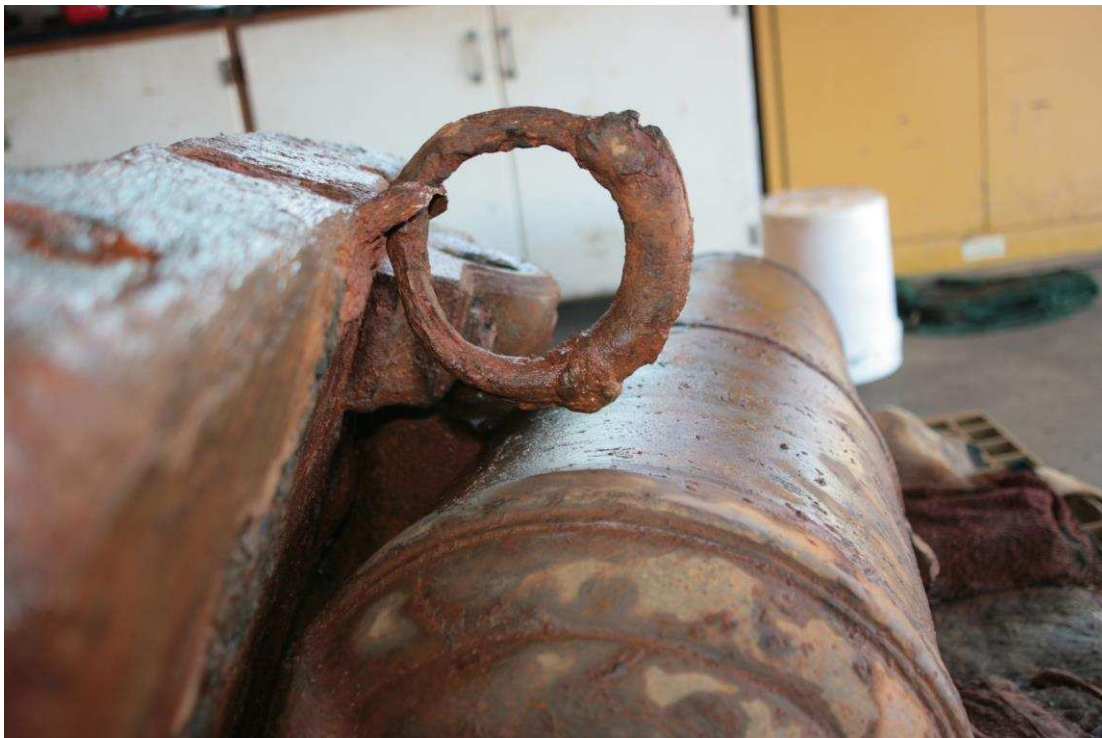
Figure 38. Iron breeching ring with leather sheathing. (Bajdek 2012)

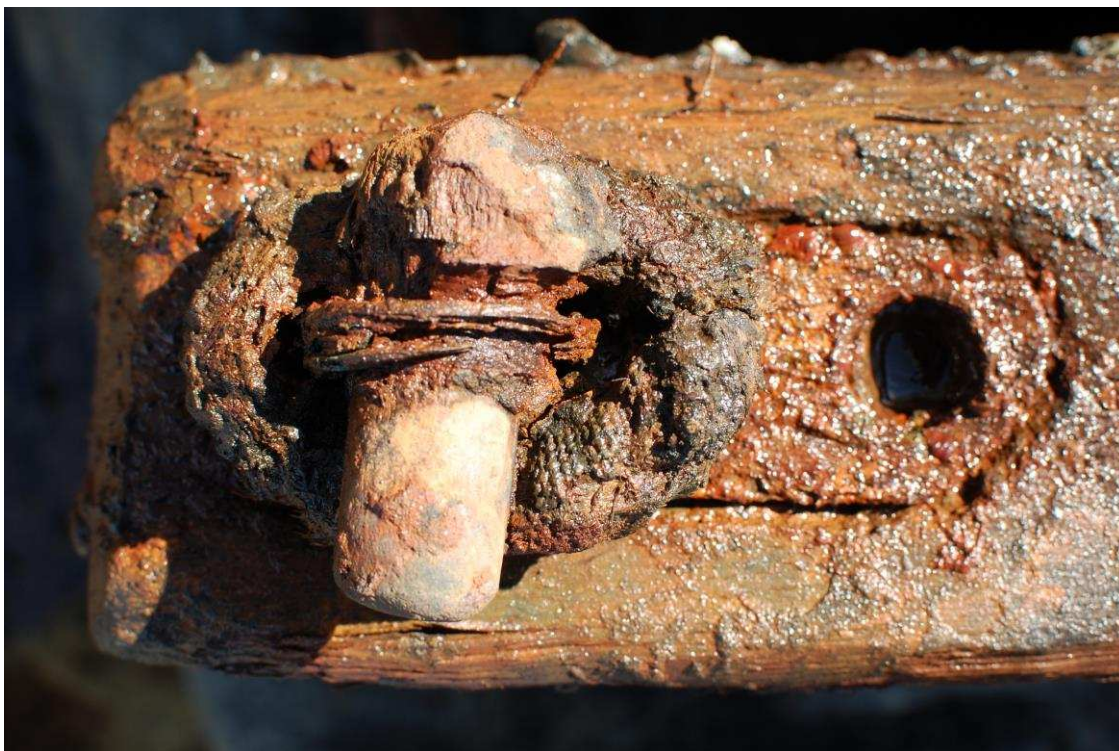
Figure 39. Carriage tackle eyebolt with rope grommet and wood plug (Bajdek 2012)

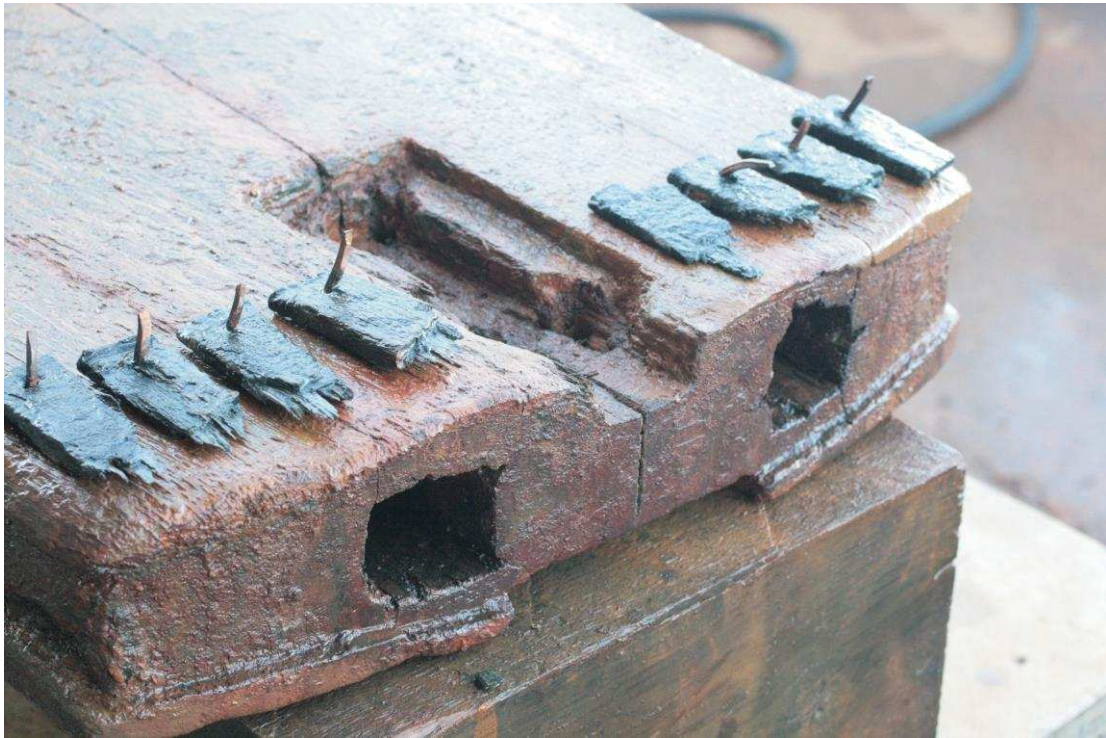
Figure 40. Spike sockets at rear of carriage with wear plate fragments and brass nails. (Bajdek 2012)

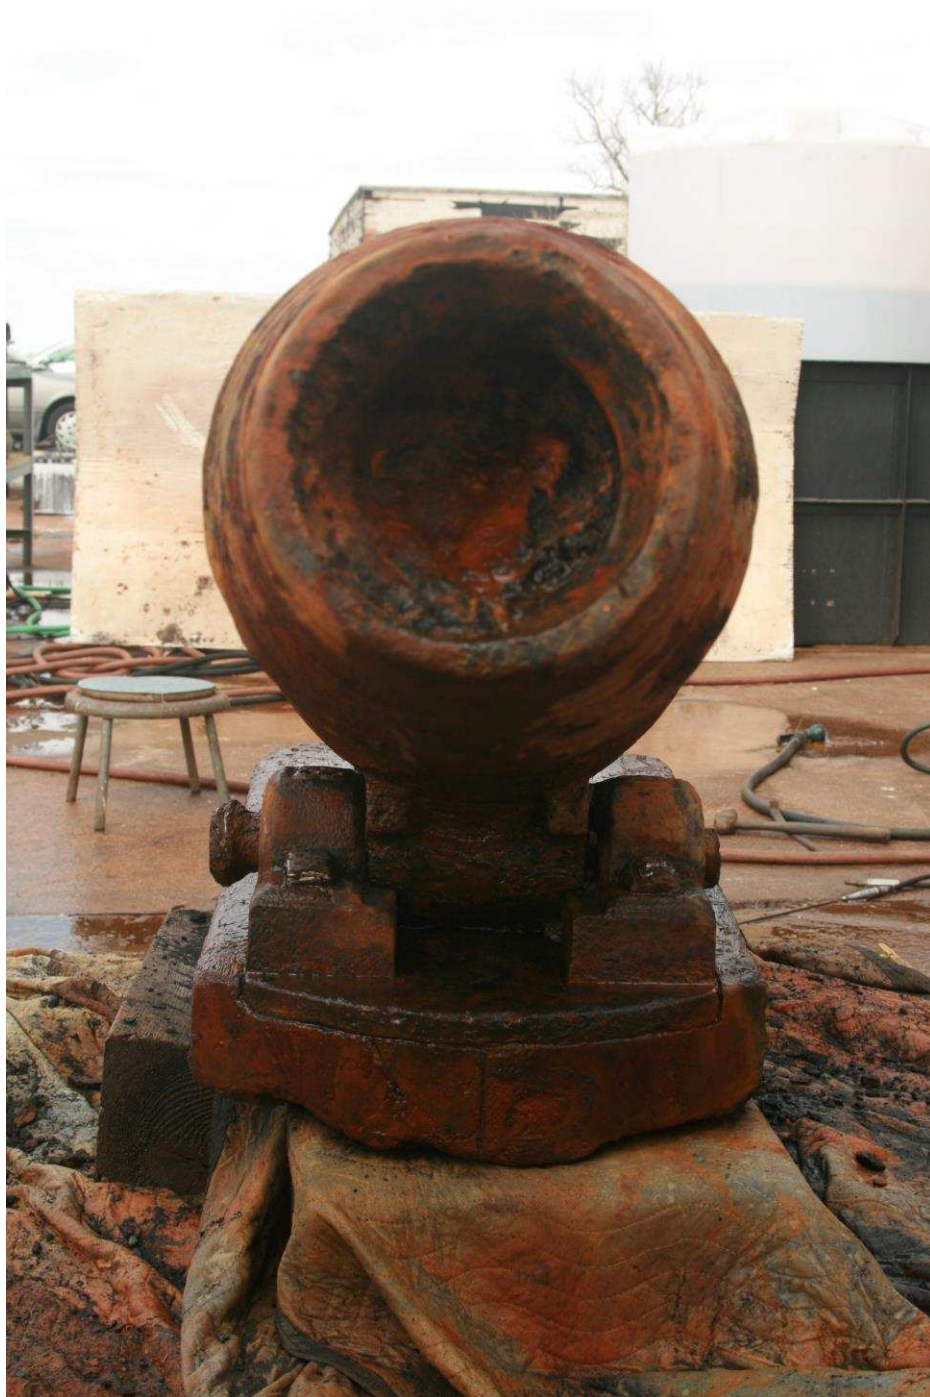
Figure 45. The concreted bore of ACC Oregon Carronade B. (Bajdek 2012)

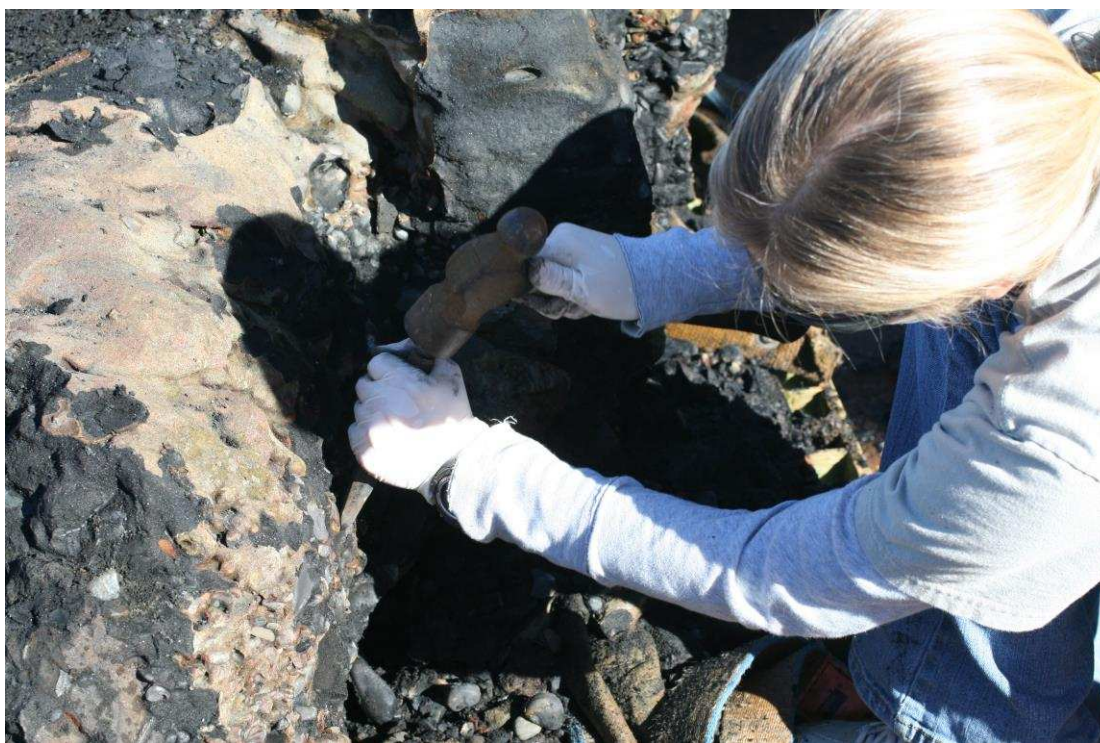
Figure 51. Hammers and chisels used to remove large pieces of concretion. (Bajdek 2012)

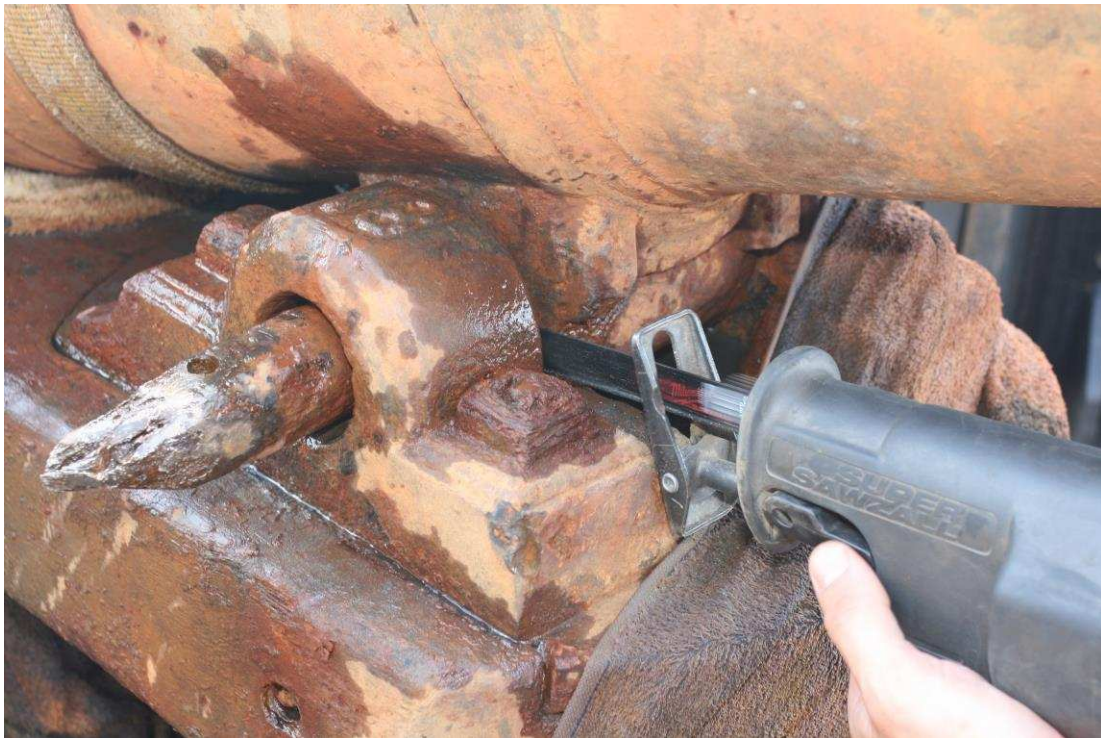
Figure 54. A reciprocating saw was used to cut through the lug bolt on ACC Oregon Carronade A. (Bajdek 2012)

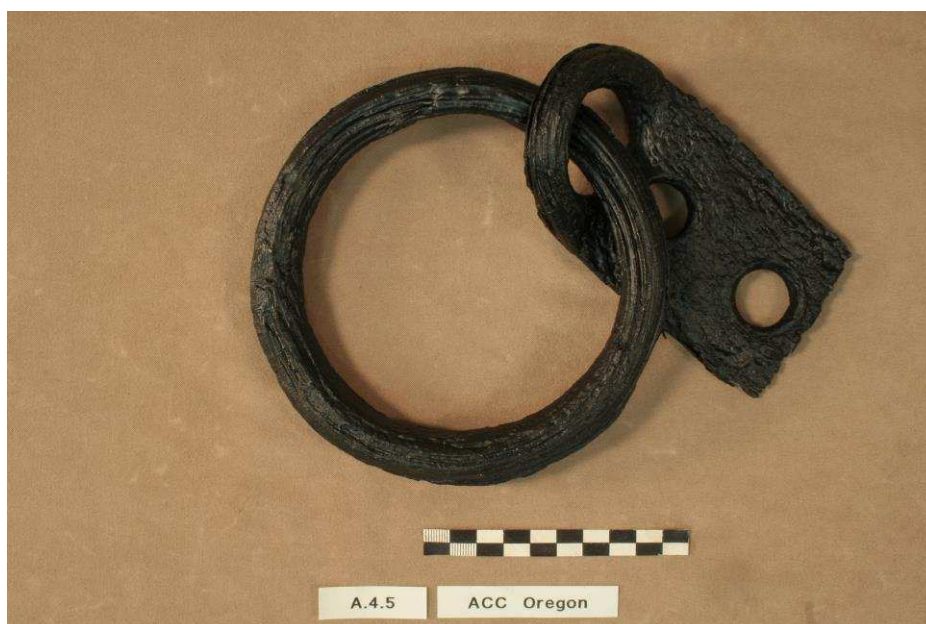
Record Number: ACC Oregon A.4.5

Identification: Breeching ring with attached breeching eyeplate
