THE INTRODUCTION AND USE OF COPPER SHEATHING - A HISTORY

Mark Staniforth

The copper sheathing and fastenings of the American China trader *Rapid* (1812)

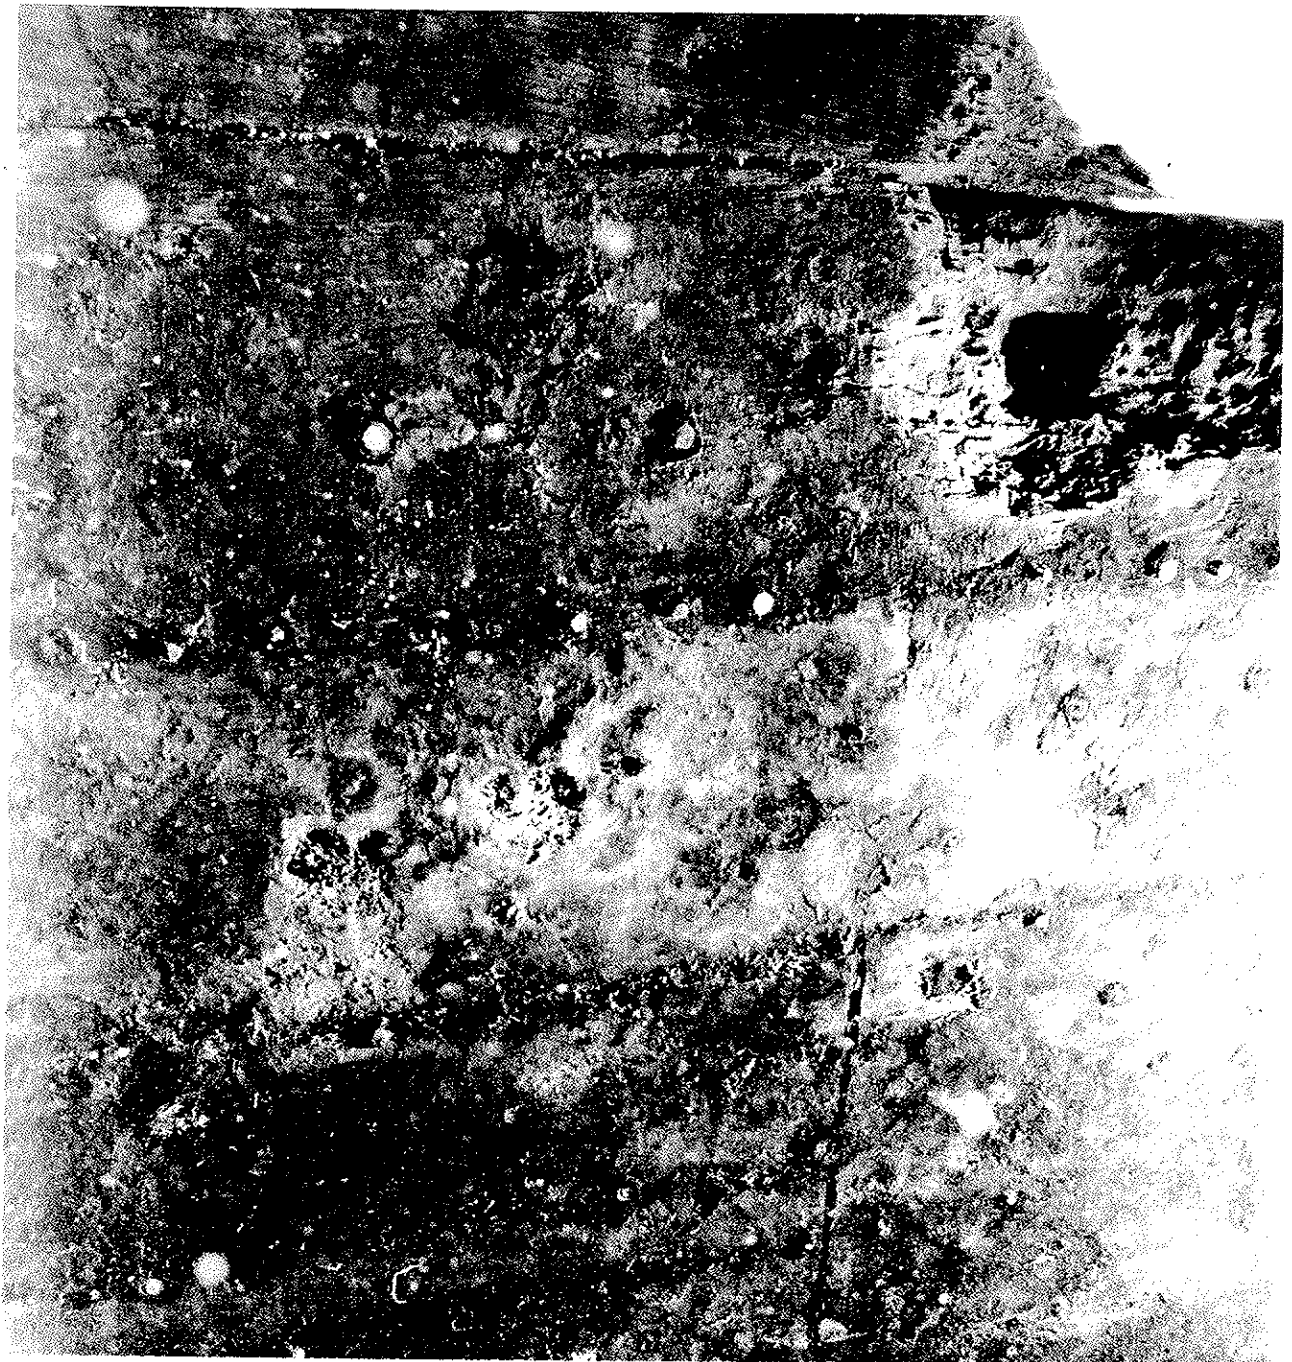
Fig. 9 Photograph showing outer planking with rows of copper sheathing tacks clearly visible.

Figure 9 shows part of the area of hull used to obtain the above results.

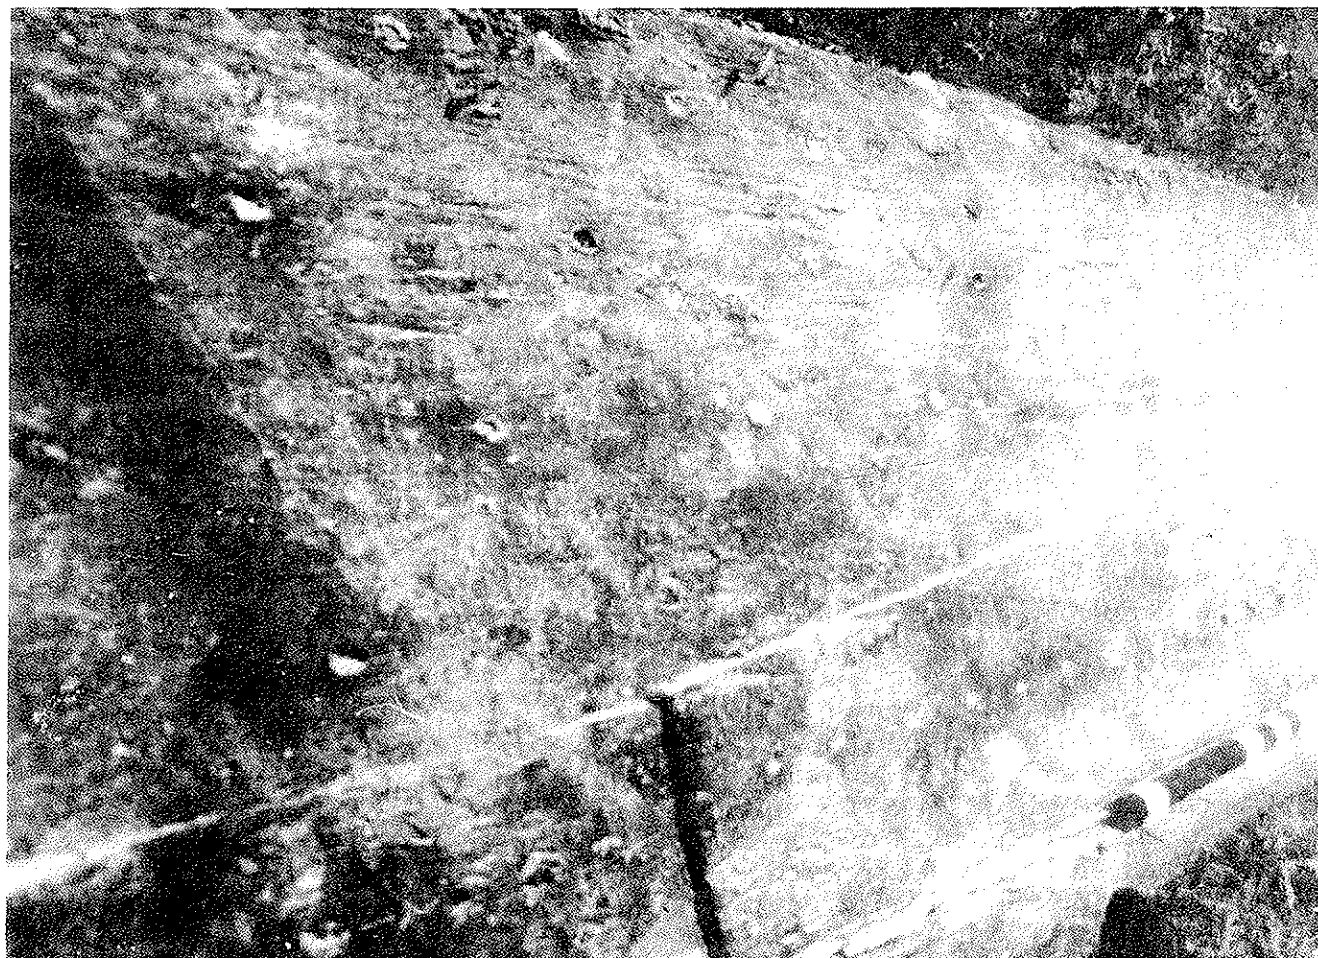
Fig. 13 Photograph of the keel, outer planking and false keel showing the keel joint.

The keel was 45 cm deep and made up of timber of two heights: the upper section was 22 cm high and the lower section 12 cm high. The keel with the outer planking above and the false keel visible below, can be seen in Figure 13. The joint in the lower timbers can be clearly seen together with the horizontal row of copper tacks attached to the copper sheathing which went under the keel.

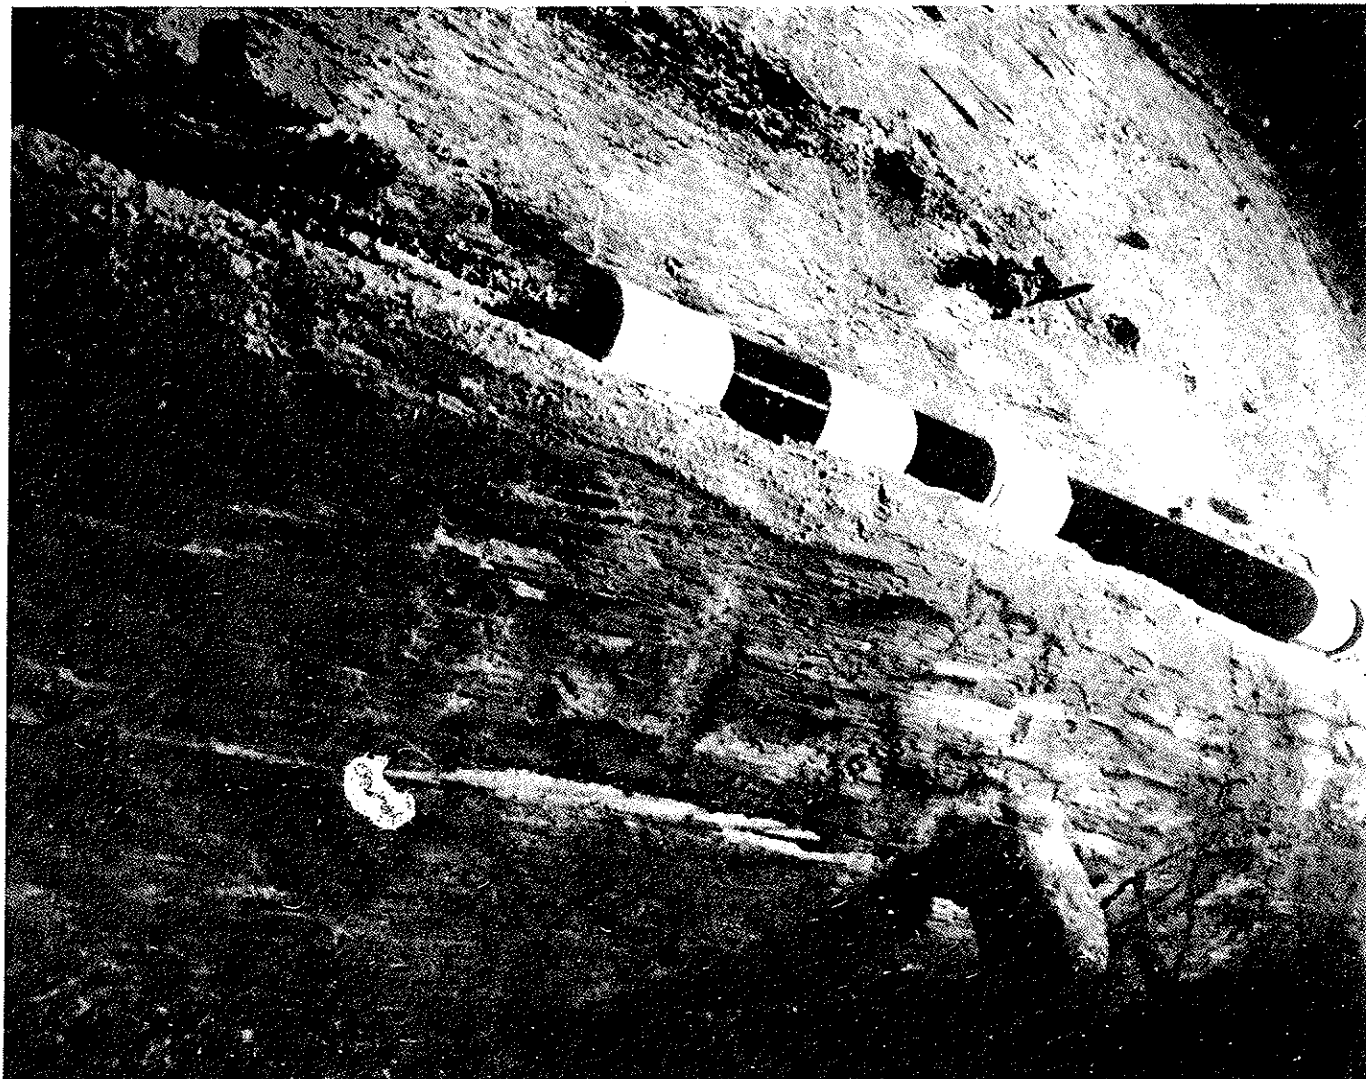
Fig. 14 Photograph of the false keel showing false keel fastenings.

The row of copper sheets over the base of the keel were placed over a thick layer of felt to cushion the false keel against the keel. The false keel was made from a roughly cut half of a tree trunk and was secured to the keel by means of 3 cm diameter copper bolts. Figure 14 shows the false keel with the scale in the join between the keel and the false keel and one of the false keel bolts appearing in the bottom right of the photograph.

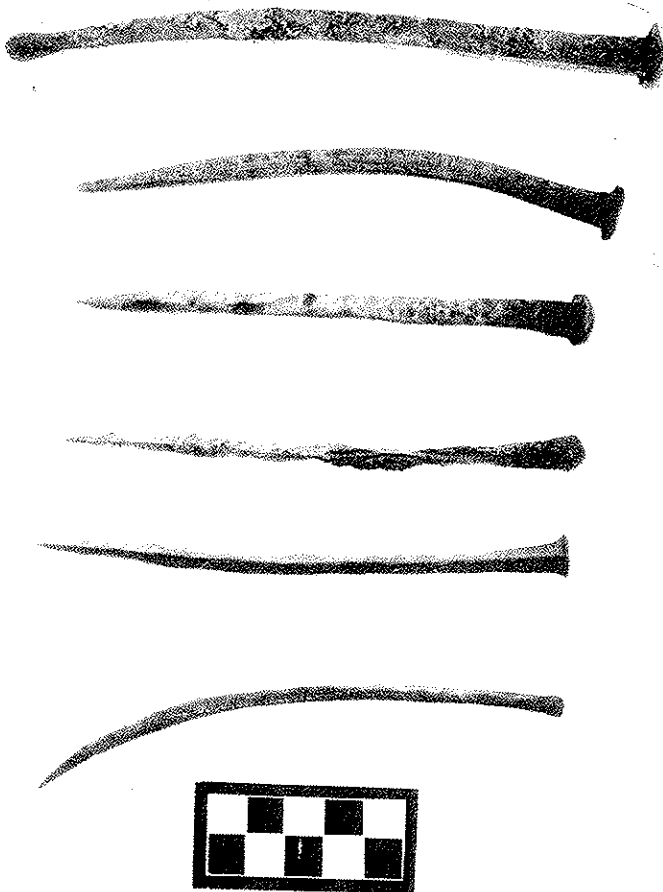
Fig. 17 Photograph of copper spikes, some showing severe corrosion.

Figure 17 shows a number of copper spikes from the *Rapid* with the one on the extreme left being from the stores and is in an unused and uncorroded condition while the others show signs of severe corrosion.
