Archaeological research on HMS *Swift*: a British Sloop-of-War lost off Patagonia, Southern Argentina, in 1770

HMS *Swift* was a British sloop-of-war which sank off the coast of Patagonia, Southern Argentina, in 1770. Since 1997 the Underwater Archaeology Programme of the National Institute of Anthropology has taken charge of the archaeological research conducted at the wreck-site. This article presents an overview of the continuing *Swift* project and the different research lines comprised in it. The latter cover aspects related to ship-construction, material culture and natural site-formation processes.

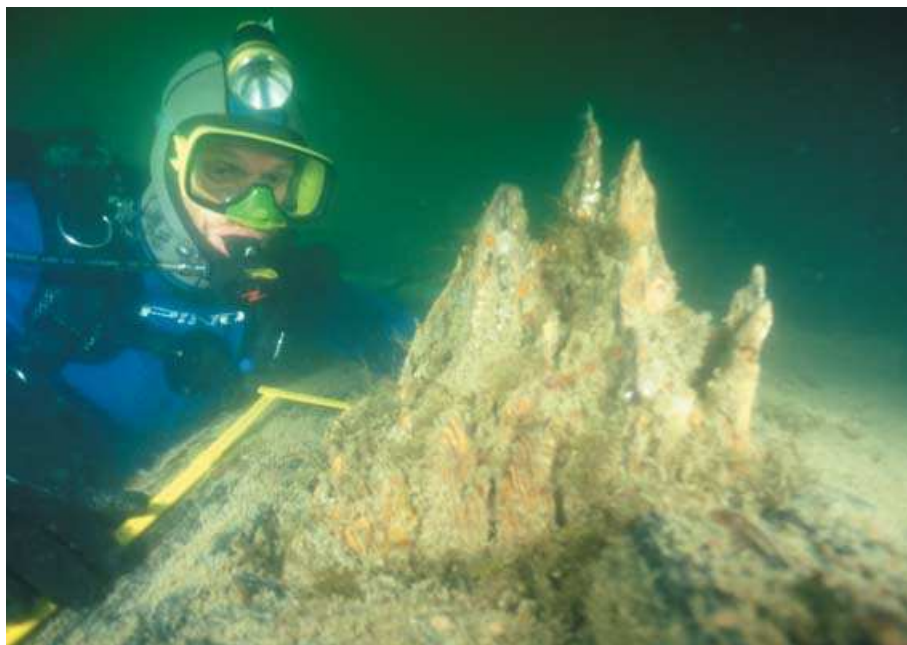
Figure 6. Mizzenmast, broken just above the partner. (S. Massaro)

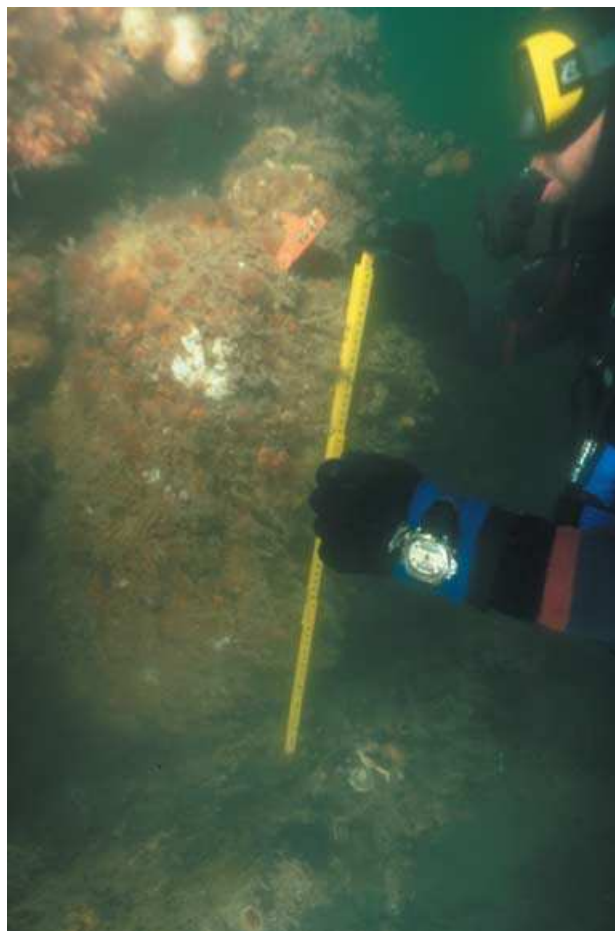
Figure 9. One of the 6-pounder cannons carried on the main deck. (S. Massaro)

To date, seven cannons have been identified at the *Swift* (Fig. 9), half the total on board. Some even have their gun-carriages. The rest of the cannons are supposed to be buried. None of those found is completely exposed, and all are covered by concretion. Two could be measured and the average length is *c.* 1.9 m. Considering the layer of concretion that covers the cannons and estimating a long-term corrosion rate of about 0.1 mm a year—some 24 mm after 233 years (Pearson, 1987; MacLeod, 1995; MacLeod, 1996; Gregory, 1999)—the *Swift*'s cannons would belong to the smallest size of the Armstrong pattern, measuring 6 ft. The distribution of cannons, concentrated on the port side, is a direct consequence of the

severe angle of the hull on the bottom. The position of four of them is consistent with the original layout on the deck on the port side, as well as with the distance between the gunports. Two of the remaining three cannons would have originally belonged on the starboard side, since their position is unlikely to relate to the port side.

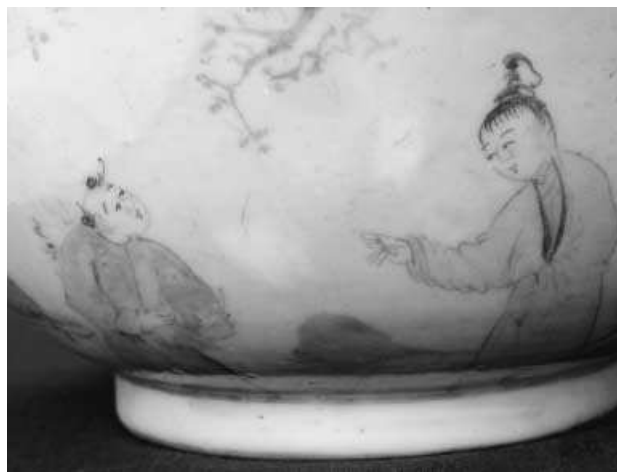
Figure 12. Blue-and-white porcelain plate (scale 2 cm). Note the different aspect that the central figure adopts depending on the perspective from which it is seen. (D. Vainstüb)

However, there are two exceptions among the assemblage found so far. One is the only bowl in which human figures are the central topic instead of the landscape (Fig. 11). The other is a plate painted in light blue on white. This has as the central motif a creature with an anthropomorphic face and serpent-like body, which adopts different aspects depending on the perspective from which the plate is seen (Fig. 12 a and b). Sadly, there is no provenance for these unique pieces.

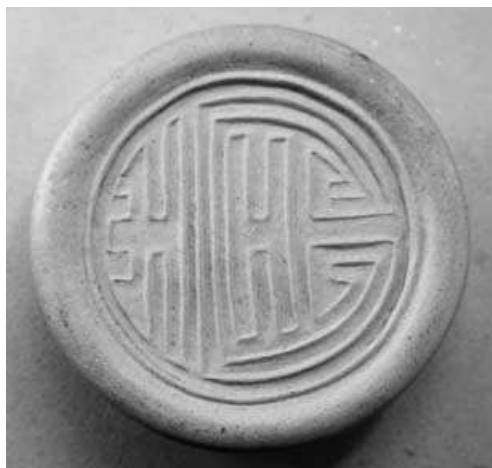
Figure 14. Oriental stamp on earthenware bowl-lid. (D. Vainstrib)

This category comprises four small, tea-size bowls, three of them complete with their lids, as well as plates. None has glaze, and their colour is given by the paste, which is of a light ochre colour in the case of bowls and lids, and reddish-ochre in the case of the plates. The bowls are of high-quality manufacture, with thin walls. Some retain very subtle traces of what seems to have been painted decoration in either blue or black. All the lids have geometric and circular oriental stamps, located in the knob (Fig. 14). These bowls

are interpreted as tea-cups, the lid presumably for retaining heat. Very similar bowls, both in shape and the type of ceramic, have been recovered on underwater sites from the island of Takashima (currently Japan), although they belong to older periods than the one considered here (Kyushu Okinawa Society for Underwater Archaeology, 1992: 67, 72). The geographical source of this set of bowls would be provincial South China (pers. comm. Shelagh Vainker, 1993). Only two plates have been found so far, made in a similar fabric to that of the bowls, but more reddish in colour. On their base they have an impressed oriental-style seal. All the examples for which we have contextual data were found in an area between the mainmast and the mizzenmast.

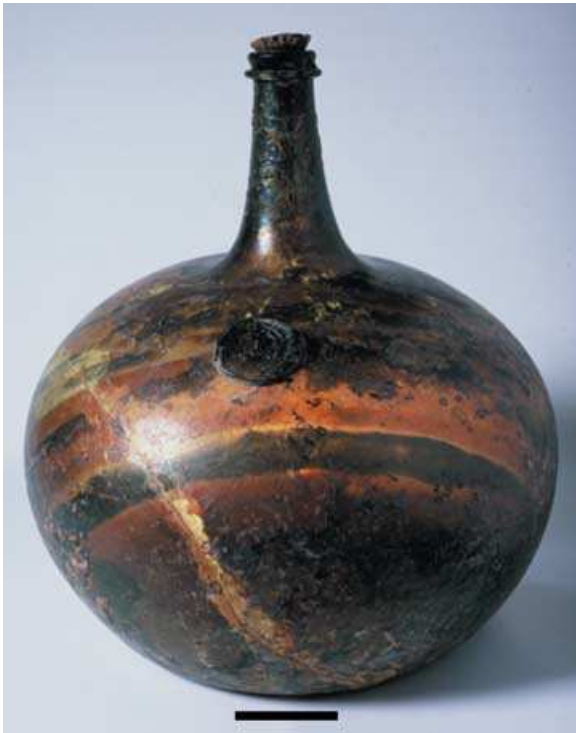
Figure 16. Glass demijohn found in association with remains of a net made of botanical fibres (scale 10 cm). (M. Setón)

The last two glass items so far recovered are a faceted and ground stopper, and a big demijohn (Fig. 16), both found in the captain's cabin. The demijohn, still to be studied in detail, was found in association with remains of a net made of botanical fibres. The 'gin bottles', tumblers and stemware were recovered from the stern. The

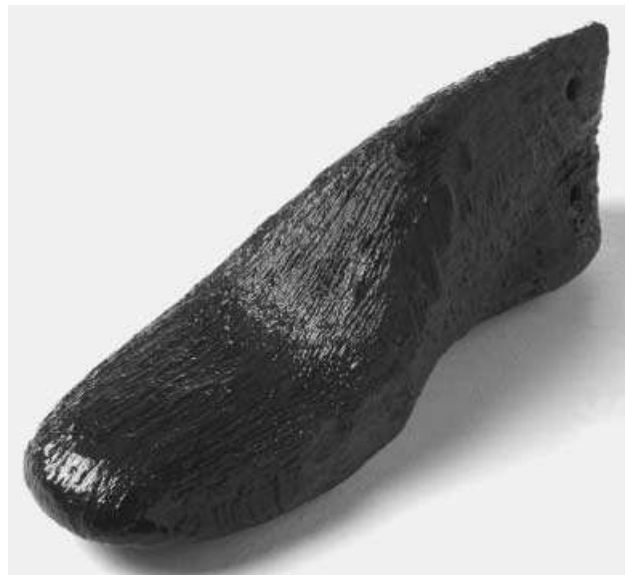
Figure 17. Wooden shoe last. (M. Setón)

captain’s cabin, is of silver); two shoe soles and one toe piece, found in the bow area; and one wooden shoe last recovered from the excavation zone (Fig. 17). The silver buckle would have belonged to one of the officers, and is representative of a high social status (Hume, 1982: 86).

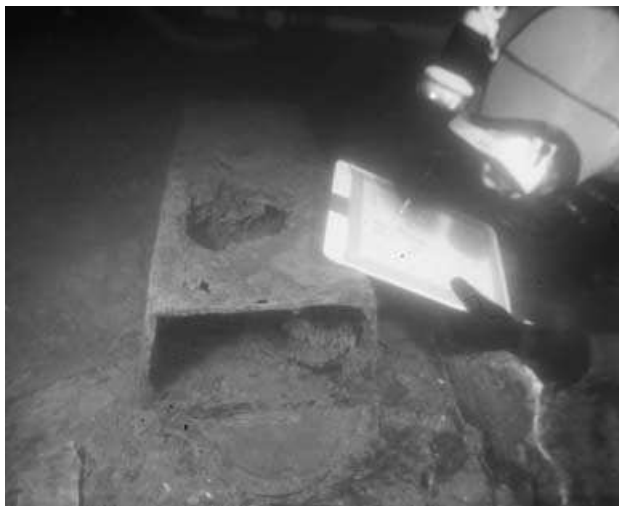
Figure 18. Fireplace located within what would be the 'Great Cabin' of the ship. (S. Massaro)

In the stern sector, within what would be the 'Great Cabin', a fireplace was found (Fig. 18). The main fire-box is made of thin, riveted copper sheets with internal iron straps, its interior lined

with plates made of a still-unidentified material which must be insulating or refractory. The external dimensions of the fire-box are 81 cm high, 32 cm wide and 20 cm deep. The grate was of iron, and only concretions remain. At the top are traces of a copper smoke-funnel. The front has two solid brass panels on the upper part and an ornate brass frame fixed with bolts and nuts. Other isolated parts were found, such as a socle, a cylindrical leg and a finial. They are all brass and would have been part of the front of the ash pan. Other evidence of the use of fireplaces on board Royal Navy ships has been recorded on the wreck-sites of the *Pandora* (1791) (Gesner, 2000: 74–7) and the *Sirius* (1790), as well as in a contemporary model of the *Royal George*, a first-rate ship of 1756 (Stanbury, 1994: 43–4). It is not clear if these fireplaces were provided by the Admiralty or were personal belongings of the officers, but their use on board ships sailing in high latitudes, such as the *Swift*, is quite logical. Two other brass artefacts recovered from the stern are a furniture knob and what may be a coat-hook. The knob is globular with a diameter of c.35 mm and has no decoration, while the hook has a flat rhomboidal shape, c.5 cm high and wide, with very ornate decoration (Fig. 19).

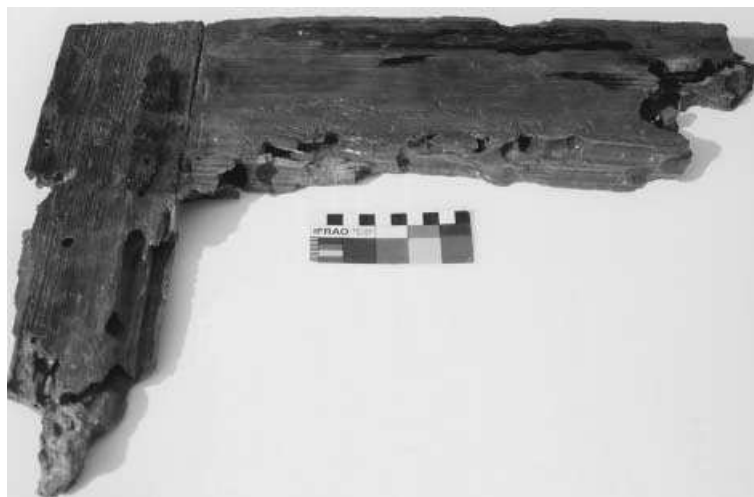
**Figure 22.** Window- or door-frame attacked by local wood-borer species. (M. Grosso)

The predominantly anaerobic conditions of the sediments, which limit the development of organisms, protect the organic remains from biodeterioration, which, in the case of wood-borers, can be quite fast and aggressive. Some perforated wood pieces found below the sediments must have been attacked during initial stages prior to the increasing sediment protection of the site. The finding of two valves confirms the presence of Teredinidae on the site, although it is not a sufficiently diagnostic element to determine the species. On the basis of previous data for the

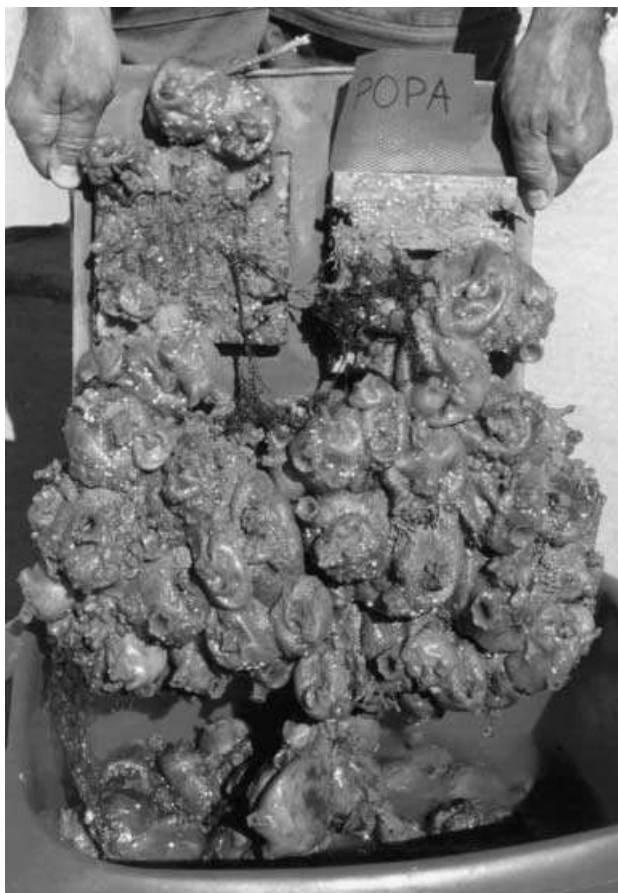
Figure 23. Climax stage of biofouling at the *Swift* site, with clear dominance of the tunicate *Paramolgula gregaria* after one year of development. (D. Vainstrib)

gregaria and *Cnemidocarpa verrucosa*. This constitutes the climax stage of the biofouling process, after which several detachments take place, which leave the original surface free for an immediate new colonisation.
