HMS VICTORY CONSERVATION MANAGEMENT PLAN

Volume 1

**THE
NATIONAL
MUSEUM**

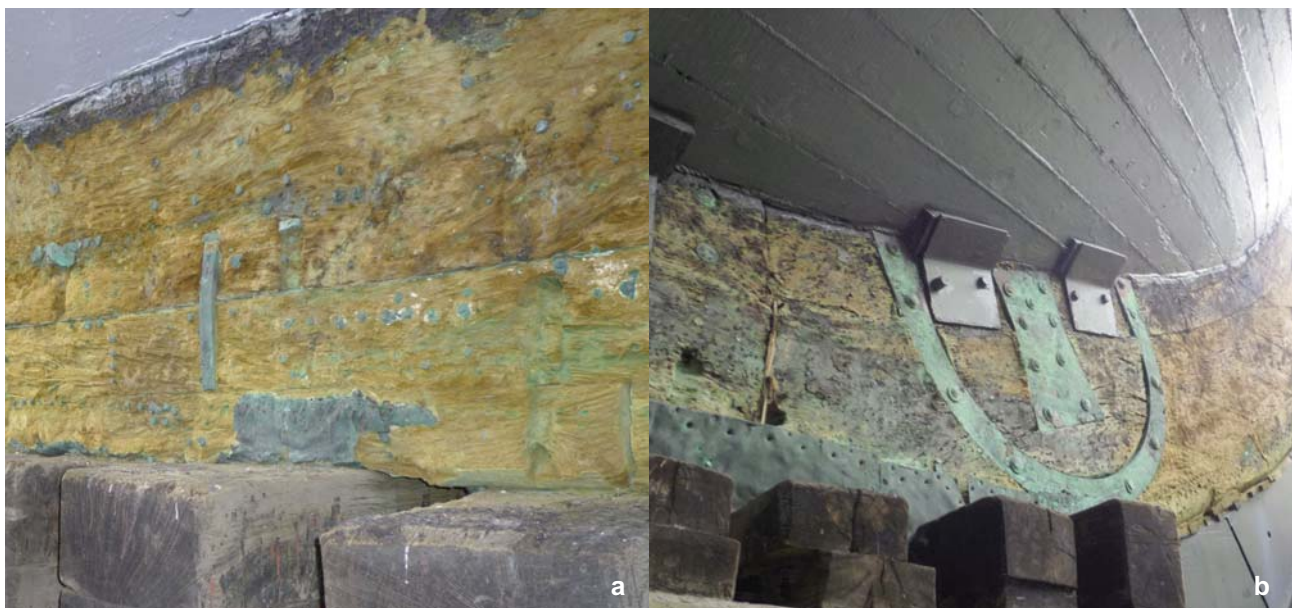
Plate 15. a) Detail of the keel structure towards the stern; b) detail of the longitudinal bow structure

While the ship's hull has maintained its 18th-century form and appearance, there are clearly several phases of fabric extant within the structure that preserve historic and archaeological evidence of differing levels of importance (see **Figures 4–9**). The keel assemblage (Gazetteer number 1.01) (**Plate 15a**), and elements of the longitudinal bow (1.03) (**Plate 15b**) and stern structure (1.02) represent considerable and even exceptional examples in this regard, as some of the oldest fabric in the ship. Indeed, it is evident that there may well be 18th- and early 19th-century fabric still extant in areas of the ship structure that are not currently visible. This also includes the surviving detail inherent on the surfaces of many of the components and the information they can provide in developing the overall understanding of *Victory's* complex life. For example, even minor details observed in the archaeology can give great insights into developments in technology, such as the remains of compounds and application techniques noted on the keel associated with the coppering of the ship from the late 18th century (see **Plate 34**).

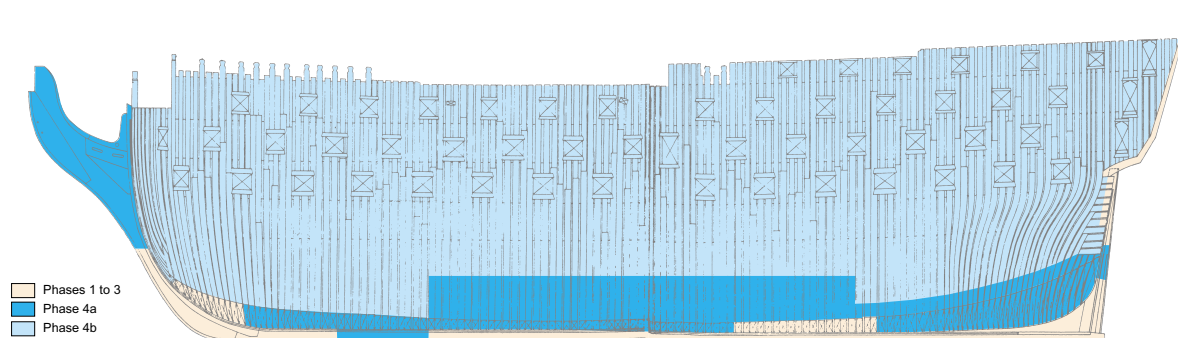
Figure 5. Port frame disposition with phasing

In relative contrast however, is the composition of the hull framing and associated structure such as the transom beams (1.04–1.09) which has undergone a significant change since *Victory*'s early career in Phase 2, despite the maintenance of the ship's form. The extensive repairs since 1922, and particularly those undertaken from the 1950s to the early 2000s, have left a palimpsest of fabric and materials that demonstrate the development in the use of techniques and materials relating to the extensive history of the repair and reconstruction of the ship (**Figures 5 and 6**).

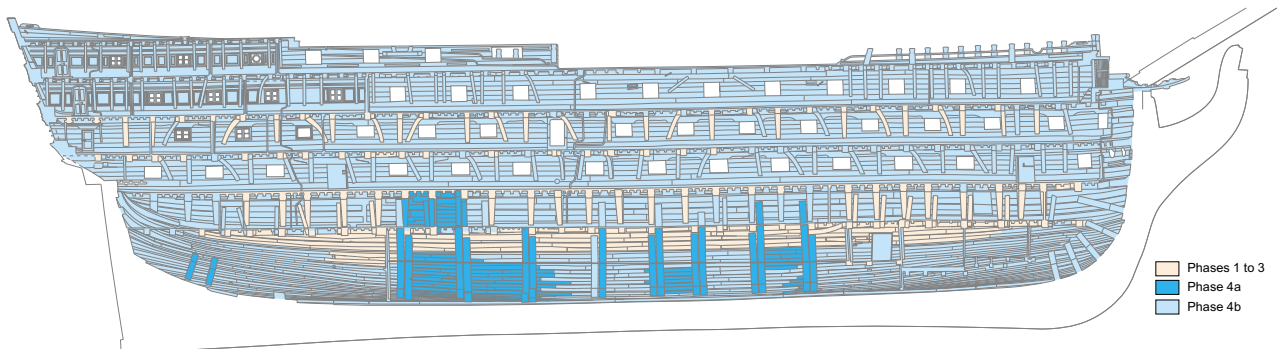
Figure 7. Port internal profile

The internal planking (1.10) of *Victory*'s mid to upper hull is almost exclusively reconstruction and repair fabric dating from the 1970s (**Figures 7 and 8**). It demonstrates quite clearly the introduction of modern fabrication techniques such as lamination; the use of tropical hardwoods (such as teak and iroko) due to the scarcity of oak and its 'failure' to survive for long in enclosed spaces; and the use of modern fastenings and adhesives to join components together. Surviving historic fabric was noted in parts of the hold which may well relate to fabric repairs in Phase 3 while the ship was afloat in Portsmouth Harbour.

The condition of the inner planking throughout the ship was assessed as part of the *Internal Shipwright Survey of HMS Victory* (Nielsen & Co. 2012). Areas of decay were noted in the timber comprising the inner planking at all deck levels, primarily from the effects of water ingress through the decks and the ship's side. On the upper and middle gundecks the areas identified as containing particular areas of rot are located around the foremast in the bow (**Plate 16**). Since the 2012 survey, the forecabin and quarterdeck have been re-caulked to arrest the ingress of water to the decks below. On the lower gundeck, the areas of decay were noted in the area around the bow, as on the decks above, but also in the area forward of the mizzen and main masts. It was suggested that the decay may well be caused by ingress of water through the ship's sides. The orlop deck observations were different again to those noted above. The port side of the ship revealed some decayed fabric between the main and mizzen masts; while on the starboard side more rotten fabric was noted between the fore and mizzen masts, likely to be as a result of this section of the ship facing the prevailing weather. In the hold the decay of fabric is similar to that noted on the orlop deck but caused more from insect attack rather than water ingress. Shrinkage of the inner planking was also noted throughout.

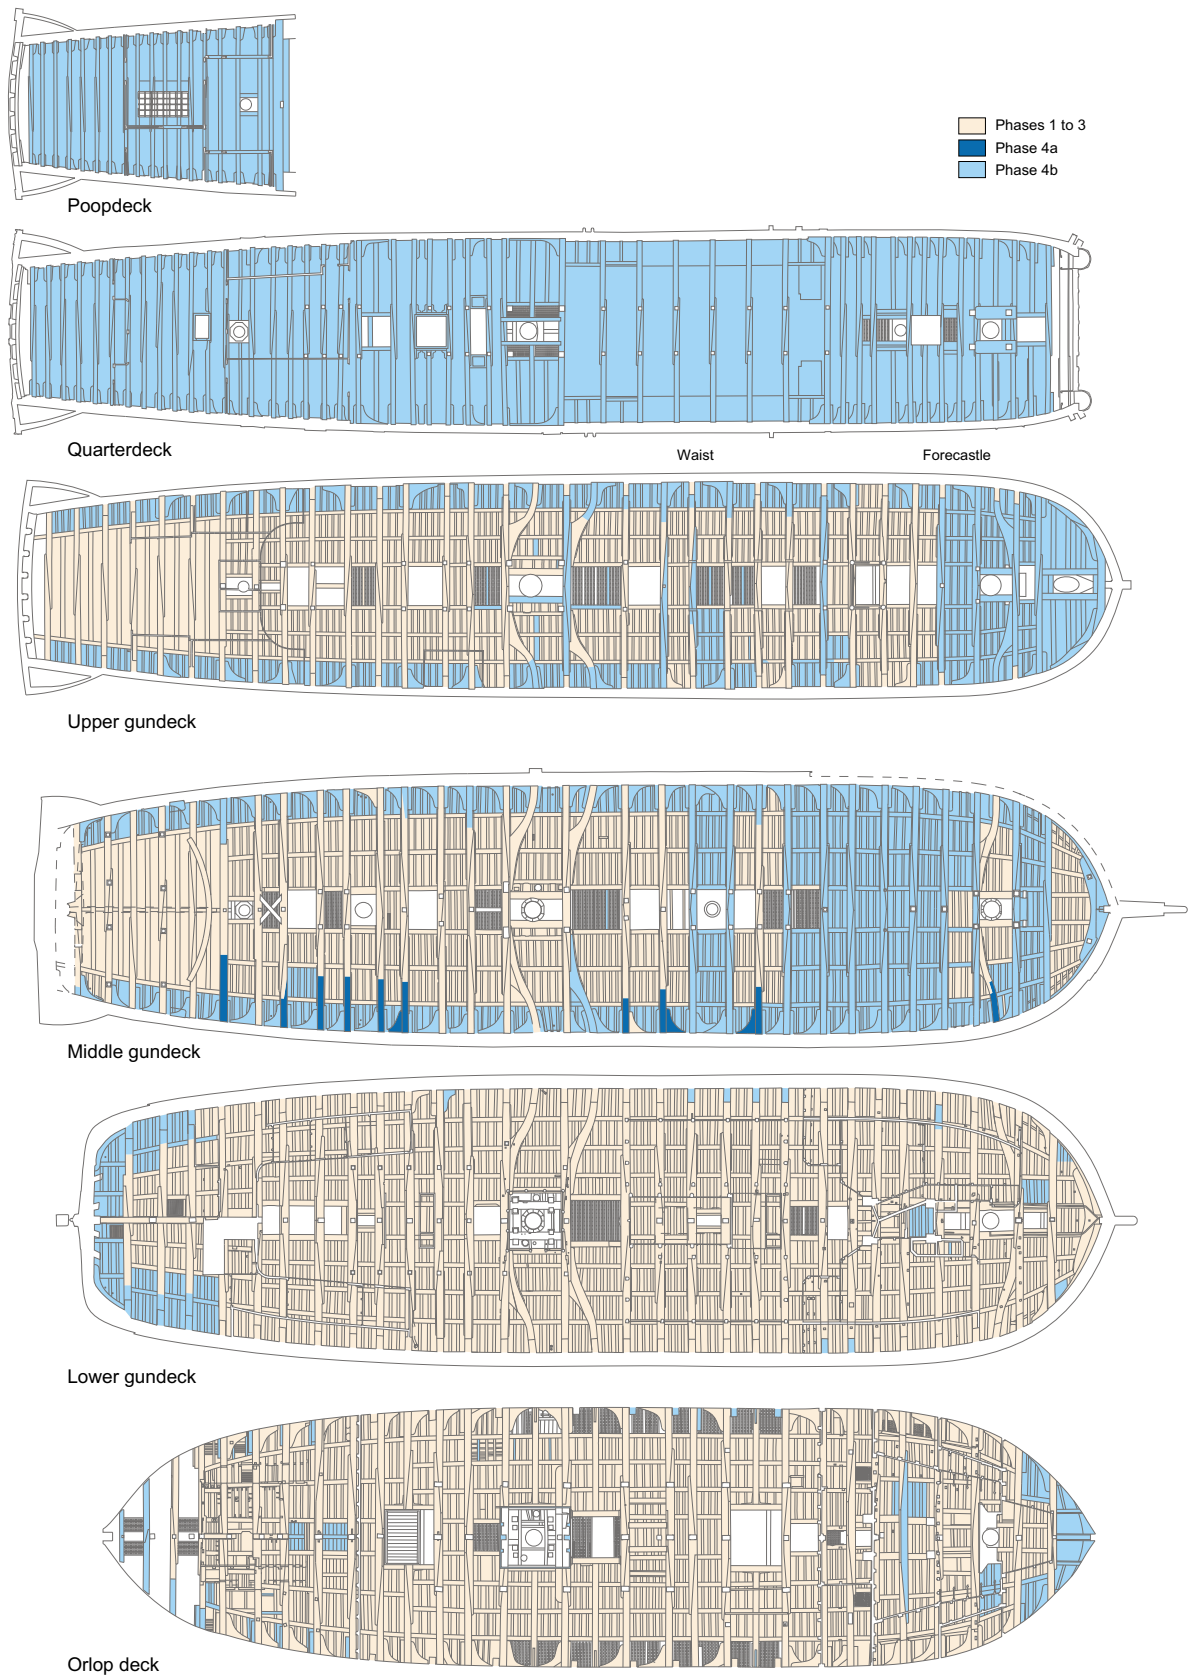
Figure 9. Deck plans indicating the distribution of phased structural elements

What is also clear is the continued trend for the more historic fabric to be present on the lower decks, and of importance, the archaeological detail inherent both in the composite construction but also the surface details present on many of the elements (**Figure 9**). A key example is the presence of shipwright's timber marks (**Plate 20**) on a large percentage of the timbers of the lower decks which give a tantalising insight into the dockyard working practices and timber management of the Royal Dockyards in general and Portsmouth in particular (**Figure 10**). In understanding the timber marks it is possible to understand the nature of the earlier repair history of the ship and how that translates into later discussions on significance and the conservation thereof.

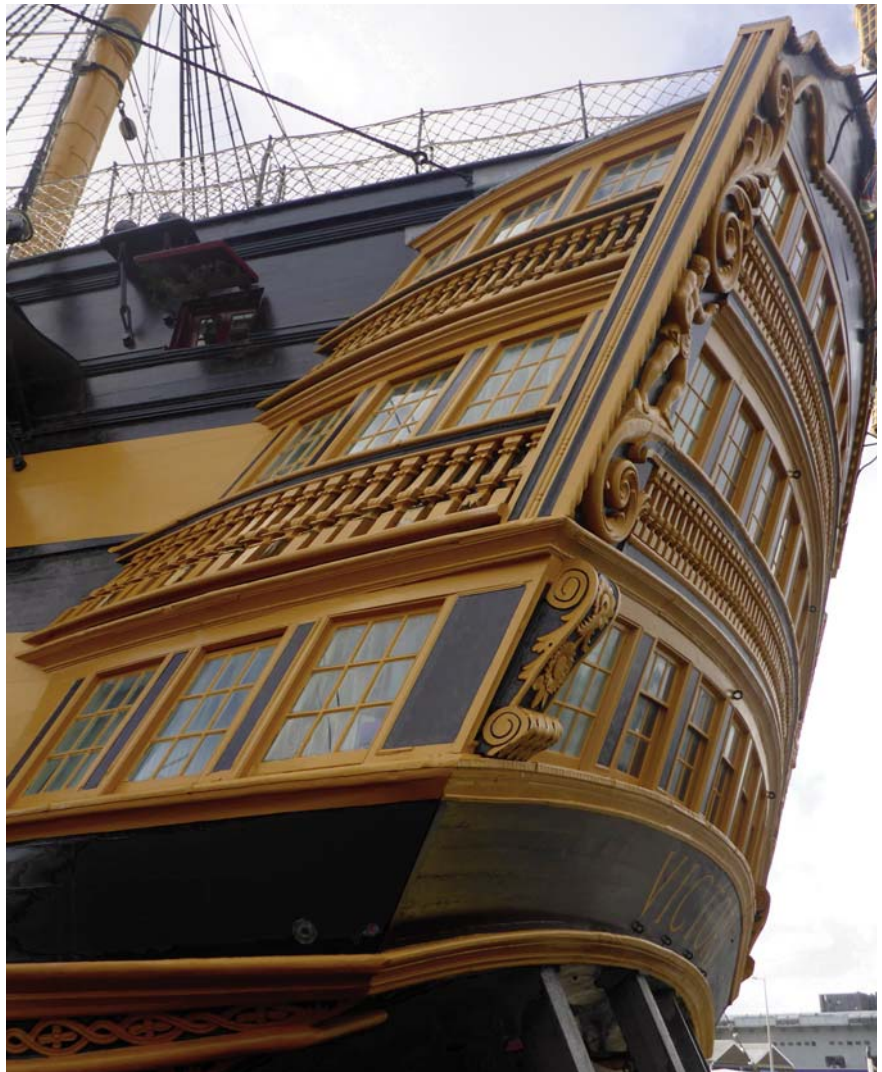
Plate 24. The port quarter galleries and transom stern highlighting the most elaborate carved decorative work on the ship

One of the most complicated elements of the ship is the stern structure and associated quarter galleries (2.07). While providing an impressive outward appearance, particularly with the decorative features, the external planking hides the complicated nature of the composite structure. The structural components comprise a mixture of historic fabric and modern repair; a visual inspection of some of the vertical stern timbers suggest that key elements are potentially illustrative of the conversion of the structure to a 'closed stern' in the large repair between 1800 and 1803 (Phase 2). Furthermore, some of the surface detail both on the stern timbers and a gunport lid at upper gundeck level revealed a suite of shipwright's timber marks, the presence of which would certainly suggest the assemblage and particular elements are of at least 19th-century date (late Phase 2 or Phase 3). The quarter galleries also provide a particularly elegant look to the stern of *Victory* and comprise fabric relating to the major repair to the stern area in the 1970s (**Plates 24** and **39**).

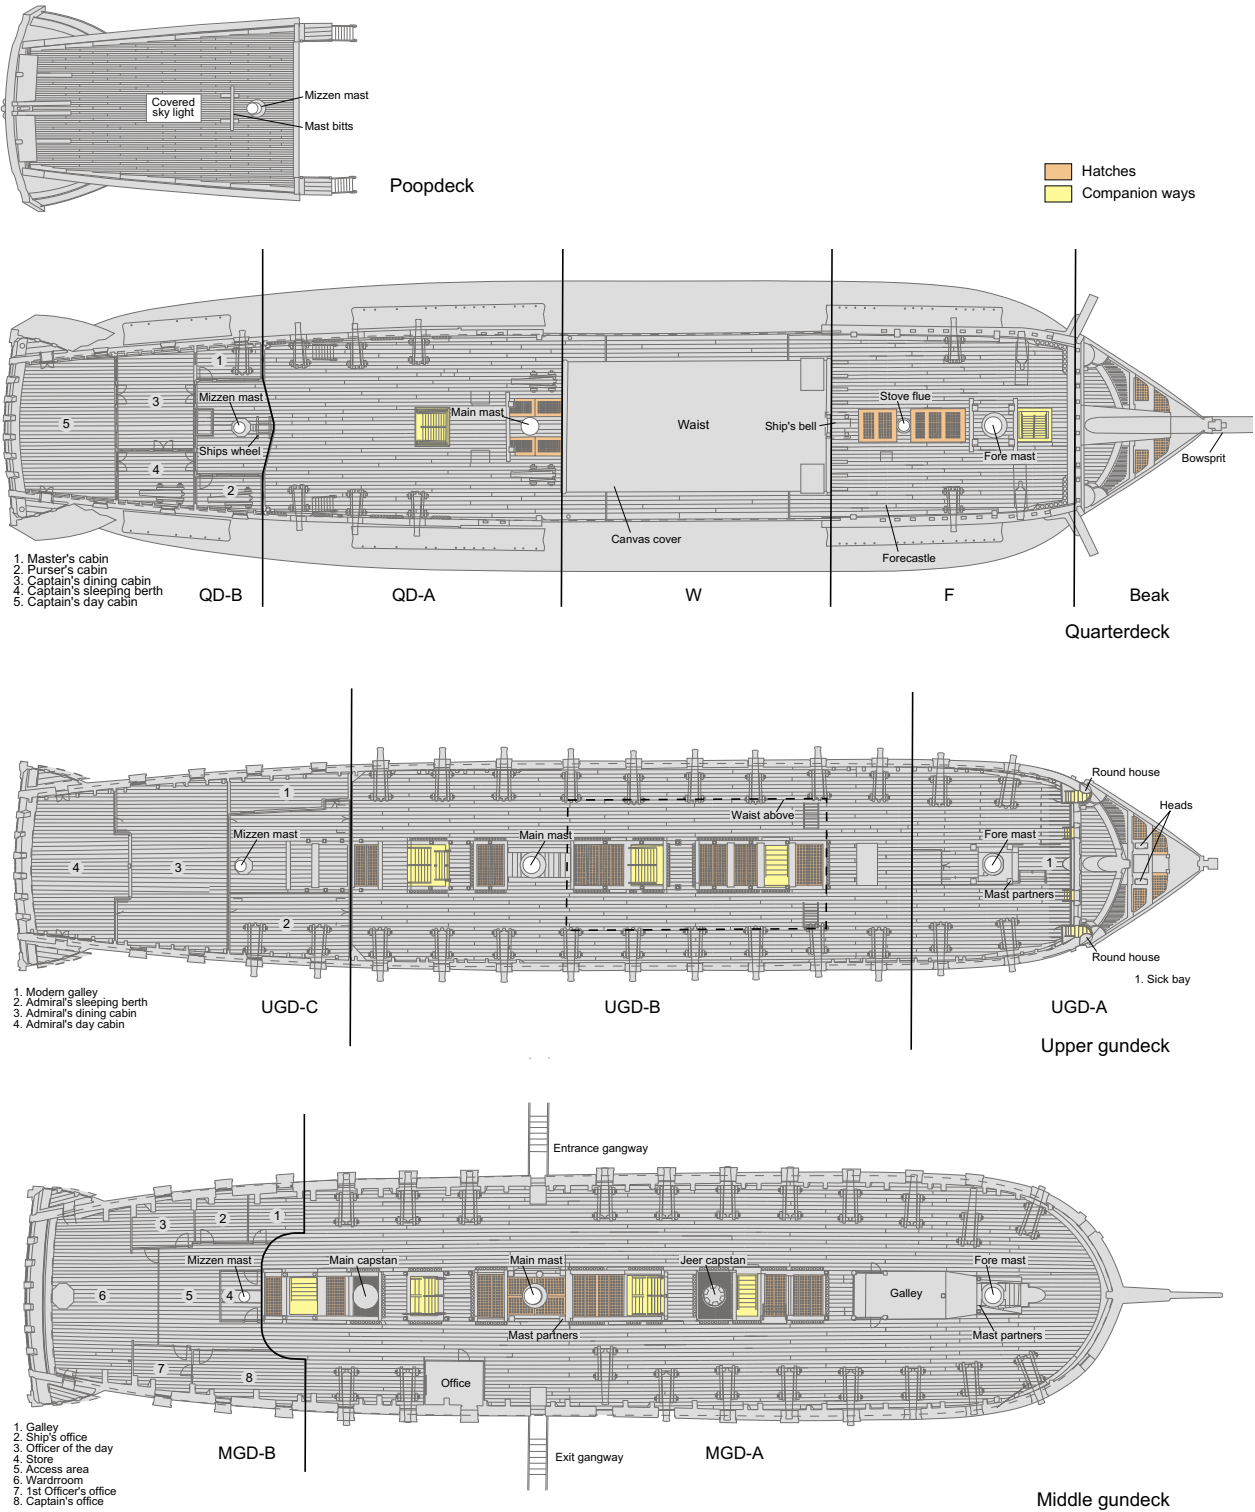
Figure 11. Tertiary structure

The upper gundeck (**Figure 11**) is the uppermost of the main decks and compared with the decks below is a light space which is visually appealing and aesthetically pleasing to the eye. Similar to the quarterdeck above, a large percentage of the hull fabric relates to the repairs and reconstruction phases, while the deck structure displays a high percentage of historic fabric relating to early Phase 3. The overall experience on the deck is one of a fairly authentic representation of how the space would have looked during the Trafalgar period. This includes the sick bay area forward (3.07) and the main deck with the covered waist (3.08) (**Plate 28**). The aft area of the deck comprises the Great Cabin and the Admiral's accommodation. This area gives the visitor a fair representation of the Trafalgar appearance and is accentuated by the period features, furniture and artefacts; in addition to the impact of the stern windows looking aft. Similar to the Captain's cabins above however, some questions arise as to the decision to varnish the bulkhead panelling in this area. In general, the area is particularly evocative of the connection with Nelson and for this reason represents one of the key areas of the ship.

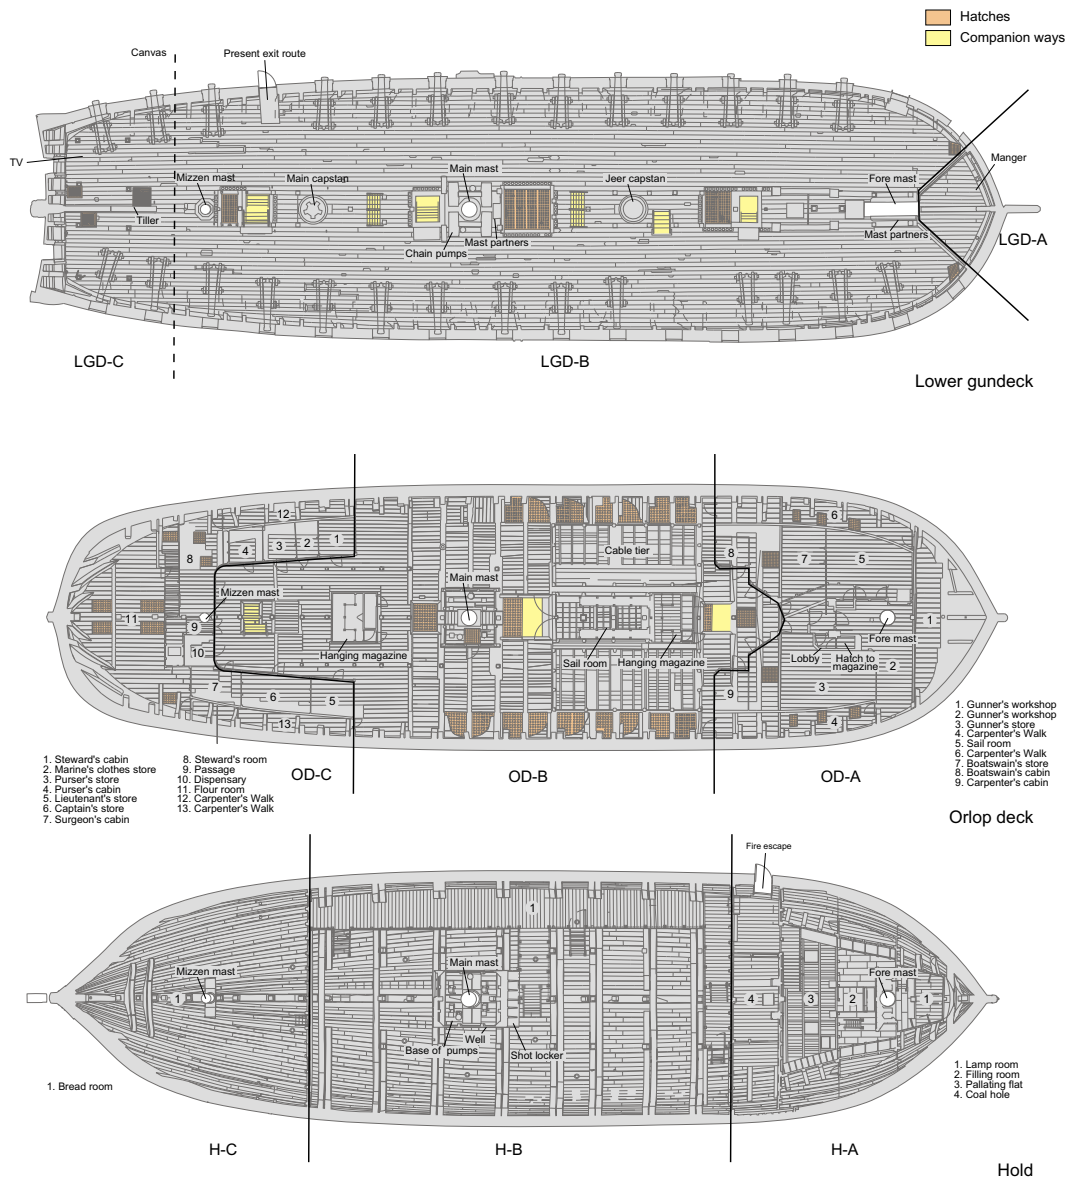
Figure 12. Tertiary structure

The orlop, like the lower gundeck, is also a particularly atmospheric deck on the ship given the lack of natural light and softly lit spaces. It is particularly evocative in relation to the function of this space, and as the place where Nelson died (**Figure 12**) (**Plate 31**). The forward area of the deck (3.15) comprises the replication of the numerous stores and cabins traditionally located in this area of the deck. However, appreciation and experience of this characterful space by the visitor is currently not possible. The main area of the deck (3.16) is fairly expansive and provides a good understanding of key structural elements and spaces located in this area; the most obvious being the cable tiers, hanging magazines, sail room, and port and starboard Carpenter's Walk. The aft area of the deck (3.17) comprises a suite of cabins and stores surrounding the surgeon's station set out to replicate the use of the area during battle. The aft-most space comprises the slop store and the bread room which are currently inaccessible to the public.

The hold comprises a number of different spaces and gives a good impression of the scale of some of the fabric elements of the lower hull (Figure 12). The forward area of the hold (3.18) comprises the replicated elements of the Grand Magazine (and the coal store behind) which whilst providing the visitor with a representation of what the space may have looked like, does constitute something of a visual intrusion. The main hold (3.19) is atmospheric and gives a good understanding of what the space was used for and the sheer scale of the space, including the pump well and the cutaway showing the interior. The extent of historic fabric, particularly in the orlop deck structure above, is also particularly striking (Plate 32). The extent of the modern intrusions and fire precautions does detract from the full appreciation of this area however. The after hold in the bread room (3.20) provides an equally striking representation of the ship's structure but is not accessible to the public and is missing all of the key features associated with the area.

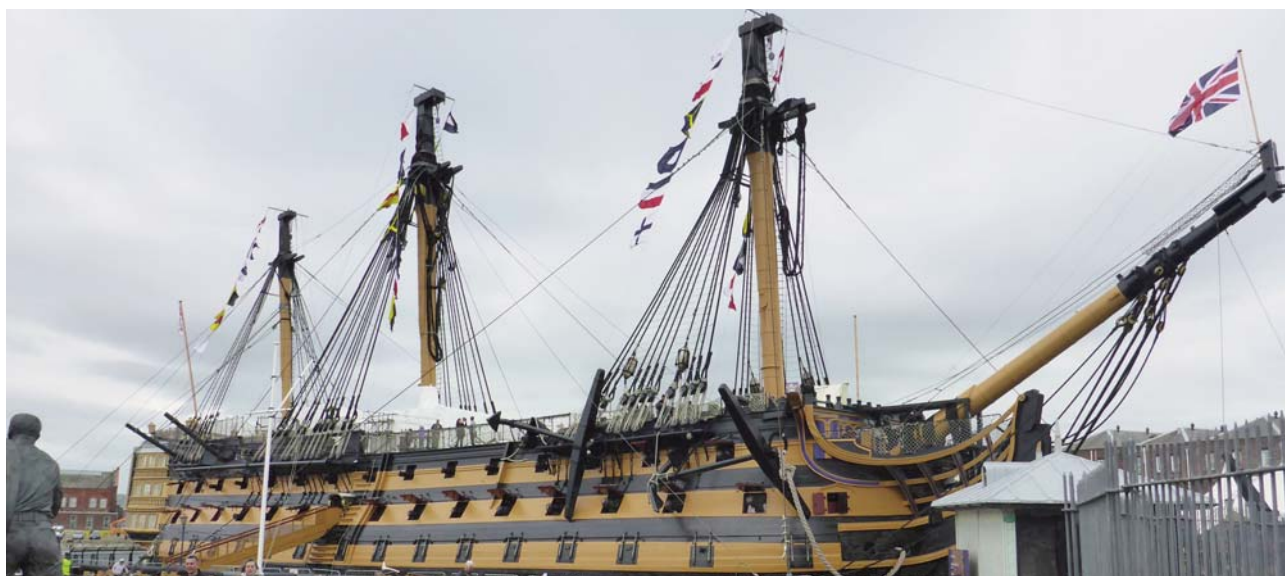
Plate 33. *Victory* on Trafalgar Day in 2013 illustrating the starboard hull and lower masts and bowsprit

The lower masts (3.22) on *HMS Victory* form a visual focal point when viewing the ship from the dockside and where the masts pass through each deck into the hold (**Plate 33**). At first glance the masts appear to fit quite well within the illustrative aspects of *Victory* as a capital warship from the Age of Sail. Indeed, unlike the replication bowsprit, upper masts, yards and rigging, the provenance of the lower masts to that of *HMS Shah* hold exceptional historical and archaeological significance in their own right as exemplars of their type, but the evidential value is diminished by the metal fabric in their construction and the presence of such in a wooden warship. Whilst the condition of the masts themselves appears to be good, it has been suggested in Neilsen & Co.'s (2012) report, and through further discussion and observations on site, that the masts, particularly the main mast, have been subject to an element of movement. This is considered to have had an effect on the adjacent deck structures which, from observations on board, suggests that the deck structure is being forced aft.

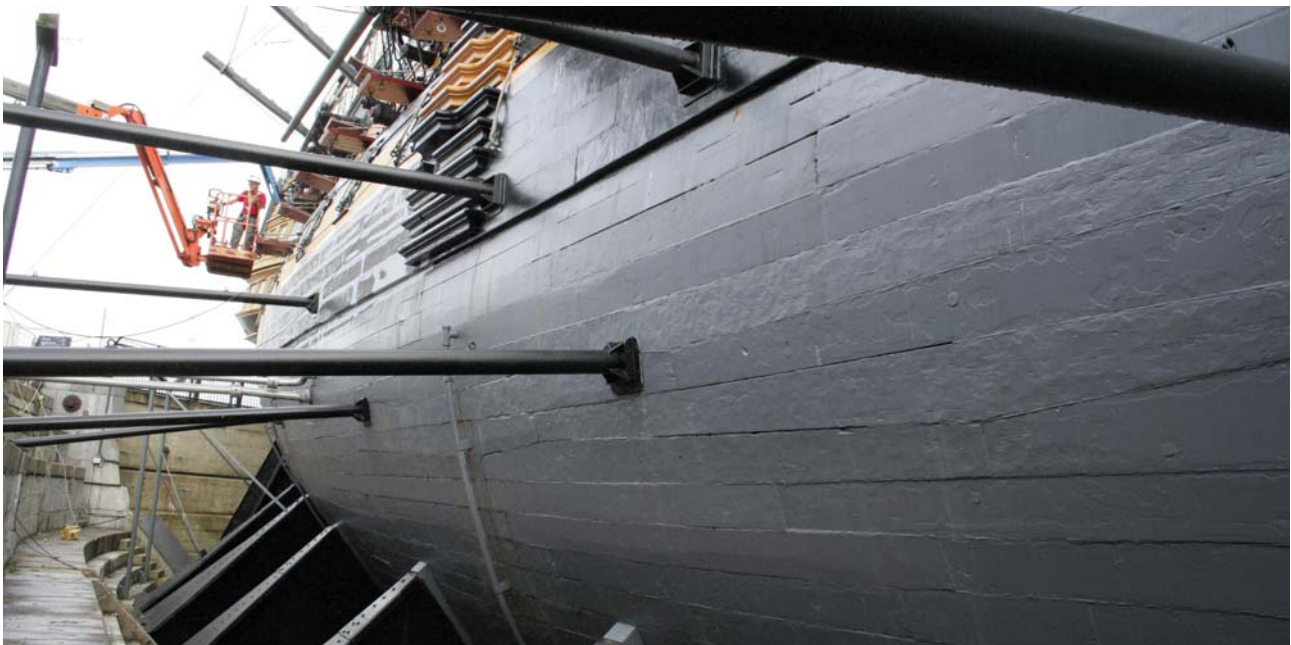
The two key issues currently affecting the ship, which pose the greatest risk to its long term survival, are those of structural stability and water ingress. Resolution of these two issues will constitute the top priority of the conservation project (**Plate 43**).

Plate 43. The current support arrangements for the hull

Policy 4 – In formally adopting the Conservation Management Plan, the key stakeholders accept that implementation of the works to achieve the long-term structural stability and water-tightness of the ship will take priority over all other uses of the ship.

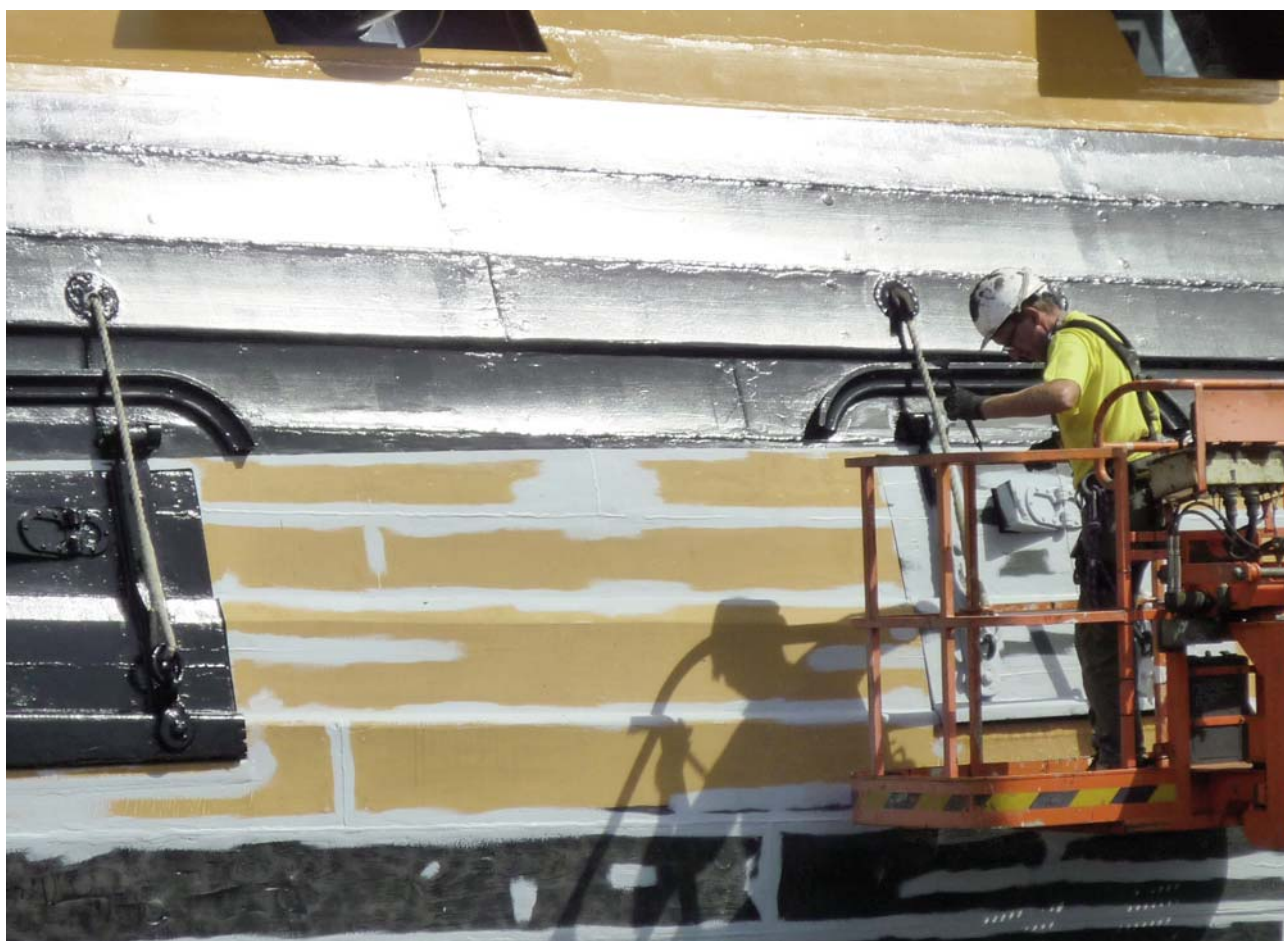
The considered decision by the HMSVPCo not to enclose the ship and dock within (or under) a protective structure makes it vulnerable to the elements of wind and salt-laden water. Whilst this preserves the ship's exceptional aesthetic value, and the contribution it makes to the character and aesthetics of the historic dockyard, it presents considerable problems relating to water ingress, and makes regular maintenance of the 'envelope' vital (**Plate 44**).

Plate 44. Maintenance to the outer hull planking

Policy 5 – *The HMSVPCo, in consultation with their specialist advisers, will review the decision to retain the ship in an open environment on a 10-yearly basis.*

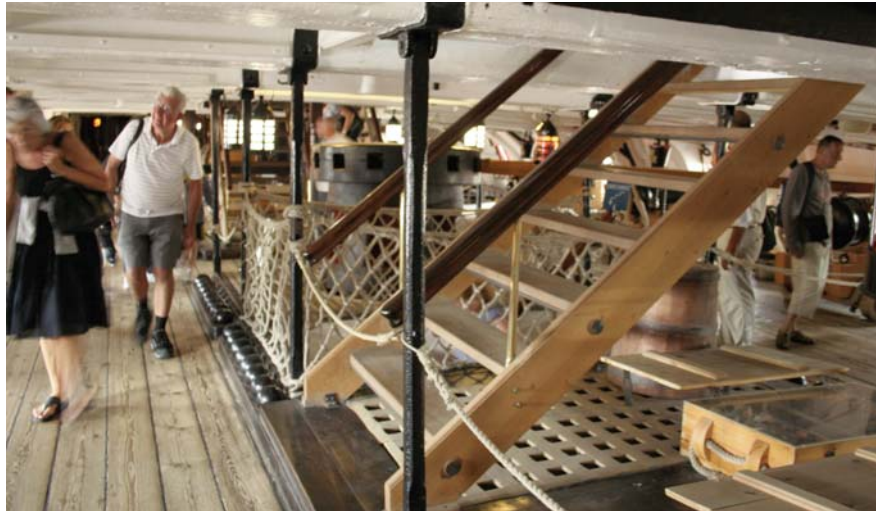
Visitor numbers to the dockyard increase year on year, and the aspirations of the NMRN and other Portsmouth Historic Dockyard stakeholders to increase visitor numbers to 1 million per annum have serious implications for the fabric of the ship and the quality of the visitor experience on board (**Plate 47**).

Plate 47. Visitors navigating the middle gundeck

Policy 14 – *The HMSVPCo will continue to work closely with the NMRN to ensure appropriate management of increasing visitor numbers through the better spread of visitors between ships, other attractions, the museum and other exhibitions. An appropriate methodology will be developed through which the impact of visitors on the fabric of the ship can be monitored, and mitigation proposals agreed and implemented.*

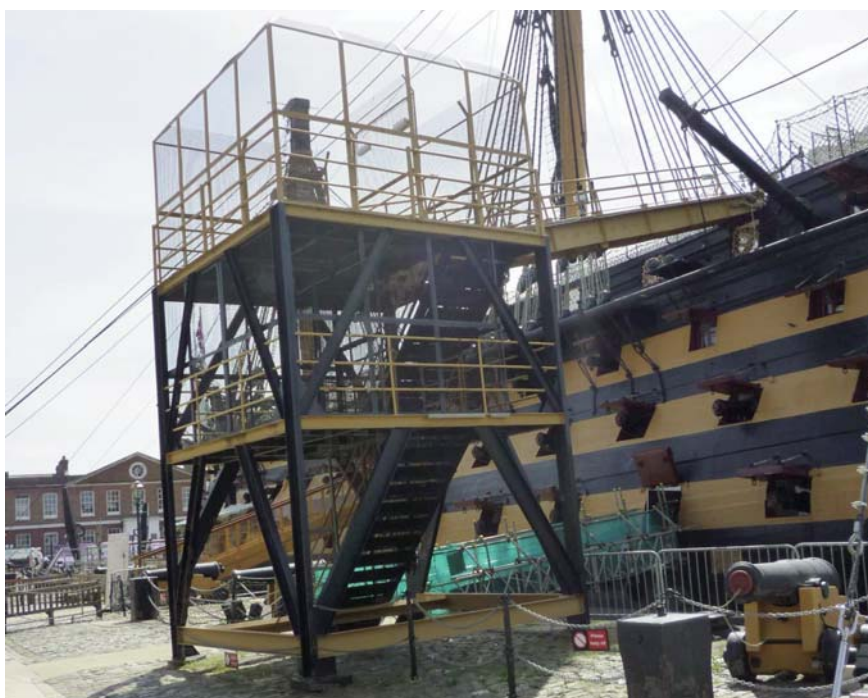
The fire escape tower at the north-east corner of the ship has been identified as having a major negative impact on the setting of the ship and the listed dock, and of compromising the aesthetic value of the ship and the dockyard. While this additional means of escape is vital in view of the number of visitors on board the ship at any one time (a number which is set to rise further) the design of the feature is entirely functional, and is unsympathetic in such close proximity of a vessel of international significance. It would be hoped that a more sympathetic design could be achieved to provide the necessary escape function; possibly in tandem with another function (**Plate 49**).

Plate 49. The current fire escape which represents a considerable reduction in the aesthetic appreciation of Victory from the dock side

Policy 19 – *The HMSVPCo and NMRN will commission an options appraisal and design for a new facility incorporating the escape route from the quarterdeck.*

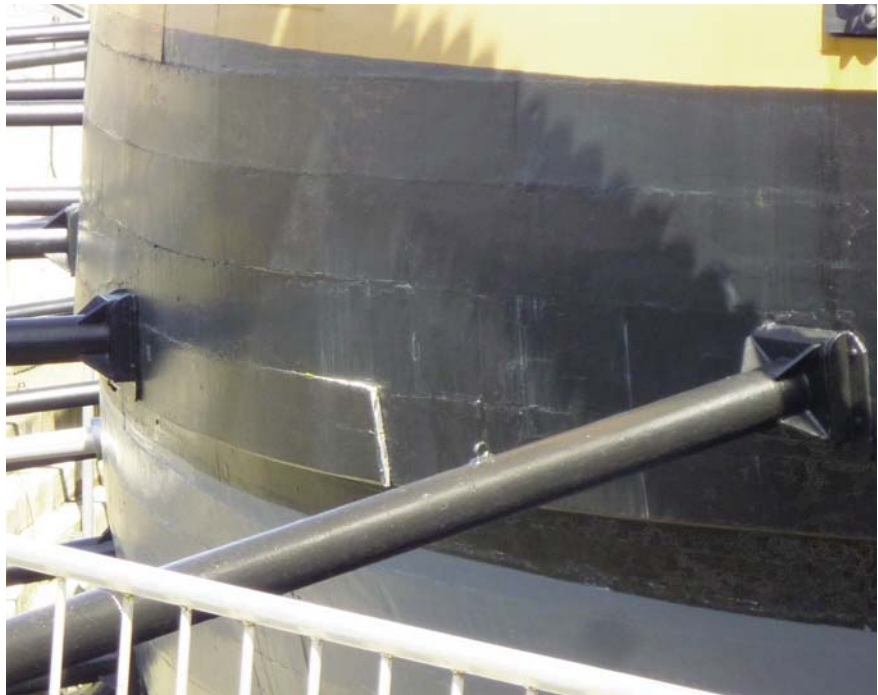
Plate 52. An indication of a 'sprung' layer of laminate on a plank of the outer hull towards the bow

Policy 27 – A decision will be made at the earliest opportunity, and in accordance with Policy 26, regarding the choice of timber species for necessary replacement of the structure and planking of the ship, to facilitate the timely purchase and seasoning of suitable timber, if necessary.

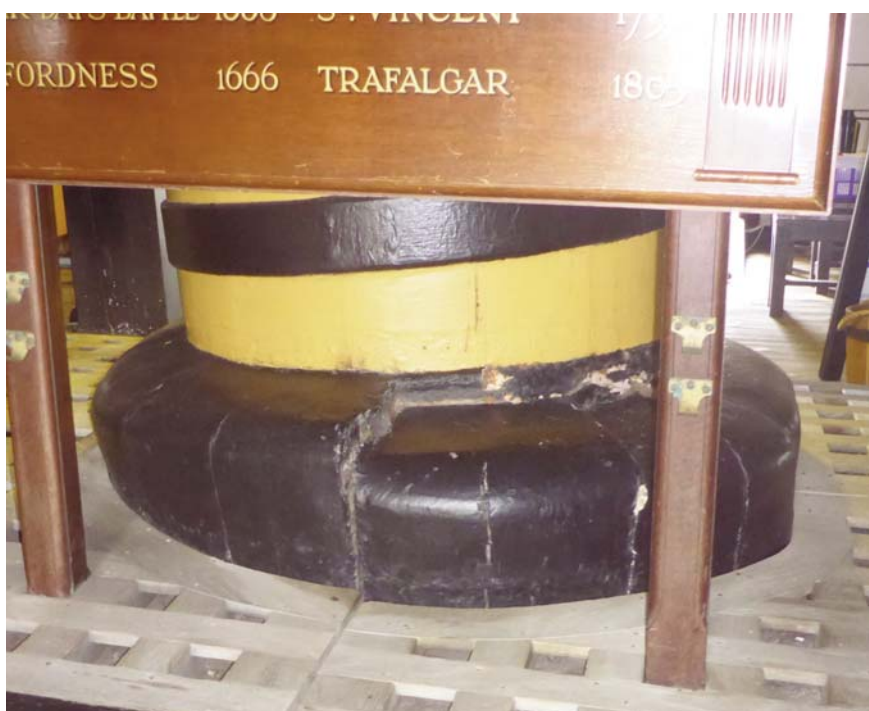
Due to their inadequate length for their current location, however, their re-use has necessitated the introduction of additional structure to support their base, thus introducing a point of weakness at the junction between the two components. Rotational movement of the main mast at this junction in January 2013 caused undue loading to be exerted on structure to the fore of the mast, and resulted in cracking of one of the timber mast partners. In response to this issue, anchor points were fixed to the dock side and adjustable tensioned guys installed to hold the masts in equilibrium. It is important that regular monitoring and adjustment of these anchor points continues, to prevent adverse loading of the ship's structure (**Plate 53**).

Plate 53. Evidence of movement of the main mast and the slipping of the mast chocks along the forward edge

Policy 34 – *A programme of regular monitoring and adjustment of the tension cables will continue at appropriate intervals to ensure that the lower masts impose no unacceptable loading on the deck structures. This work will be carried out by, or under the supervision of Fenton Holloway Ltd.*

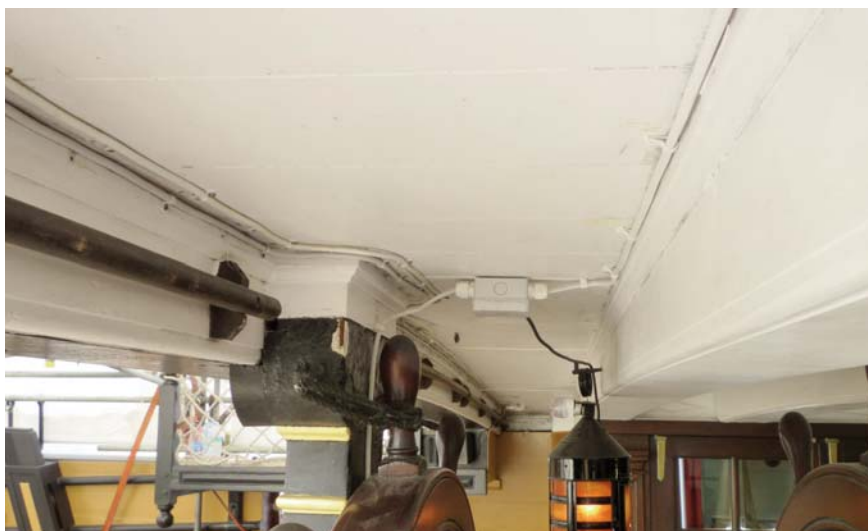
Service runs through the ship, particularly wiring, and those connecting between the ship and dock are highly visually intrusive in the context of an 18th-century wooden warship. Throughout the ship the majority of wiring is surface mounted, and in many cases multiple cables and wires run in parallel along timber members (**Plate 54**).

These features adversely affect the evidential value of the ship by physically impacting on the timbers to which they attach, and in cases obscuring rase marks and other notable features of the timber structure. They also negatively impact on the aesthetic character of the interiors of the ship by introducing overtly modern features in an untidy configuration.

Plate 54. Evidence of wiring noted at the break of the poop on the quarterdeck

While it is accepted that features such as lighting, fire detection, fire suppression (when installed) are vital to the security of the ship and all persons on board, it is considered imperative that the plethora of incrementally installed cabling is rationalised to reduce its visual impact. It is recommended that a detailed survey of the servicing of the ship is undertaken, using data from the 3-D model (laser scan) and visual observation, with the aim to designing a less intrusive scheme. The idea of introducing conduits or hidden channels along elements of the deck head structures should be explored (**Plate 55**).
