## Preliminary Analysis of the Hull of the Roman Ship from Grado, Gorizia, Italy

Carlo Beltrame

The hull of the Roman wreck at Grado has been partially preserved under the cargo of amphoras. The right side presents a rare evidence of a section of the waterway. The ship has been assembled by mortise-and-tenon technique following a shell-first conception. All the frames, except one, are of pine while planking is either of pine and elm. Some strakes, of *larix*, are a repair made by patch-tenons; a wale shows an other kind of repair. Various signs left by the shipwright are on the hull. In the stern area, a box of wooden elements had to protect a 'hydraulic system'.

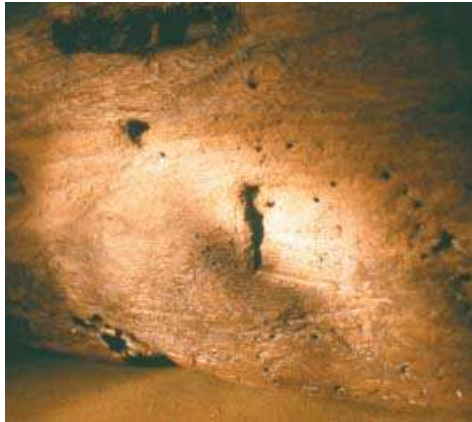
Figure 1. Scarf on a side of the keel. (C. Beltrame and D. Gaddi)

The keel of the ship is 9.5 m long. It has a trapezoidal section without rabbets and is connected to the garboards by mortises and tenons. There are evident traces of teredo on the bottom. On the sides of the keel there are square cavities, probably made to host side fastenings and possibly used to hold the keel rigid to the ways (Fig. 1). The stem and stern posts are not complete; they have rabbets where they were joined to the garboard, both by tenons and nails (Figs 2 and 3), and were connected to the keel by 'trait de Jupiter' joints (complex keyed hook scarfs). On the bottom of the sternpost-joint there are two nails (Fig. 4); as on the Madrague de Giens wreck (Rival, 1991: 165) and on ship no. 1 of Fiumicino. They were probably used to strengthen this part of the junction.

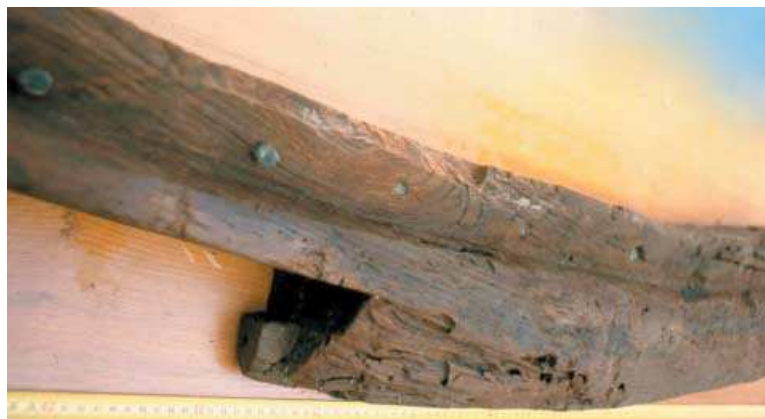
Figure 3. Rabbet and nails on the stempost. (C. Beltrame and D. Gaddi)

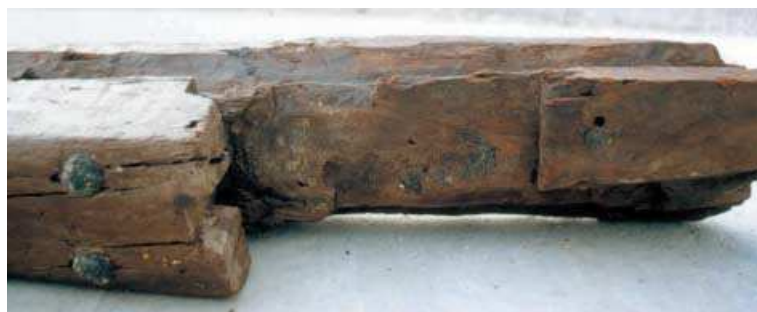
Figure 4. *Trait de Jupiter* joint of the sternpost reinforced by iron nails. (C. Beltrame and D. Gaddi)

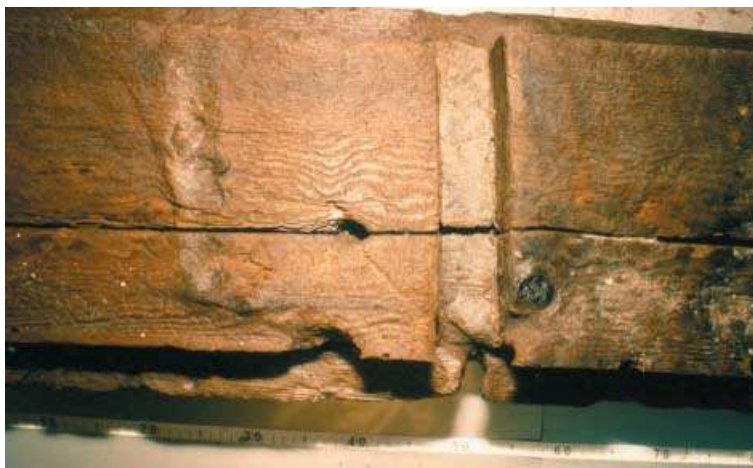
Figure 6. Insertions under the keelson. (C. Beltrame and D. Gaddi)

lets it sit over two beams (or 'small keelsons'), about 6.5 m long, without any nails. These beams are worked to stay on the frames. Nails, one with a flower-shaped head, held the small keelsons on to these frames. Each 'small keelson' has insertions in order to host two small wooden elements necessary to chock the keelson. On the bottom, this last one has five insertions (Fig. 6). In two of these, there are small wooden elements to stop movements along the axis of the ship where the mast stopped other movements.

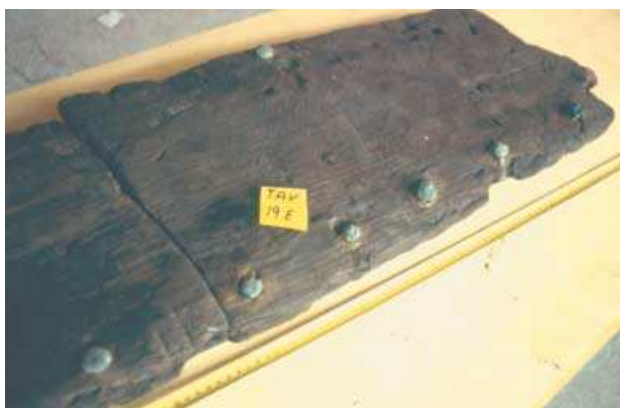
Figure 7. Nails along the edge of the garboard. (C. Beltrame and D. Gaddi)

the garboards by iron nails (Fig. 7). This solution, documented on many Roman ships, reinforced a very critical part of the hull where the planks had to bow. Traces of charring for bending the wood are present on the inner extremities.

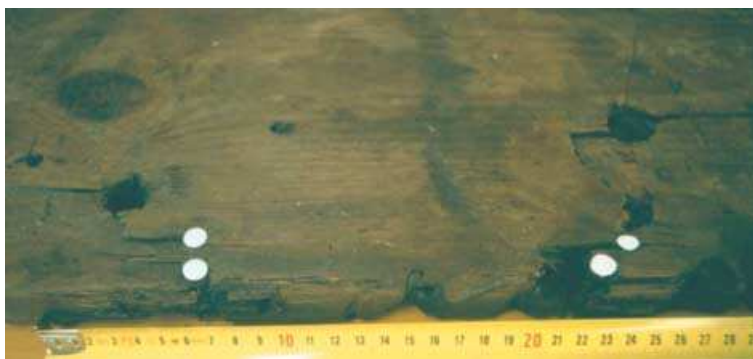
Figure 8. Double-pegs to stop tenons on a plank. (C. Beltrame and D. Gaddi)

On the better-preserved side there are 19 outer planks, whose average width ranges from 10 to 28 cm, and the thickness from 2.5 to 4.5 cm. They have been sawn on both radial and longitudinal axes. After they have been sawn, the *faber navalis* has worked their inner face by adze. No rule was followed in the building process and the centre of the tree is either outside or inside. In these planks, the average distance between the mortises is 7–8 cm, but this is very irregular. Various anomalies have been recorded on these joints. We have found three pegs, instead of two, to stop one tenon (Fig. 8), pegs not connected with any mortise, and mortises and tenons without pegs. In some cases these anomalies could be interpreted as the shipwright's mistakes, but we must bear in mind that the presence of pairs of pegs to fasten one tenon in a plank has also been seen on the

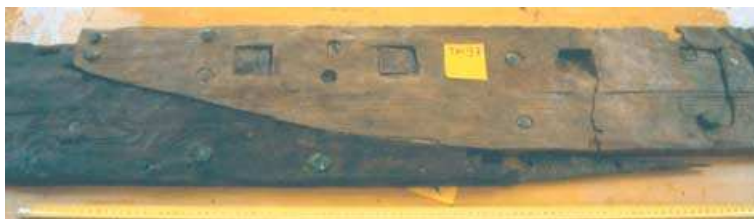
Figure 9. Diagonal scarf between two planks. (C. Beltrame and D. Gaddi)

Planks are jointed by diagonal scarfs and, in some cases, horizontal nails helped the junction of the extremities (Fig. 9). Each side of the ship has three wales. They are about 9 cm thick and have vertical diagonal flat scarfs (Fig. 10); these are also present in the so called '*pirogue*' from Pisa S. Rossore (Bruni, 2000: fig. 35). Wales and other planks are coated with a white material made from animal fat (Fig. 11); we cannot say whether it was paint or covering. In any case, as on all the other ships dated after the 1st century AD, the bottom of this vessel does not have any lead sheathing, but only a simple coating of pitch.

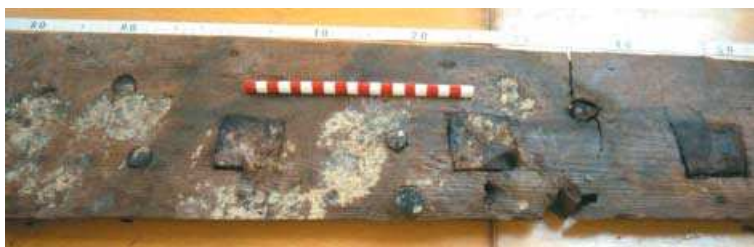
Figure 11. Patch-tenons and white coating on a plank. (C. Beltrame and D. Gaddi)

The Grado ship has had a significant amount of repair. Some planks have been substituted thanks to the use of patch-tenons inserted from the outside (Fig. 11), as on the Herculaneum boat (Steffy, 1999: 398). This direction of insertion is less frequent than that from inside the ship, as can be seen on the Roman wrecks of Tour Fondue (Dangreux, 1997), Barthélémy B (Joncheray and Joncheray, 1997a) and no. 5 of Place Jules Verne (Pomey, 1999: 323). This is probably due to the fact that normally only the inner side of the hull's

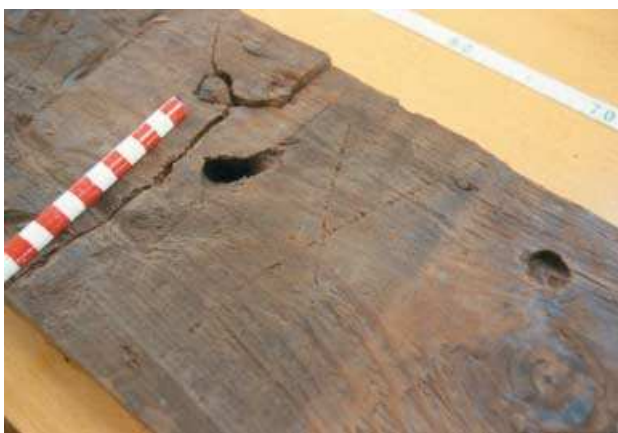
Figure 13. X graffiti between parallel lines on the inside face of a plank. (C. Beltrame and D. Gaddi)

On the inner side of some of the planks, the *faber navalis* made X-shaped graffiti between parallel lines, in the space not occupied by the frames (Fig. 13). Because these signs are present on replaced planks only, they must have been reference marks for use during the replacement of the planking. The analysis of this evidence is still in progress, taking into consideration the presence of similar parallel lines on the Punic ship of Marsala (Frost, 1981: 197), the Roman wrecks no. 4, Place Jules Verne (Pomey, 1999: 322), Gervais 3 (Liou and Gassend, 1990: fig. 98), Chrétienne A (Frost, 1963: 266), Chrétienne C (Joncheray, 1975: fig. 19), Mainz (pers. comm. R. Bockius), Oberstimm (Bockius, 2002: 18–19, 21, 51), and the Yassi Ada Byzantine wreck (Van Doorninck, 1982: 59).

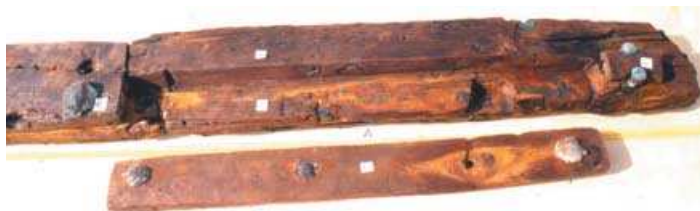
Figure 14. A complex repair on a wale. (C. Beltrame and D. Gaddi)

A repair is also present on a wale. In fact a plank has been repaired to replace a broken part with three small pieces of wood (Fig. 14). These elements have been nailed one on to the other in order to fill the space left by the working of the thick plank. This repair has no structural force but only an aesthetic value. A horizontal nail on a plank could have been used during the building of the ship to close a break. A moving knot on a plank has been stopped with two small nails to prevent a hole; in any case, the hole could not become dangerous because the plank was at a high level.

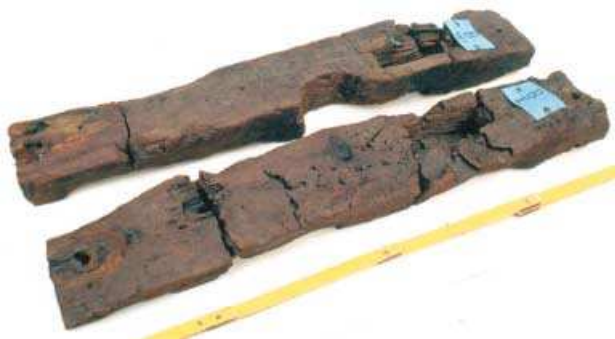
Figure 15. Small planks present on each side of the longitudinal axis of the ship. (C. Beltrame and D. Gaddi)

In the stern area are two small planks, about 75 cm long, made of red fir (*Picea abies* Karst), one on each side of the longitudinal axis of the ship (Fig. 16). They were nailed over floor-timbers

and had rectangular mortises that could have hosted a small stanchion. Connected to these were horizontal tablets of fir (either *Picea abies* Karst or *Abies alba* Mill) which, together with floor-timbers, protected a lead tube that was inserted in the hull between the garboard and the first strake. The tube was nailed to the planks thanks to the presence of a double flange. The interpretation of this tube is still not clear, but, considering that piston pumps were already known in the Roman period and that they could be made either of metal or of wood (Schjøler, 1999), it is possible that it was part of a pump which was either recovered from the site or destroyed by post-depositional agencies. The pump could either discharge water, in a very modern way, under the bottom of the ship, or suck in water from the sea; we are more inclined to the second hypothesis (Beltrame and Gaddi, 2005: 42–6).
