7/27/15

Young America 1853 – POB 1:96 Part 10 – Hull Fairing – Method 1

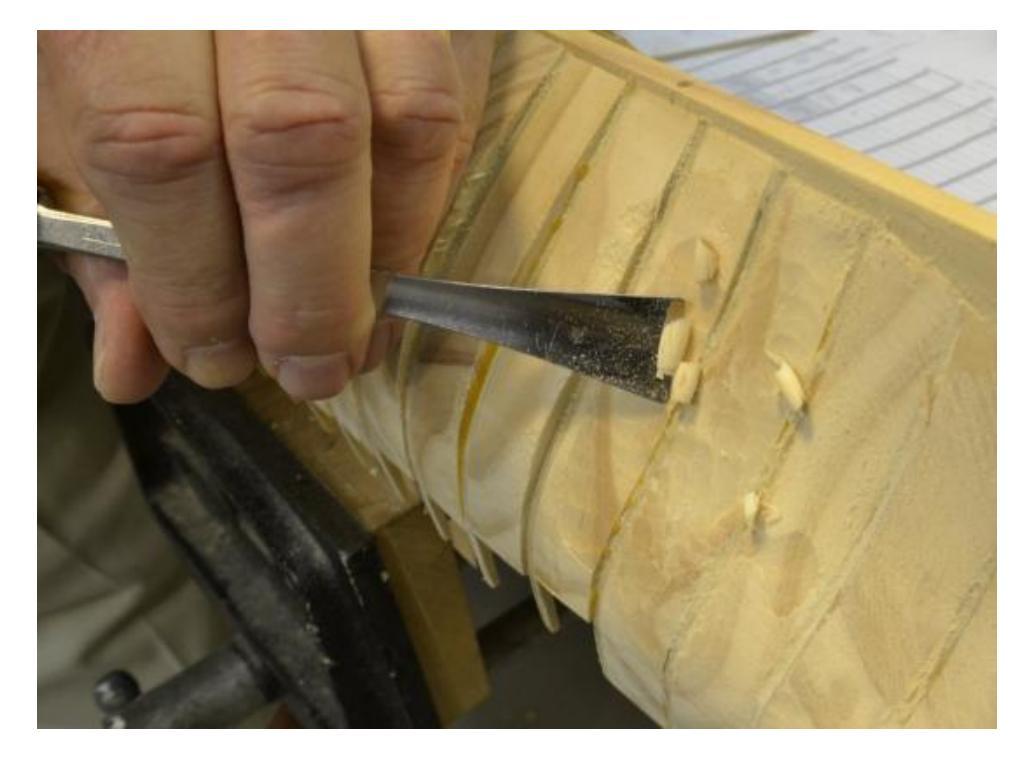
The first picture shows shavings being pared off the hull using a shallow curved gouge with hand pressure.

A solid anchoring of the hull is essential to allow two hands for this work. The sharp gouge easily removes thin cross-grain shavings. In the next picture a deeper gouge is being used with a mallet to chip off larger pieces of the extreme bevels near the stern. Again, this requires the hull to be firmly secured.

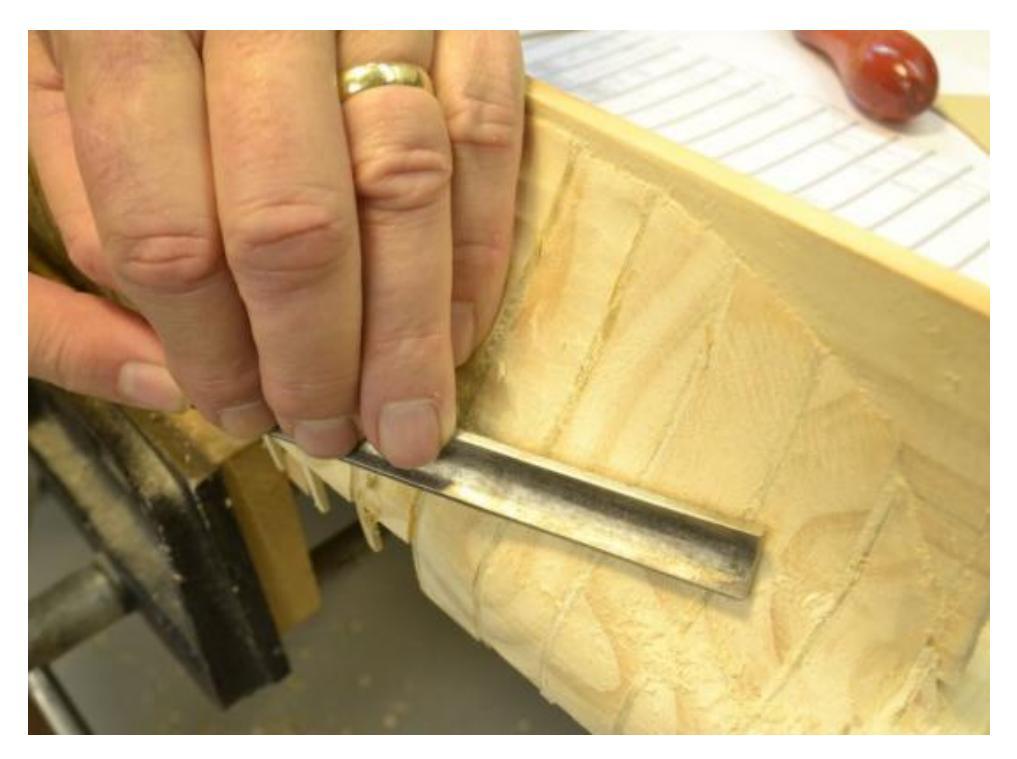
After paring with the gouges the shape was further smoothed out with fine-cut rasps. The curved rasp in the next picture was used on the concave surfaces.

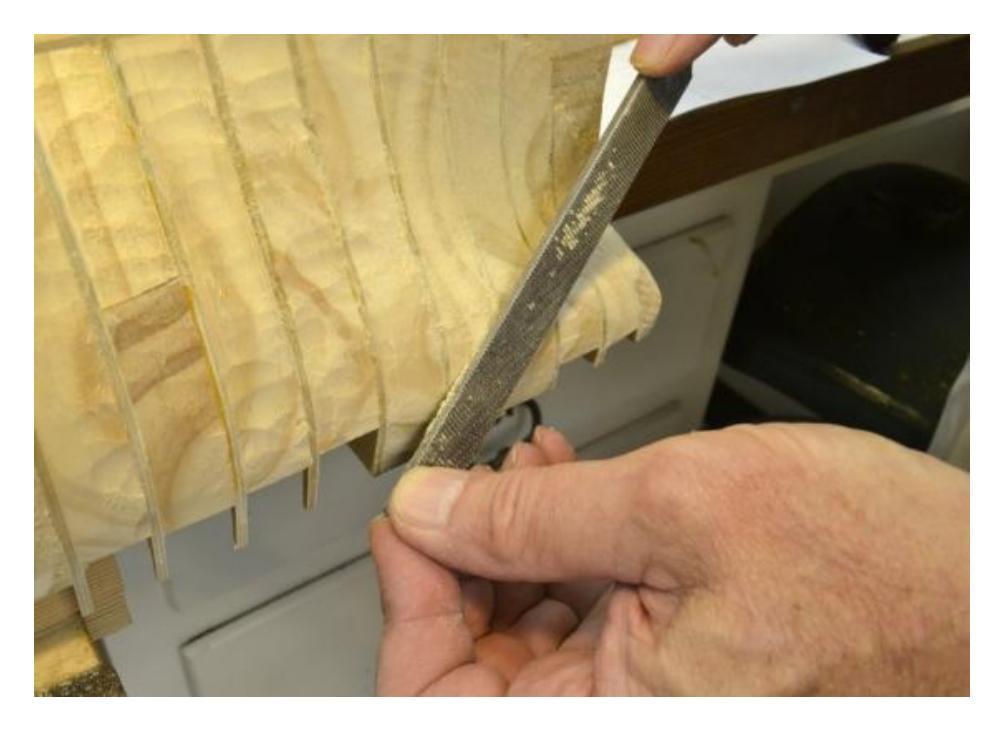
A flat rasp was used on the convex hull surfaces as shown in the next picture.

The rasps used here are fine-cut Iwasaki® carving rasps. This is not a job for the coarse hardwarestore variety. You can pay almost anything for a rasp. These are good quality and reasonably priced. The last step on this side was done with 120-grit sandpaper on Softsander® pads – as shown in the next two pictures.

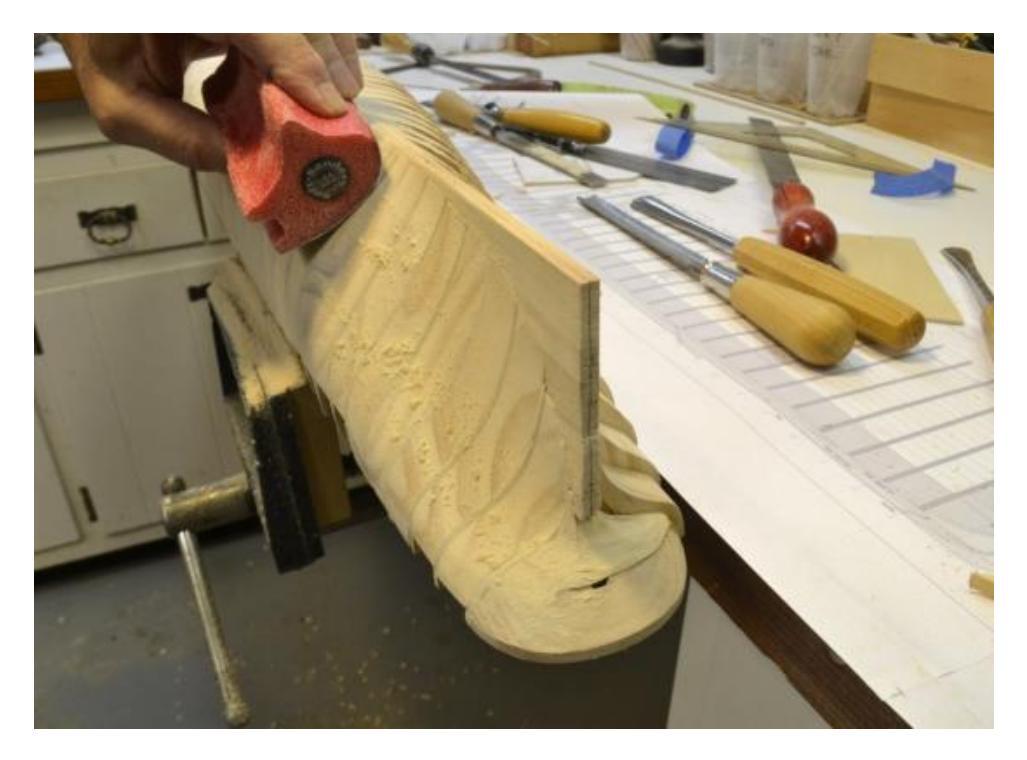
The above picture shows the finished and unbeveled sides and gives an idea of the amounts of wood to be removed.

The rasping and sanding bevel the plywood bulkheads as necessary to leave a smooth surface. This involves trimming only the small side of the plywood shapes. This point is indicated by feel as well as sight.
