Young America 1853 – POB 1:96

Part 18 – Fairing the Upper Works

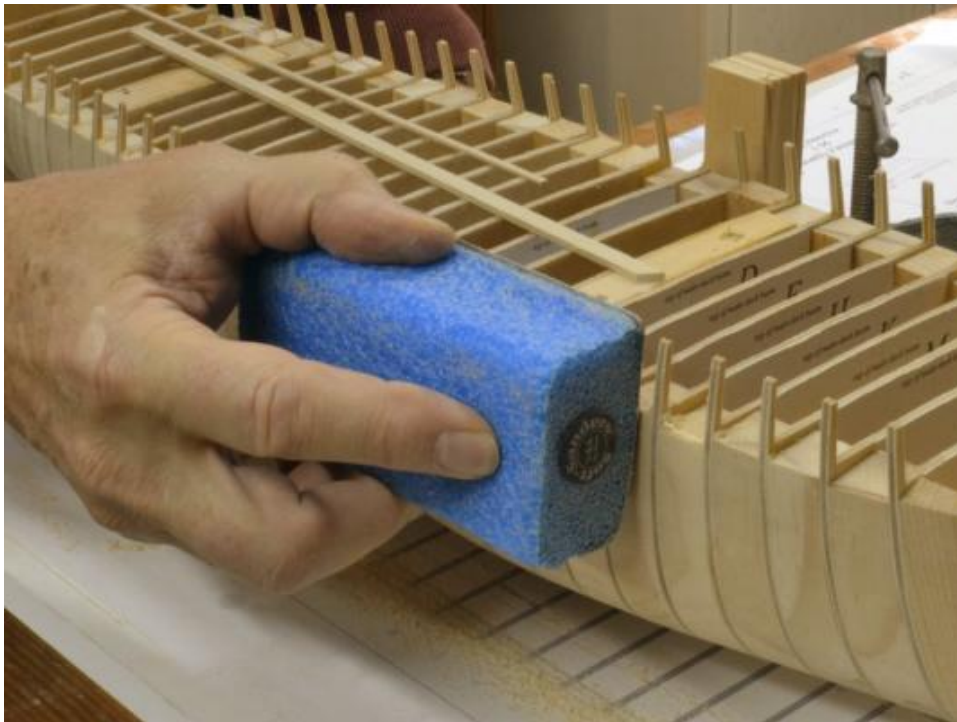
When the hull was faired earlier, in the inverted position, little attention was paid to the upper works, so the outside of the toptimbers needed some work. The sanding required to fair the outside of these was light. The first picture shows this in progress using 220-grit paper on a Softsander® foam pad.

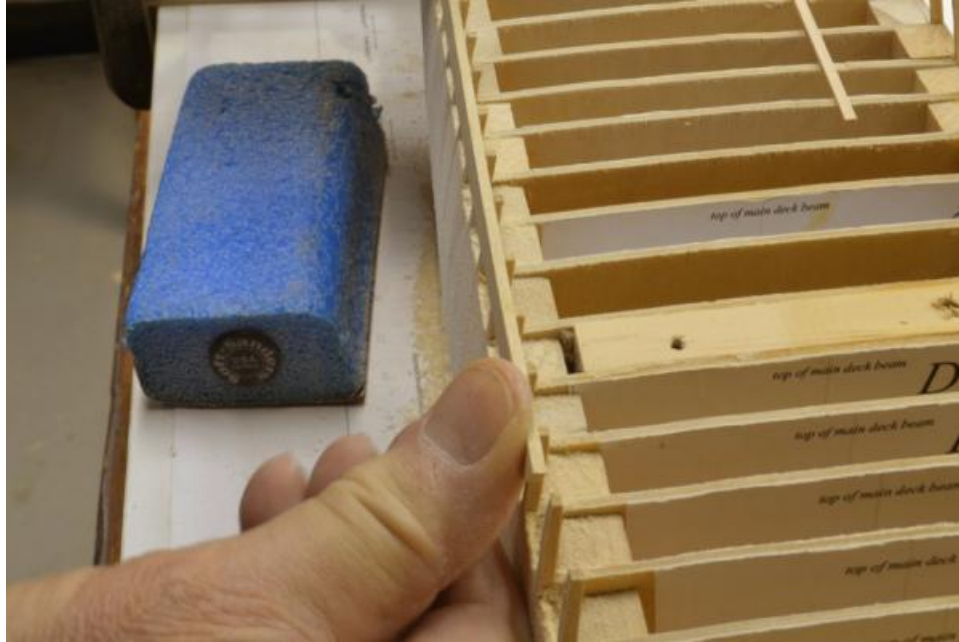
In the next picture the fairness is being checked with a pine batten.

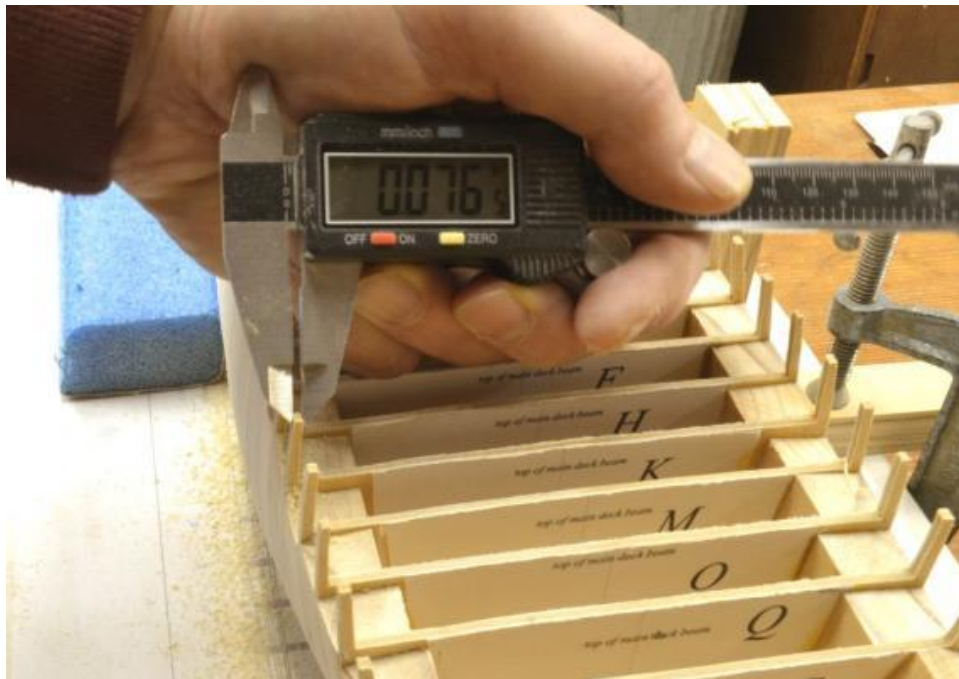
The toptimbers were molded 6" at the top. In the next picture this is being checked with calipers.

You can see from the reading that they are still oversized somewhat at .076". They would later be faired to the final 6" (.0625") by sanding the insides – but only after some reinforcing outer planking was in place. However, it was necessary at this stage to fair the deck "beams" accurately – as shown in the next photo.

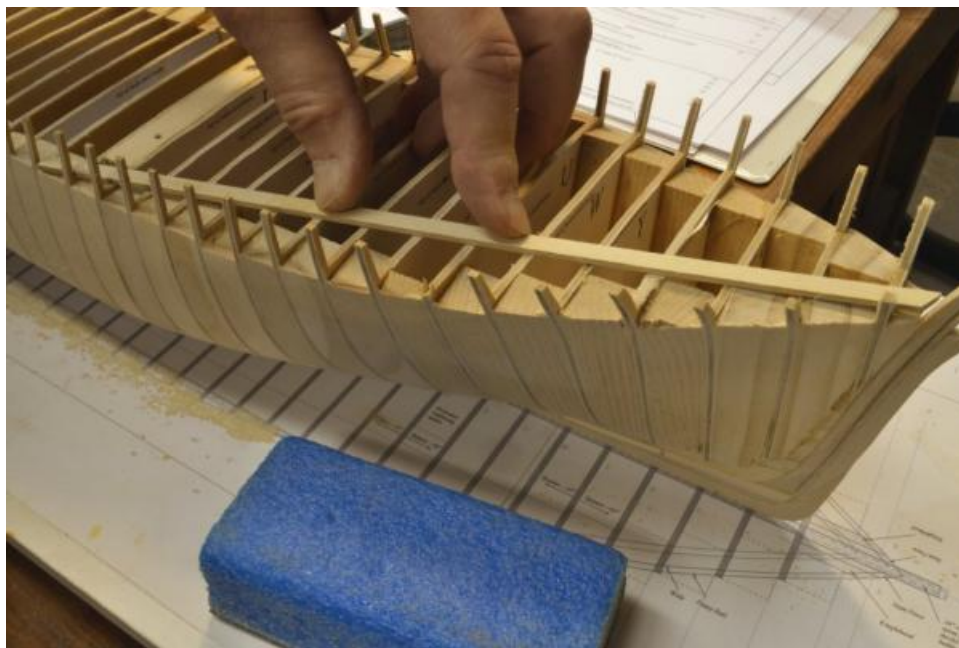
Fairing of the deck was particularly important to avoid waviness in the thin deck planking that would be added later. In the next picture this is being checked during the sanding process using a pine batten.

When this work was being done, I did not expect to take this model to much further and consequently spent less time getting the deck line faired than I should have. I will show the final deck planking later. While acceptable, more attention at this stage would have yielded a truly beautiful installation of the long, spacious open main deck.
