## The basque whaling ship from Red Bay, Labrador: a treasure trove of data on Iberian atlantic shipbuilding design and techniques in the mid-16th century

## ROBERT GRENIER

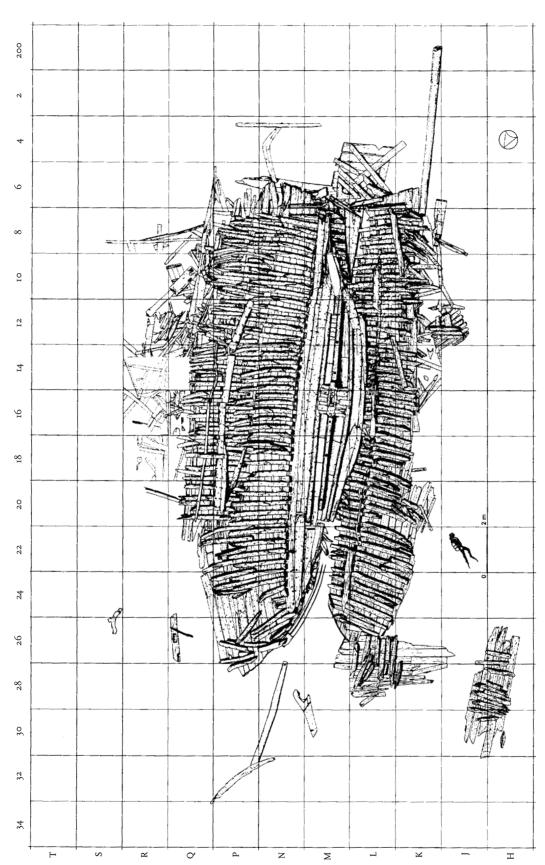
curve of the stem, the keelson and main mast step, followed by the lower end of the stern post and the collapsed transom. The longitudinal timbers on the upper middle section indicate the level of the lower deck (Drawing: P. Waddell, Parks Canada; 24M-84-101-07). FIG. 1 - Site plan showing mostly articulated structural remains, exposed following the excavation of the hull interior. From left to right down the centreline are: the bowsprit, leading to the gentle

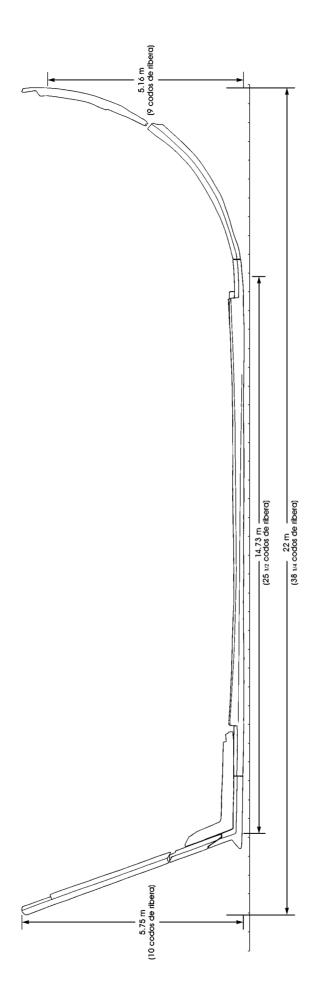
FIG. 3 – Profile of the principal timbers, showing their basic dimensions. The stem conforms roughly to an arc of 9 codos (5.16m) radius, reflecting theheight of the stem at its forwardmost point. The keel length (14.73m) ispresented here as a measurement between the upturn in the keel rabbet at stemand stem. At the stem this corresponds to the aft end of the keel-to-stemscarph (not visible) while in the stem this occurs at the upturn of the heeltimber (Drawing: C. Piper, Parks Canada; 24M-94-103-2).

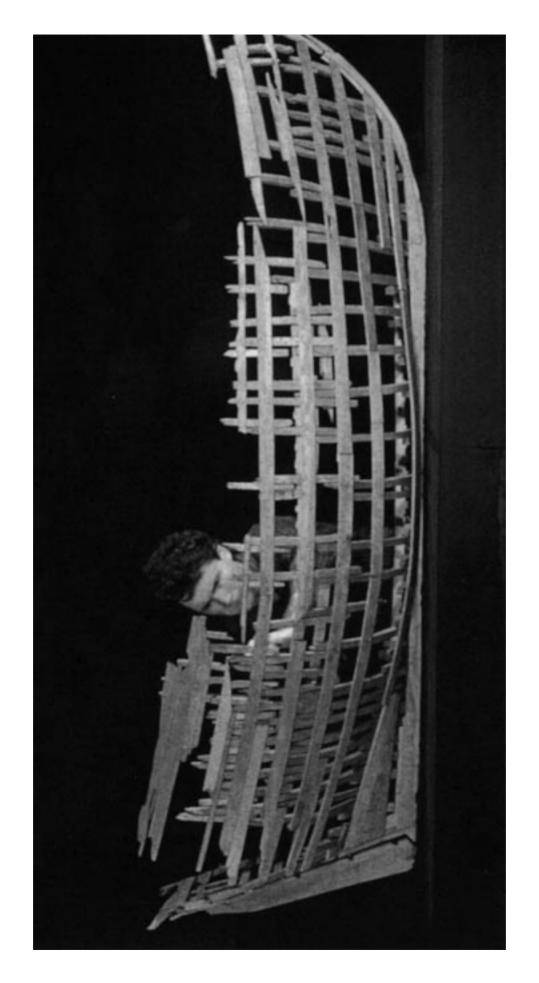
FIG. 4 – During the excavation, construction of a 1:10 scale model of the hull remains was commenced, following Richard Steffy's pioneering work on this research process. This is an outboard view of the starboard side of the archaeological model, mostly up to the waterline. Model maker Marcel Gingras is shown behind. Only selected framing and planking is in place (Photo: D. Pagé, Parks Canada, RD-4459T).

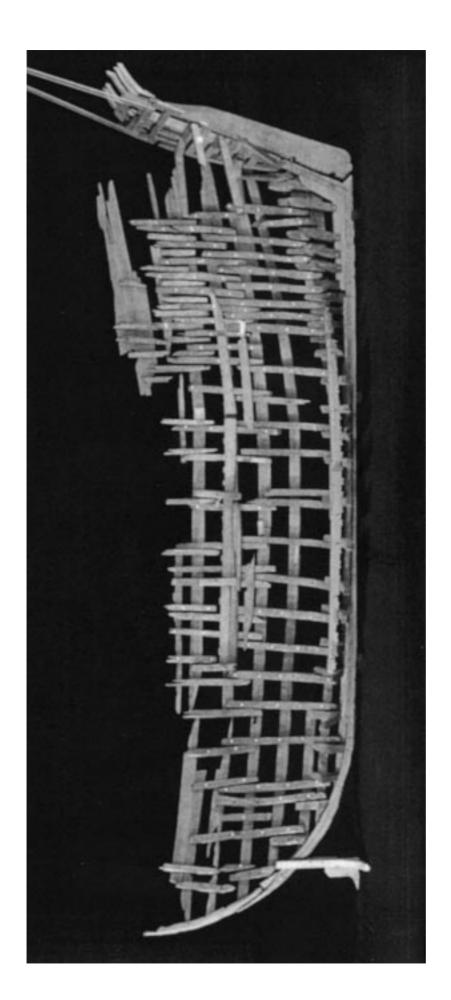
frame, were pre-assembled and laterally connected at dovetail joints (Figures 9 - 13). 'Floating frames', as in shell-first construction framing method, were not laterally connected and are evident on the model at the level of the second futtocks from bow to stern and at the level of the first futtocks fore and aft of the central pre-assembled frames. The white dots show mysterious inner 'plugs' linked to the - Inboard view of the starboard side of the model with selected frames and planks in place. The floors and first futtocks of fourteen midship frames, from the 7th aft to the 6th forward of the master design and construction process (Photo: D. Pagé, Parks Canada, RD-4458T).

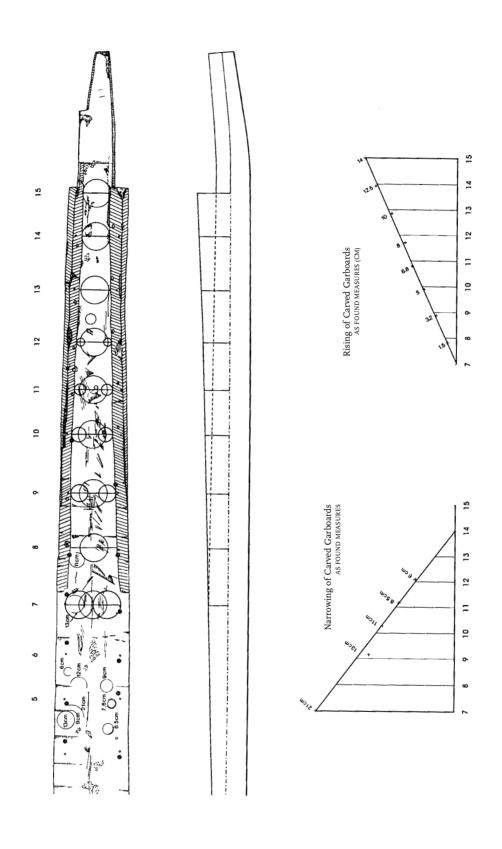
face (an example of the graminho system). The narrowing decreased in increments that corresponded to the diameters of the scribed circles. While the flat surface of the keel is horizontal, the sides of the integrated garboards rise with no relationship to the scribed circles (Drawing: C. Piper, Parks Canada; 24M-94-103-1,1a, 1b). FIG. 6 - Schematic drawings showing the forward end of the keel, in plan and in starboard profile, at the positions of the 7th - 15th frames forward of the master frame. They show the keel's rising forward end with integrated carved garboards, the narrowing of the flat surface between the garboards, and our interpretation of how the scribed circles were related to the narrowing of this sur-

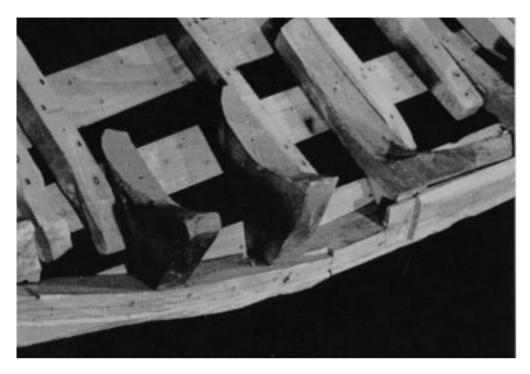
FIG. 7 — Detail of the model showing an oblique view of the scarph joint between the carved keel with integrated garboards (at right) and the heel of the stem (at left). Notice how the forward end of the carved keel yields to a standard garboard arrangement at the stem scarph (Photo: R. Chan, Parks Canada, RD-309X).

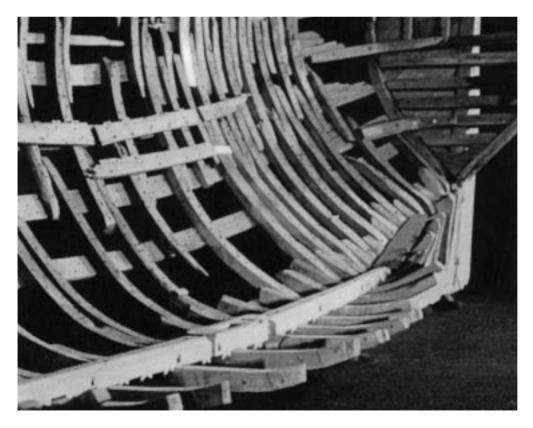
FIG. 8 – The model, looking aft viewed obliquely, from the centre towards the starboard quarter, featuring the keelson, main mast step, dovetailed floor timbers, and, in the background, a portion of the transom structure (Photo: R. Chan, Parks Canada, RD-3IOX).

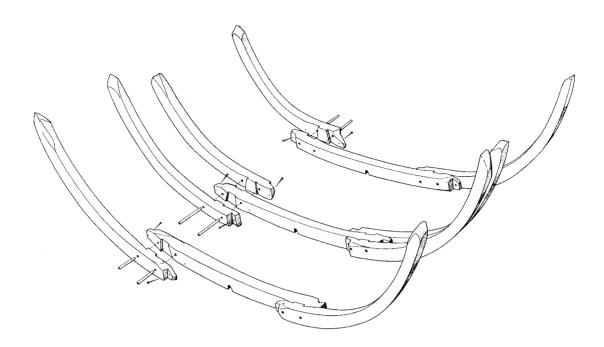
FIG. 9 — Exploded view of the lateral dovetail joints of the master frame and of the 1st frames forward and aft, both identical in section to the master. Notice the combination of two large treenail fastenings and two metal spikes at each floor to first futtock joint, all of which were driven fore-aft (Drawing: R. Hellier, Parks Canada; 24M-83-103-14).

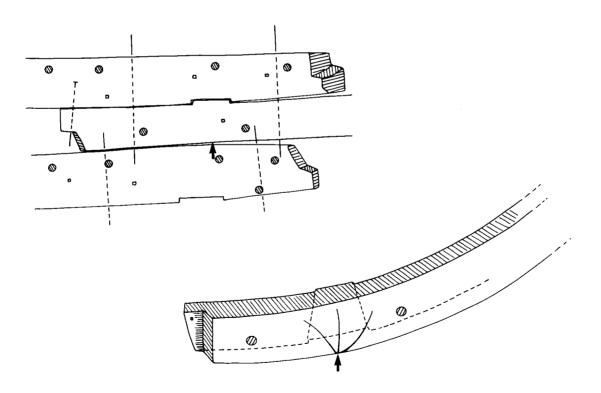
FIG. 10 – Schematic drawing showing the location of a scribed 'arrow' used to mark the turn of the bilge on the first futtock, TT 407. Similar marks were found on other futtocks from the fourteen morticed frames (Drawing: C. Piper, Parks Canada; 24M-94-103-9).

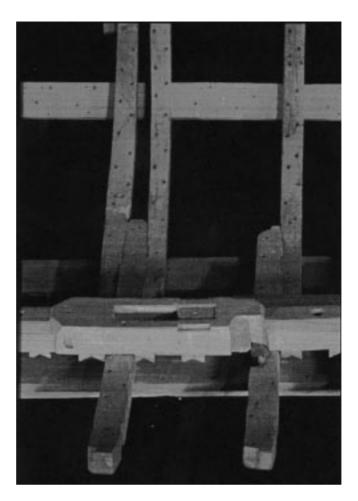
FIG. 11 — Detail inboard view of the model, facing starboard, featuring the mast step assembly locked over the master frame (at left), the main mast mortice, the roughly cut pump well sump, and the indented under side of the keelson. Notice that originally four first futtocks were dovetailed to the master floor, although only two are in place on the model (Photo: D. Pagé, Parks Canada, RD-444oT).

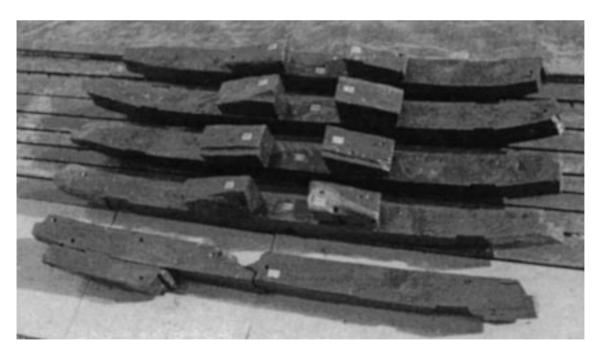
FIG. 12 — After they were raised to the surface for recording, four of the midship floor timbers (1st forward to 3rd aft of the master frame, top to bottom) and eight reinforcing chocks for the main mast step were placed in their original arrangement for this photograph. The second frame from the top is the master frame, with two dovetail mortices at either end. In the foreground, the floor shows the carved-out sump hole cut vertically through it (Photo: R. Chan, Parks Canada; 24M-2056M).

FIG. 15 — Reconstruction drawing of the mast step assembly as found, facing the starboard bow, showing: the keelson's enlarged dimensions around the rectangular mortice for the mast heel (with an inserted corrective block), the roughly cut sump hole on the port side, and, as shown in Figure 12, four chocks on either side of the step separated by empty spaces which were sealed by short planks. The chocks were morticed into heavy footwales, which ran parallel to the keelson. In the foreground, unfastened limber planks lie atop the floors between the keelson and footwales. Notice the 'T' shape of the carved keel (Drawing: C. Piper, Parks Canada; 24M-87-103-1a).

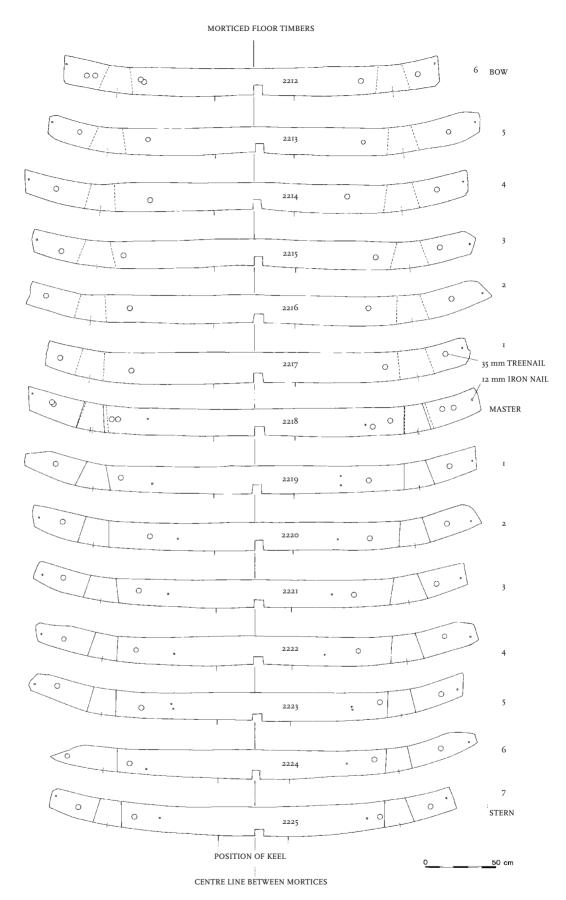
FIG. 13 – Schematic drawing showing the stern faces of fourteen morticed midship floor timbers. Mortices cut into the forward faces of the floors are indicated by a dashed line (Drawing: C. Piper, Parks Canada; 24M-92-103-5).

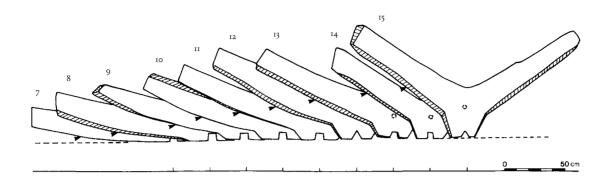
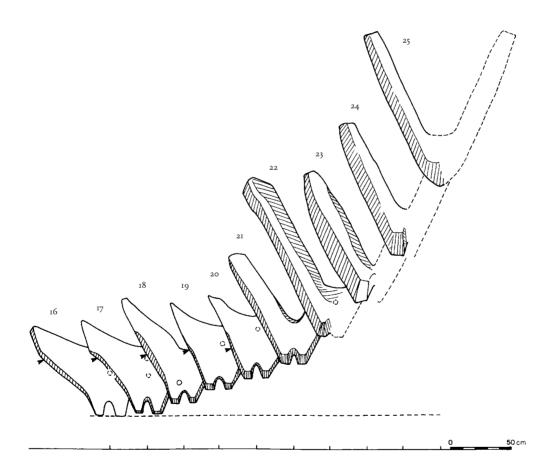
FIG. 14 — Schematic drawings of the rising floor timbers 7th — 25th forward of the master frame. Unexplained 35mm 'plugs' were located on the aft faces of the crutches (except the 18th forward), and are indicated here by a dashed 'o' since the view is from forward. The arrows indicate the position of the flower-line ribband. Notice the variability in the shape of the limber holes (Drawing: C. Piper, Parks Canada; 24M-95-103-21, 21a).

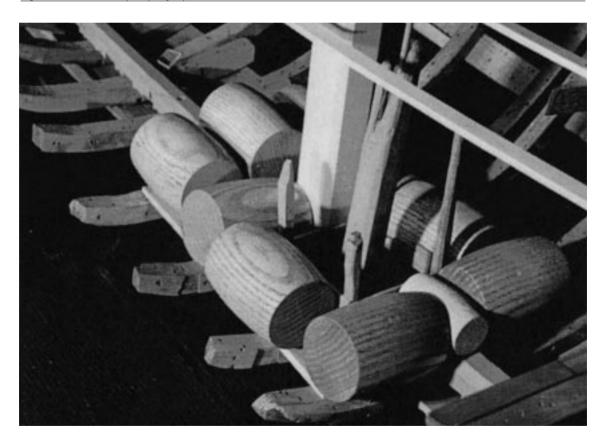
FIG. 16 – Model detail showing the base of the main mast and the pump well assembly with the pump tube in the middle, surrounded by the four corner posts of the well chamber. The cask stowage arrangement shown here was determined archaeologically by *in-situ* cask remains and dunnage patterns on the ceiling left by ballast stones around the pump well (Photo: R. Chan, Parks Canada, RD-302X).

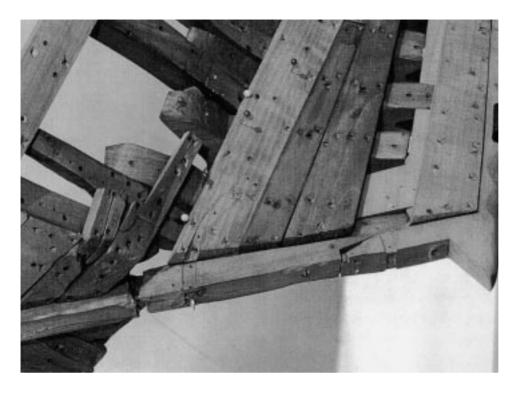
FIG. 18 — Lower starboard stern of the model at the keel and stern post junction, showing carved planks wrapped around the lower end of the fashion piece, creating a seamless link between the transom and starboard side. This was a clever way to overcome weakness and leakage at this critical junction in the square tuck hull (Photo: R. Chan, Parks Canada; RD-1137W).

FIG. 20 — The model's transom planked in a chevron pattern with the carved planks shown in Figure 18 at its base. The starboard transom is pierced by a large, square loading port with a hinged cover. On the port side, a much smaller square port shows signs of a nailed cover on the outside. The transom and stern post also show the imprint of two rudder gudgeons and straps. A third gudgeon mortice appears at the very top end of the stern post just below the tiller port. Above the tiller port is a single carved timber morticed over the counter frames and pierced with two hawse holes. On the port side top corner above the transom beam, a standing knee defines the tumblehome of the absent fashion piece (Photo: C. Moore & R. Chan, Parks Canada, RD-1106W).

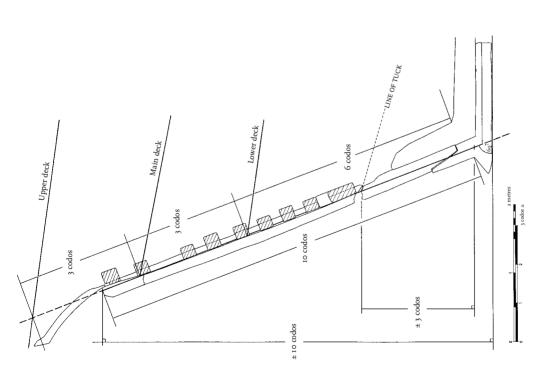
FIG...η – Schematic drawing of the stern post's starboard elevation showing how the basic proportions of the stern are whole *codos de ribera* (57.46cm) measurements. Also notice the 69° angle of the stern post, a diagnostic feature of ships of the period (Drawing: C. Piper, Parks Canada; 24M-91-103-15a)

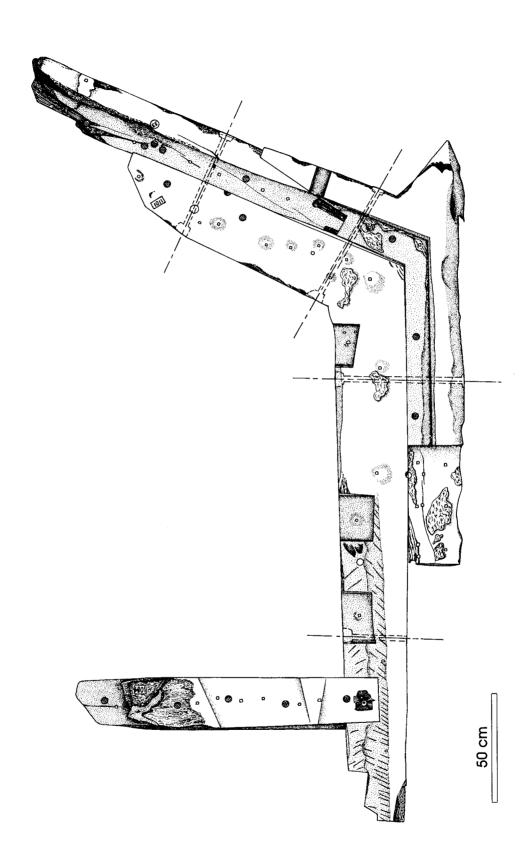
FIG. 19 – Drawing of the port side of the heel assemblage showing the lower fragment of the stern post scarphed to the heel timber and linked together by a huge stern knee and iron bolts. One crutical timber, the 17th aft of the master frame, is shown morticed over the forward end of the knee (Drawing: S. Laurie-Bourque, Parks Canada; 24M-83-103-2).

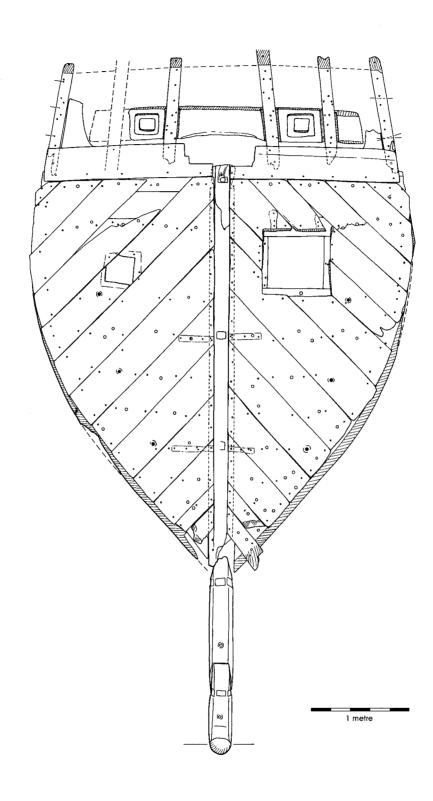
FIG. 21 – A drawing of the flat transom showing many of the features identified in Fig. 20. Notice the six large iron bolt holes which reveal the positions of internal lodging knees, some of which are shown in Fig. 22. This drawing also emphasizes the location of the two lowermost rudder gudgeons and their strapping, out of a total of five (Drawing: C. Piper, Parks Canada; 24M-91-103-14a).

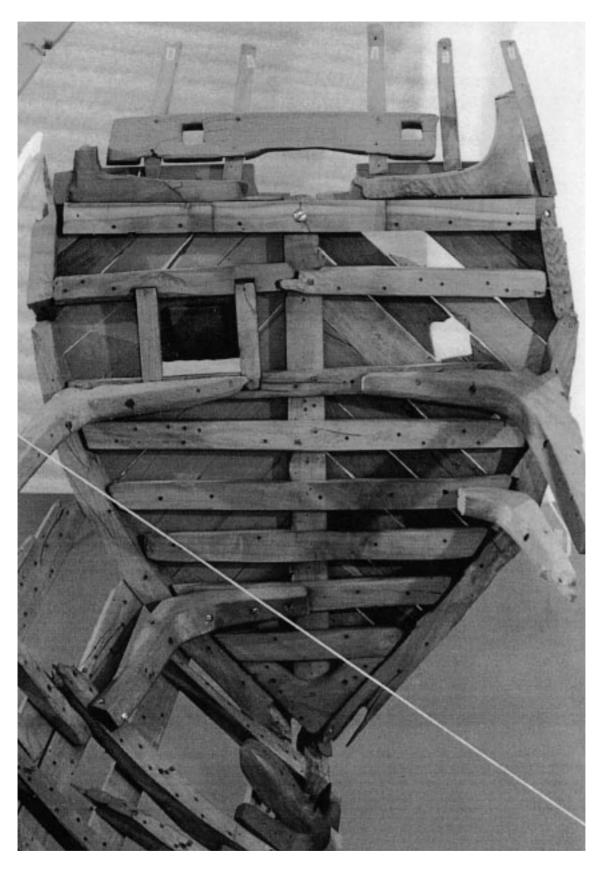
$_{\text{FIG.}\,22}$  – The model, showing the inboard structure of the flat transom stern. The break-up of the hull scattered many of the lodging knees, and at least two examples missing here were not relocated on site (Photo: C. Moore, Parks Canada; RD 1162W).

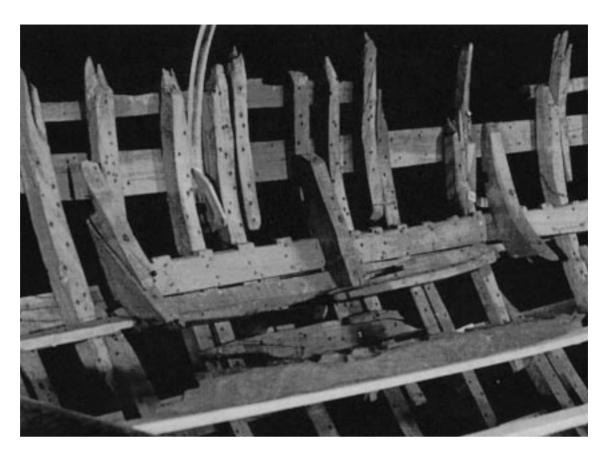
FIG. 23 – Inboard view of the starboard side of the model, showing three lower deck standing knee fragments fixed to the wall of the ship. They were flanked by short, notched sill planks (*albaola*), and sat over a carved waterway. Below the carved waterway fragment on the model, in the centre of the photograph, is a short section of the beam shelf (Photo: R. Chan, RD-326X).

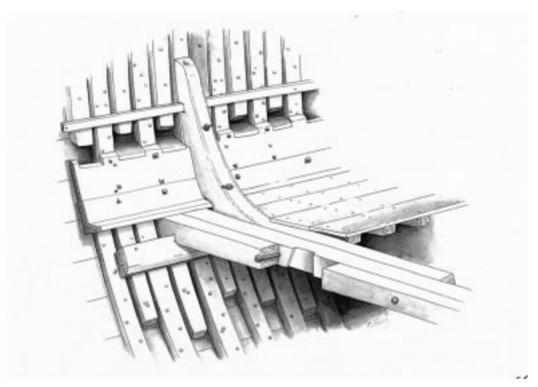
FIG. 24 – Lower deck reconstruction drawing from archaeological evidence, featuring: double deck beam, standing knee, waterway, *albaola*, and stringer (Drawing: C. Piper, Parks Canada; 24M-93-103-8).

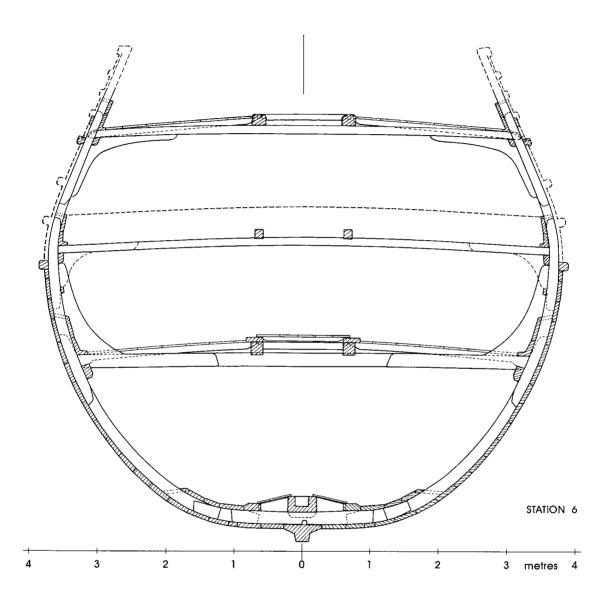
FIG. 25 — The Red Bay vessel's reconstructed midship section, taken at the master frame. Most of the main deck features had vanished, except for a few indicators on fragments of related futtocks. While evidence for the level of the main deck in the bow and stern is firm, the evidence available for its level at midship is somewhat ambiguous. On the one hand an initial location at 3 cubits (codos de ribera of 57.46 cm) above the lower deck as expected from the documents and Basque practices, while on the other hand a subsequent raising of this deck there (shown by the dotted line) is suggested by fastener evidence. It should be noted that the available evidence suggests the absence of planking on the main deck at midship. The upper and lower deck levels are more firmly established by archaeological evidence (Drawing: C. Piper, Parks Canada; 24M-92-103-7b).

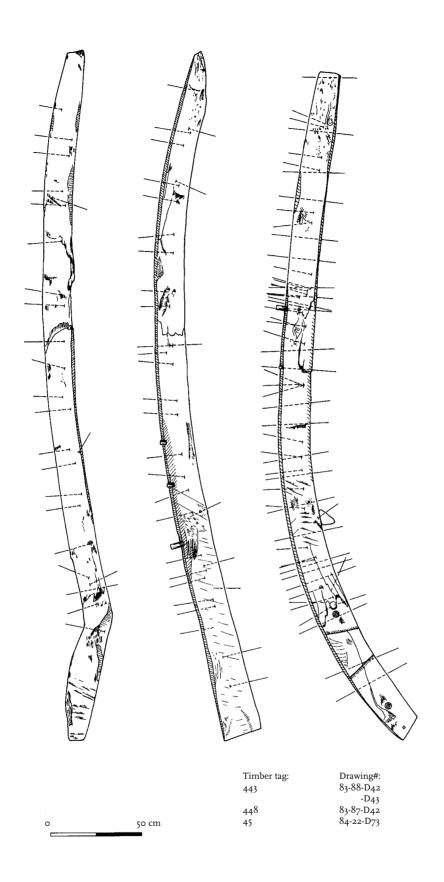
FIG. 28 – Drawings of three futtocks of different types illustrating the level of detailed archaeological recording of timbers conducted at Red Bay, including tool marks and fastener angles and depths of penetration (Drawings: J.C. Farley, C. Piper, R. Hellier, Parks Canada; 24M-95-103-9A).

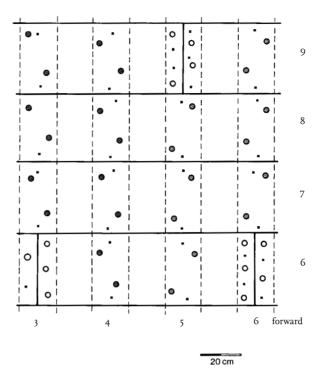
FIG. 29 — Schematic drawing showing the typical fastening pattern of two treenails and two iron nails per frame in the outer hull planking. This detail shows strakes 6 to 9 in the area of the 3rd to 6th first futtocks forward of the master frame. Notice the change of treenail pattern: treenails on the 3rd and 4th futtocks angle aft, while those on the 5th and 6th futtocks angle forward. Also observe the variability in the butt-end fastening pattern (Drawing: C. Piper, Parks Canada; 24M-94-103-13).

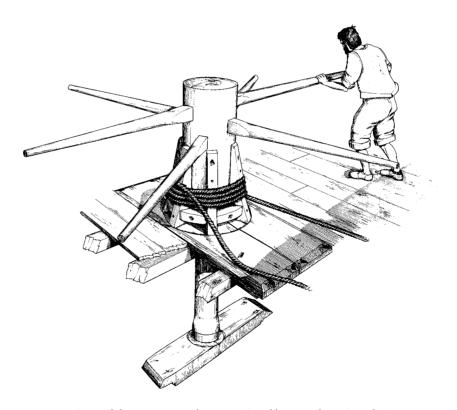
FIG. 30 – The capstan reconstruction, with bars, partner, and step, positioned between the main and mizzen masts on the upper deck. The increased thickness of the partner assembly at its forward end (middle right) is noticeable, designed to compensate for the deck sloping down forwards. The step sits transversely astride two hatch carlings on the main deck below. The capstan is a one-piece timber fitted with six whelps to guide and grab the turns of the rope at its lower end (Drawing: R. Hellier, Parks Canada, 24M-83-103-4).
